Rail Accident Investigation Branch

Rail Accident Report

Derailment at Ely Dock junction 22 June 2007

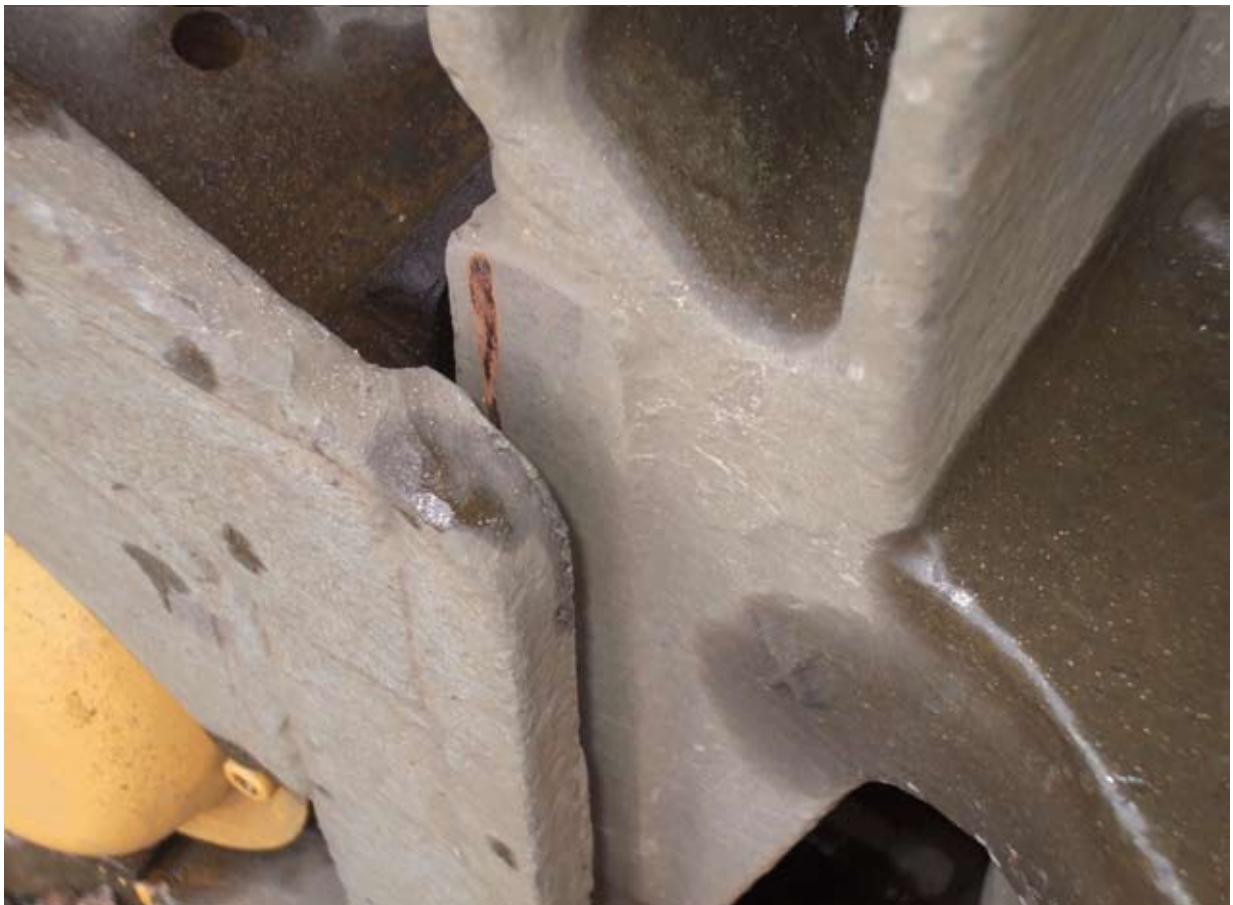
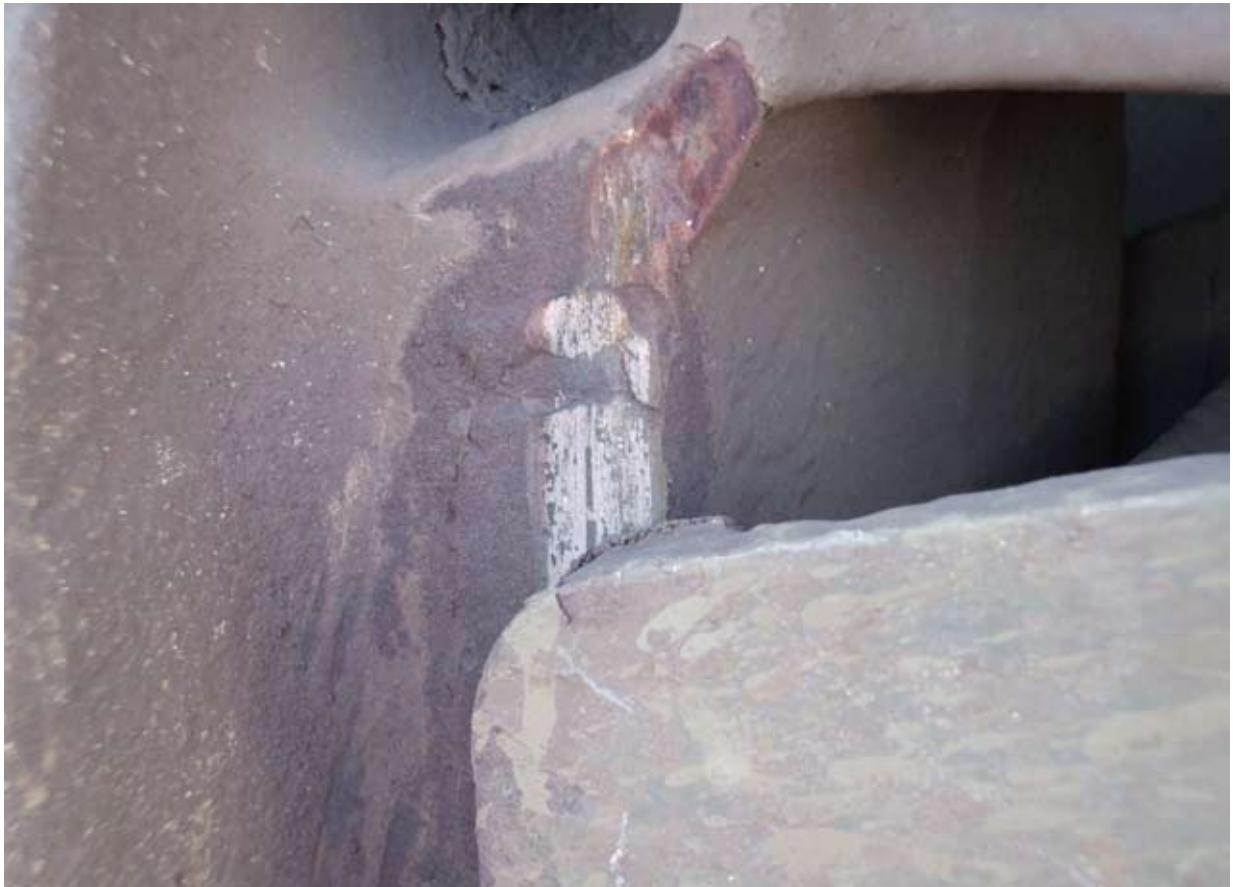
Figures 51 & 52: Wear and heat damage to pedestal liners of SDT PHA wagons
