Rail Accident Investigation Branch

Rail Accident Report

**Derailment of a road rail vehicle at Terryhoogan,
near Scarva, Northern Ireland
9 March 2008**

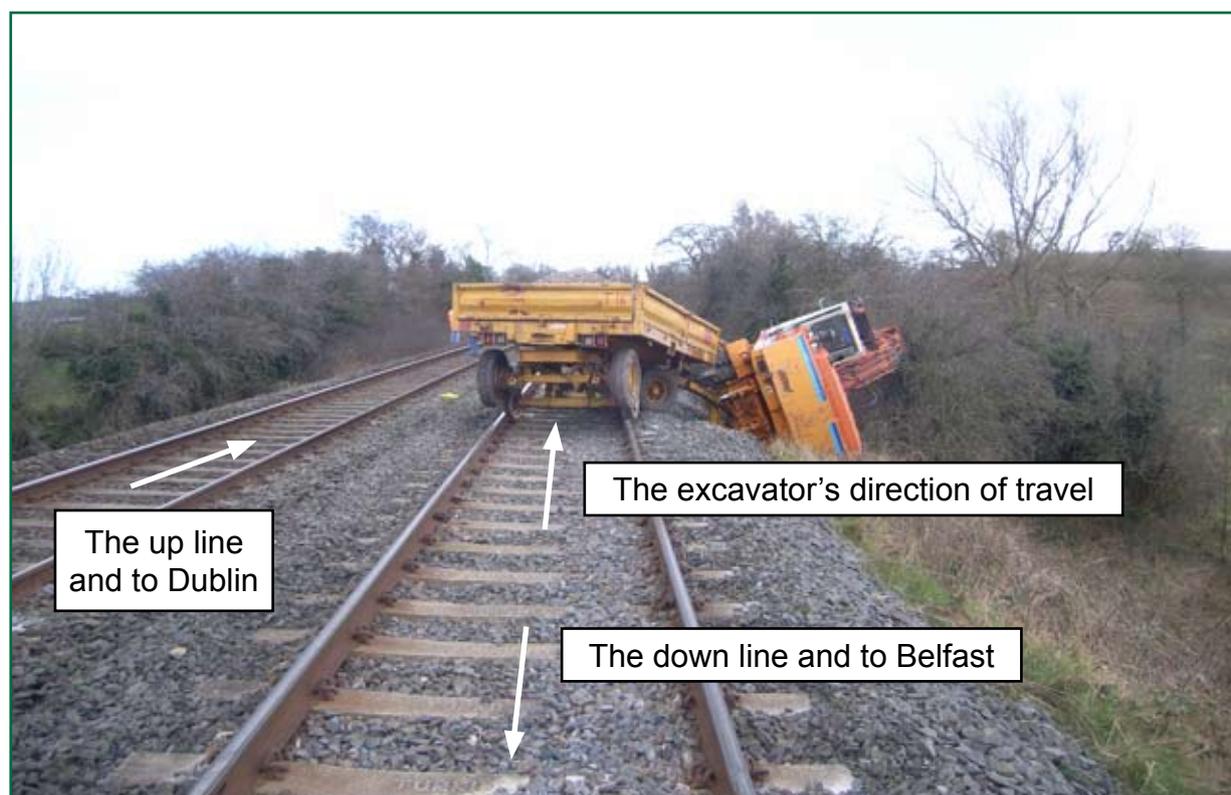
Figure 2: The excavator and the trailing wagon

- 33 By calculation, it was determined that the excavator overturned and stopped within 3 seconds of derailing. It came to rest 6.5 metres from the point of derailment; here, it was completely off the track and on its side, supported in this position on the embankment by a tree. Its descent derailed its wagons and pulled them part way over the embankment edge (Figures 2 and 11).

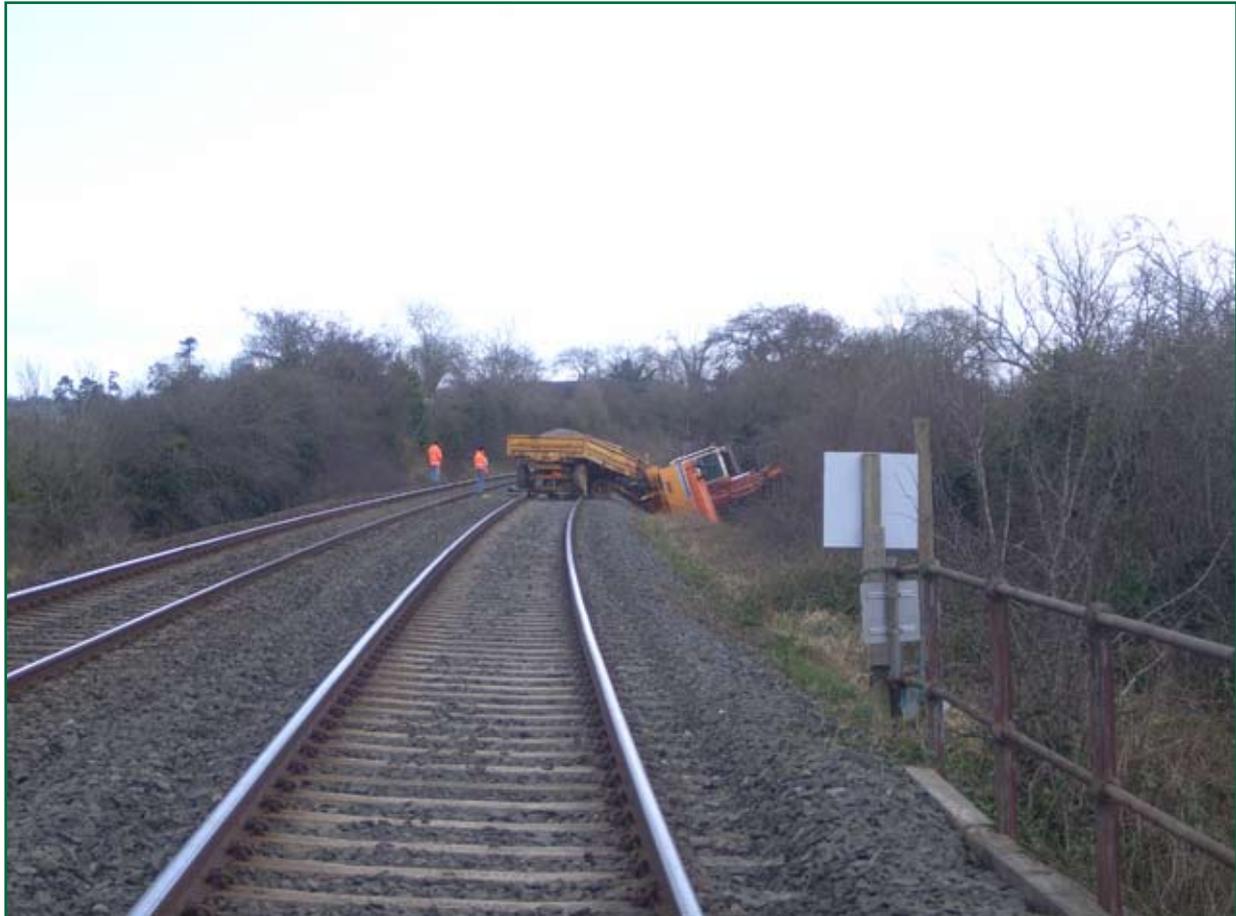
- 14 At the point of derailment the line runs on a narrow and steep sided embankment. The track rises at 1 in 137 and is canted (banked) for a right-hand curve (Figure 3); as a result, vehicles that negotiate the curve at low speed move towards the inside of the curve, their right-hand rail wheel flanges running in contact with the right-hand rail.

Figure 3: The track is curved, canted (banked), and on a rising gradient in the direction of travel

- 42 The following factors were causal to the derailment:
- a. the operator transferring the excavator's weight from its rail to its road wheels (paragraph 28); and
 - b. the canted track that brought the excavator's right-hand rail wheel flanges into contact with the right-hand rail (paragraph 14).

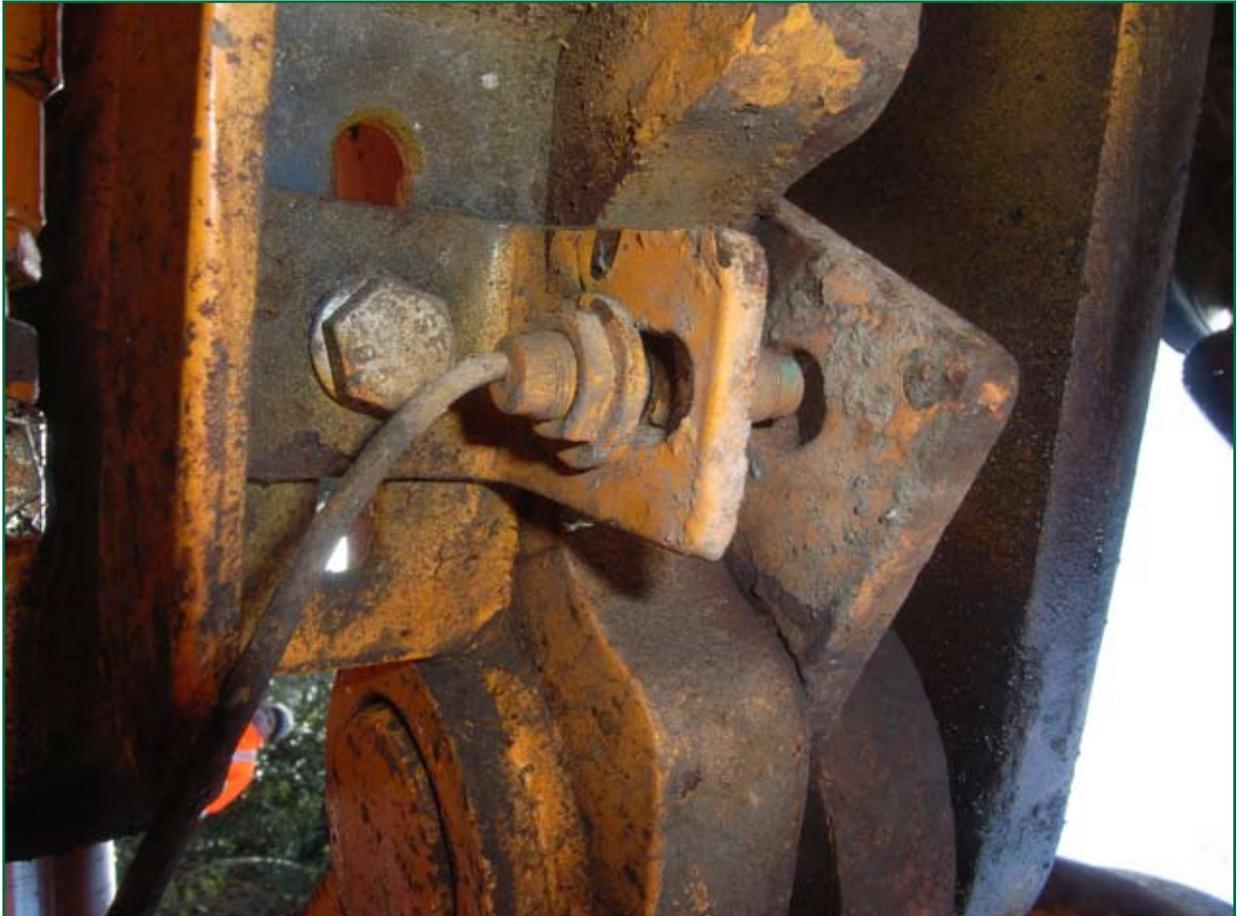
Figure 6: The sensor for detecting that the rail wheels are fully deployed

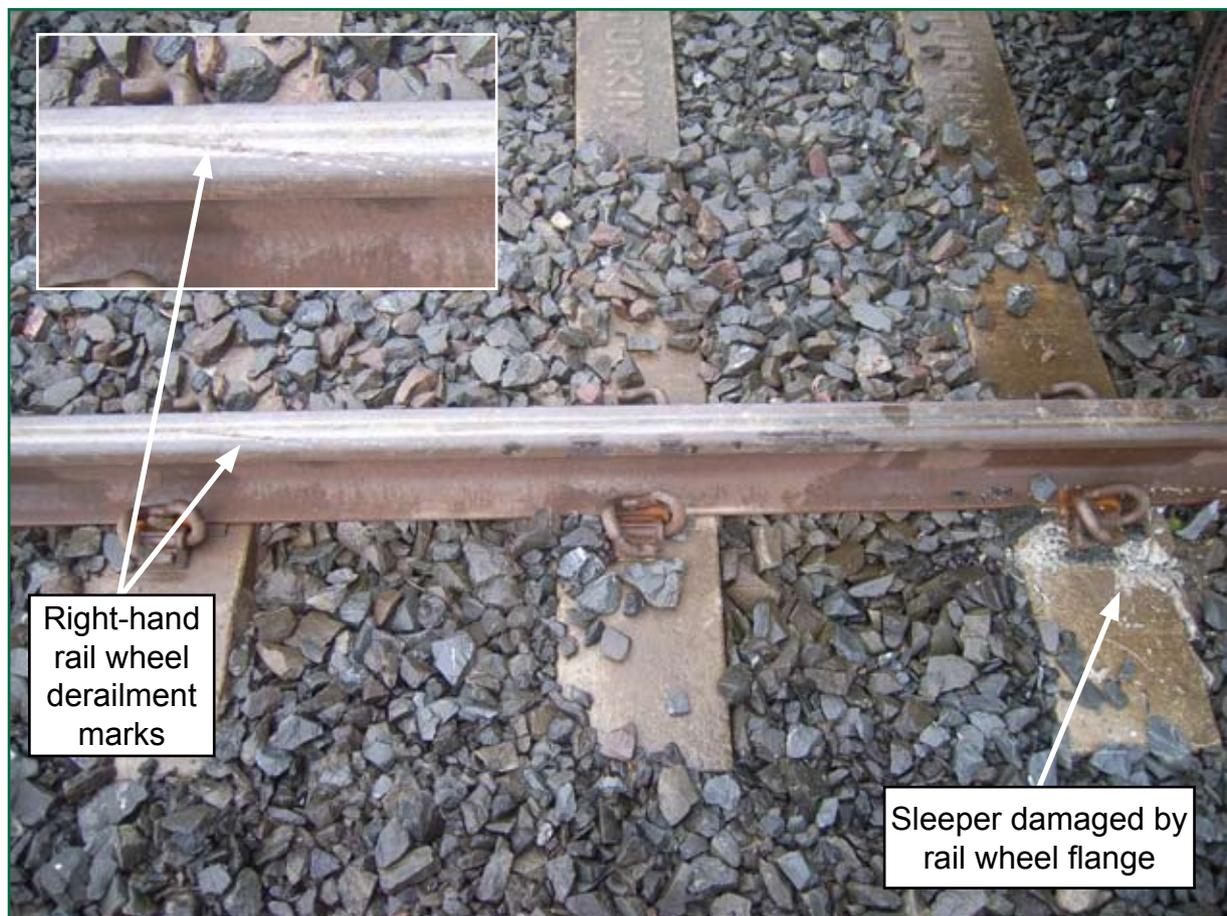
- 32 As the excavator negotiated the canted right-hand curve the driver felt it veer to the right; less than a second later and before he had time to react, it ran down the embankment. At the point of derailment, the right hand rail bore the flange marks of the trailing right hand rail wheel that had derailed before going on to damage three sleepers (Figures 9 and 10).

Figure 9: The point of derailment

- 41 The immediate cause of the derailment was flange climb; the lateral contact force at the excavator's trailing right-hand rail wheel resulted in a vertical force that exceeded the weight applied through it, forcing the wheel up, onto and then off the rail (paragraph 32).

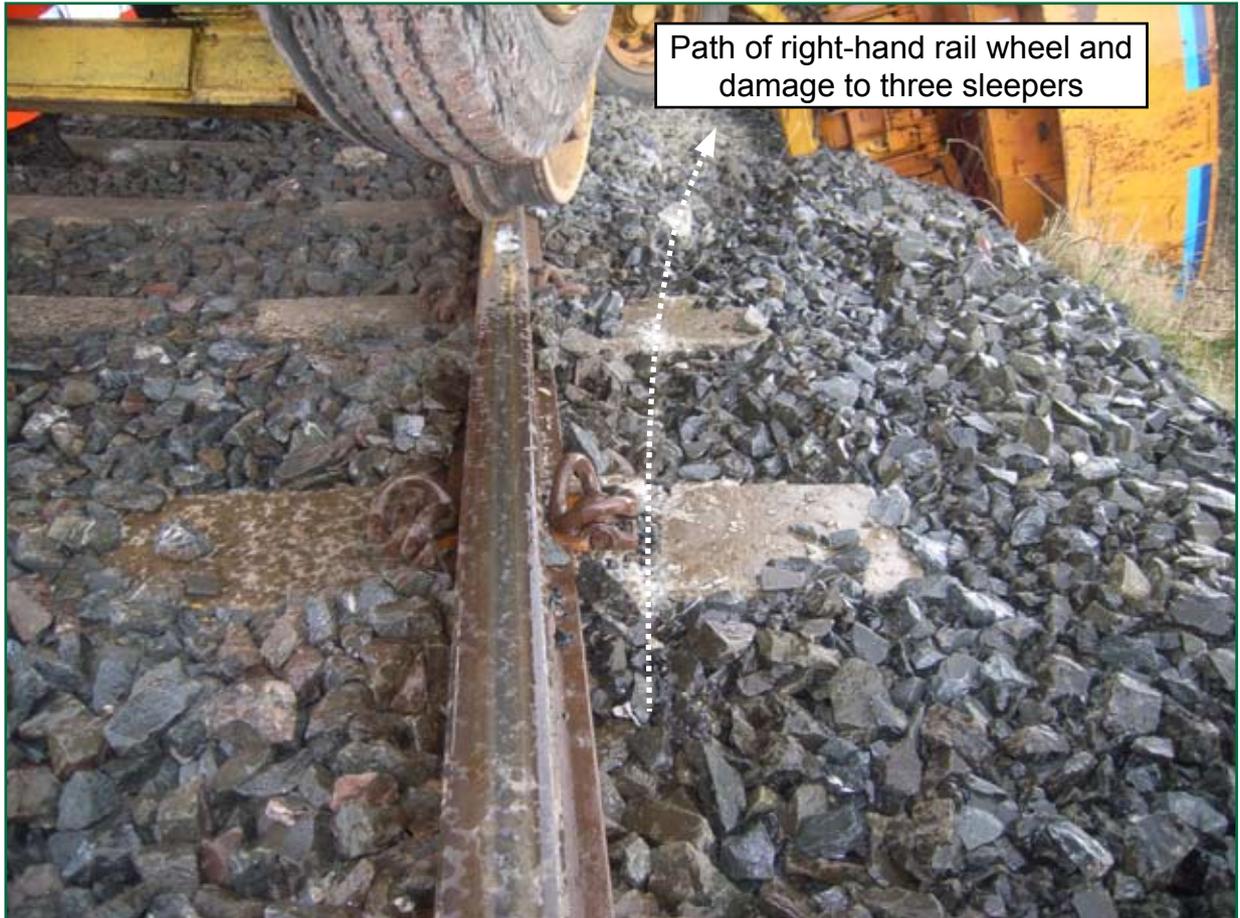
Figure 10: The path of the excavator's rail wheels immediately after derailment

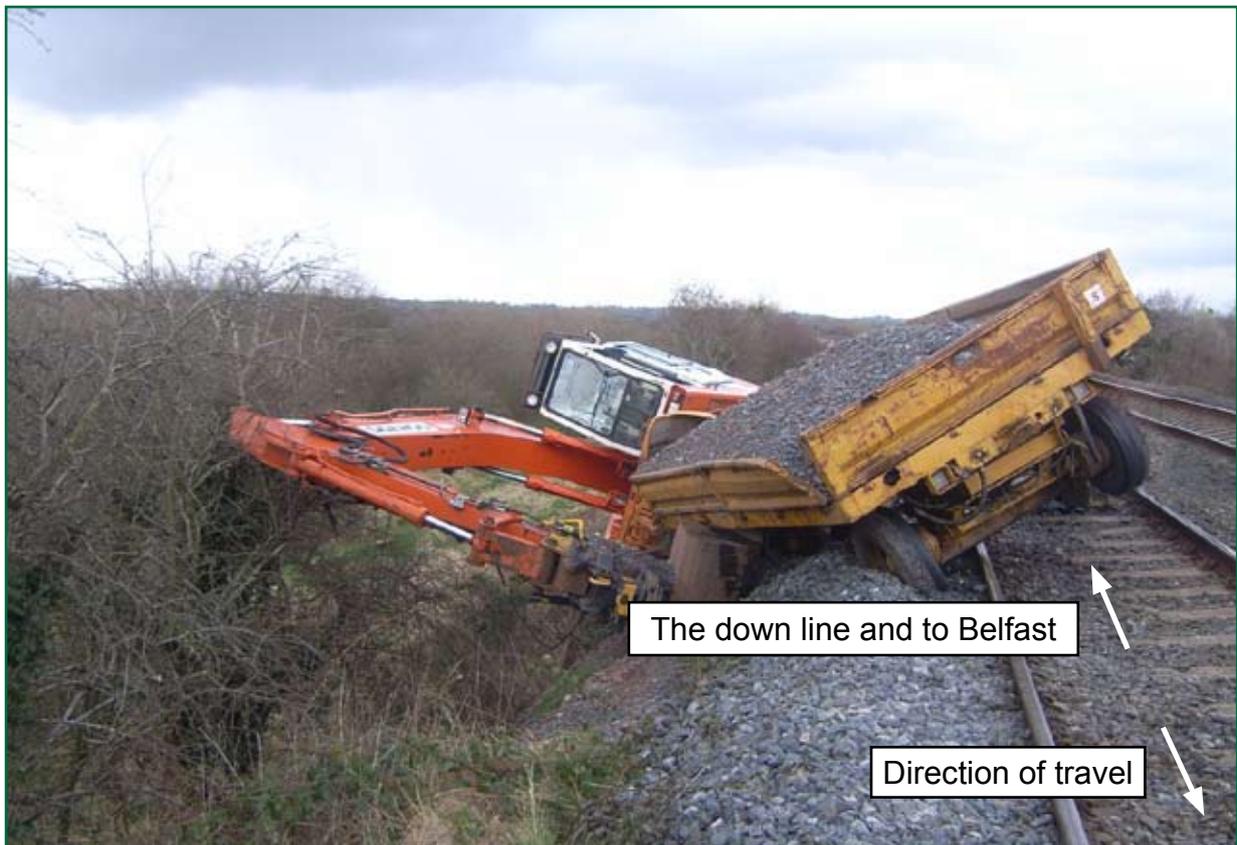
Figure 11: The excavator and the leading wagon

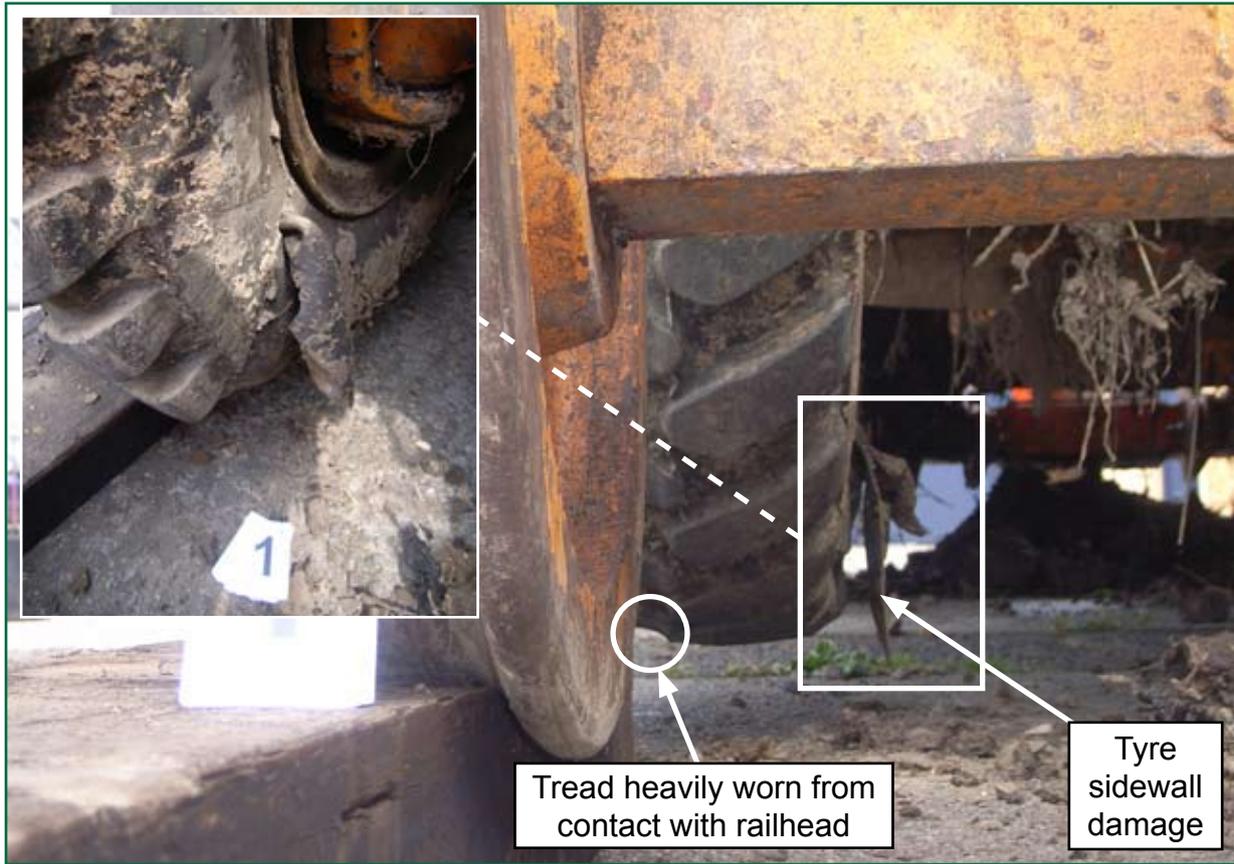
- 46 Consequently, Northern Excavators did not maintain the excavator to compensate for tyres that became progressively worn from contact with the railhead (Figure 12), transferring more weight from the excavator's road wheels to its rail wheels.

Figure 12: A rail wheel and its adjacent treaded tyre

- the excavator's road tyres were damaged (Figures 12 and 13) and continued to function only because they had been foam and not air filled;
 - the wagons' service brakes had been disabled; and

- 1 The Downpatrick and County Down Railway should make arrangements to:
 - a. maintain the excavator so that it distributes its weight appropriately in low ride mode;

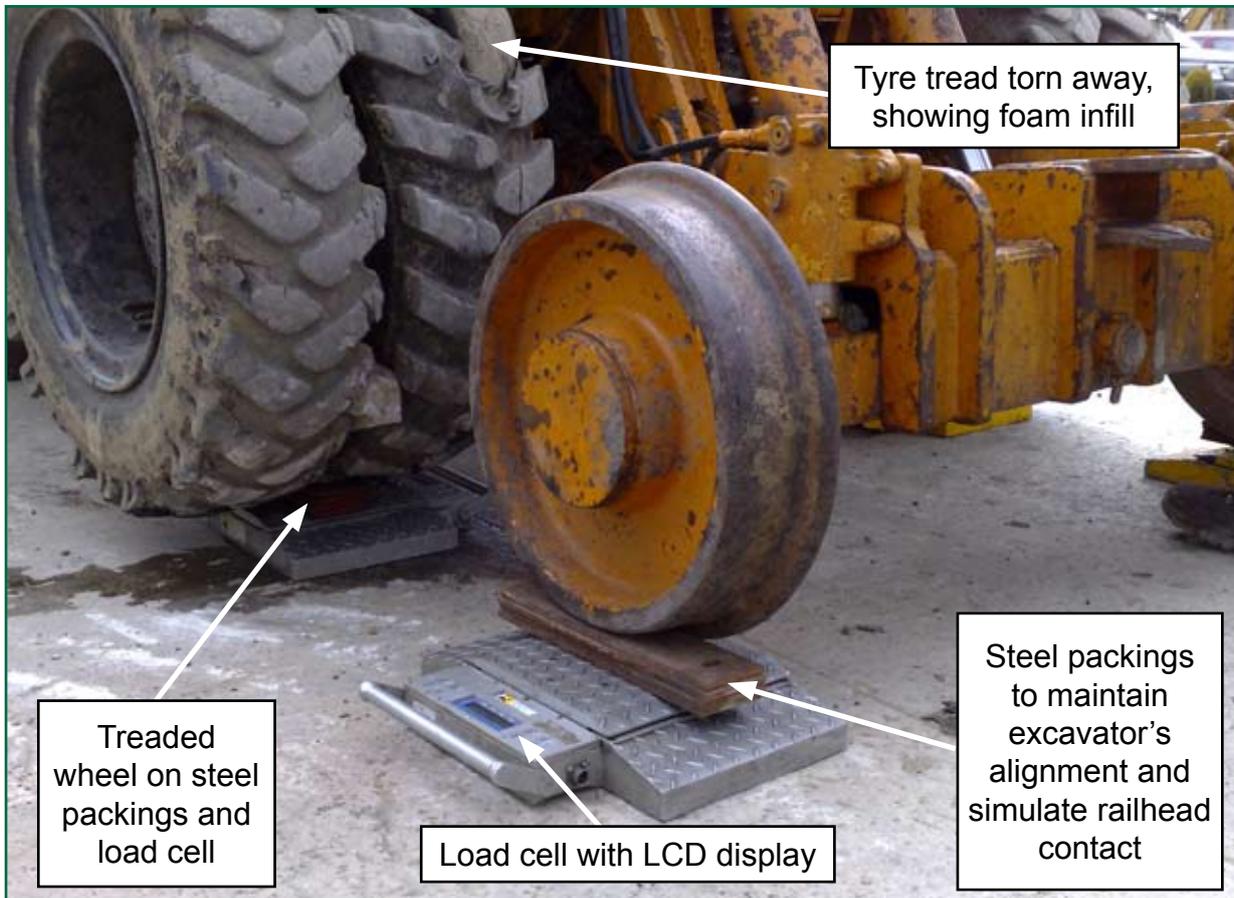
- 47 After the accident, the RAIB measured the excavator's weight distribution in its pre-set low ride mode and found that it applied 95% of its weight through its rail wheels and 5% through its road wheels (Figures 13 and 14).

Figure 13: Measurement of the excavator's weight distribution in low ride mode

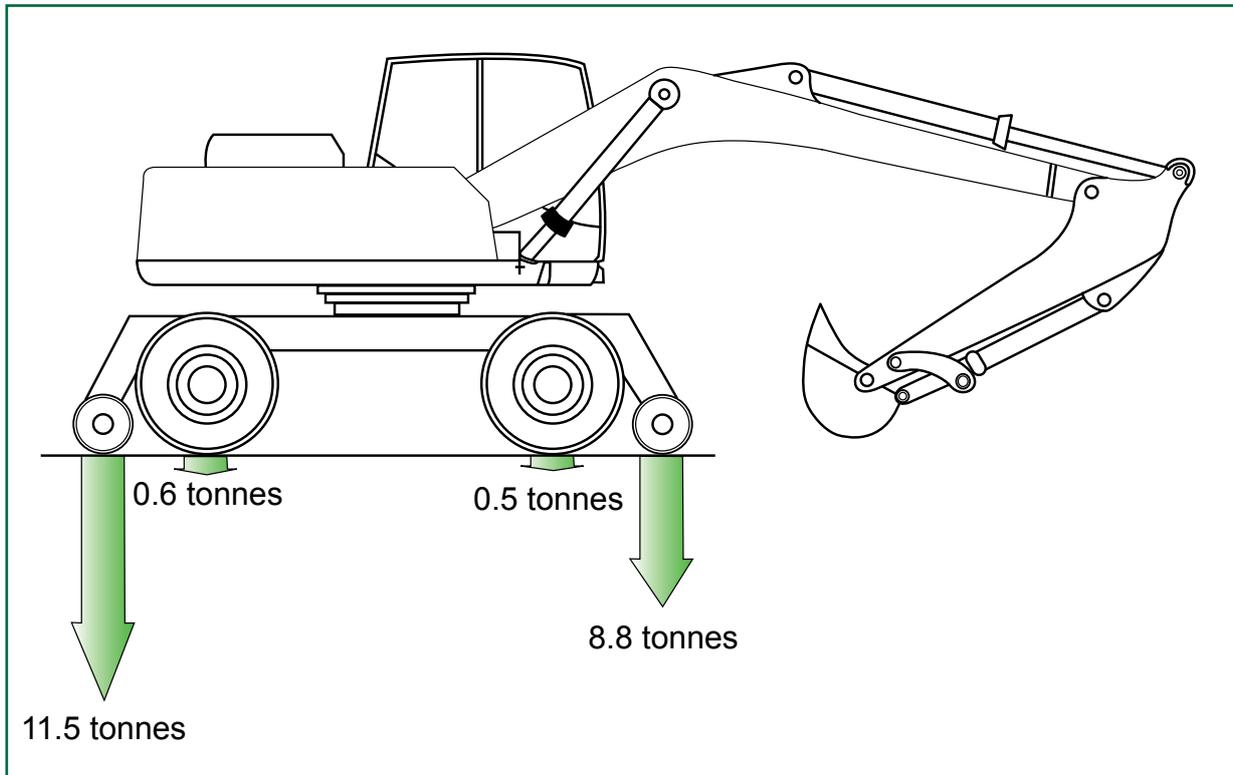
Figure 8: A 'high ride' vehicle

Figure 14: The excavator's weight distribution in low ride mode - 95% through rail wheels and 5% through road wheels

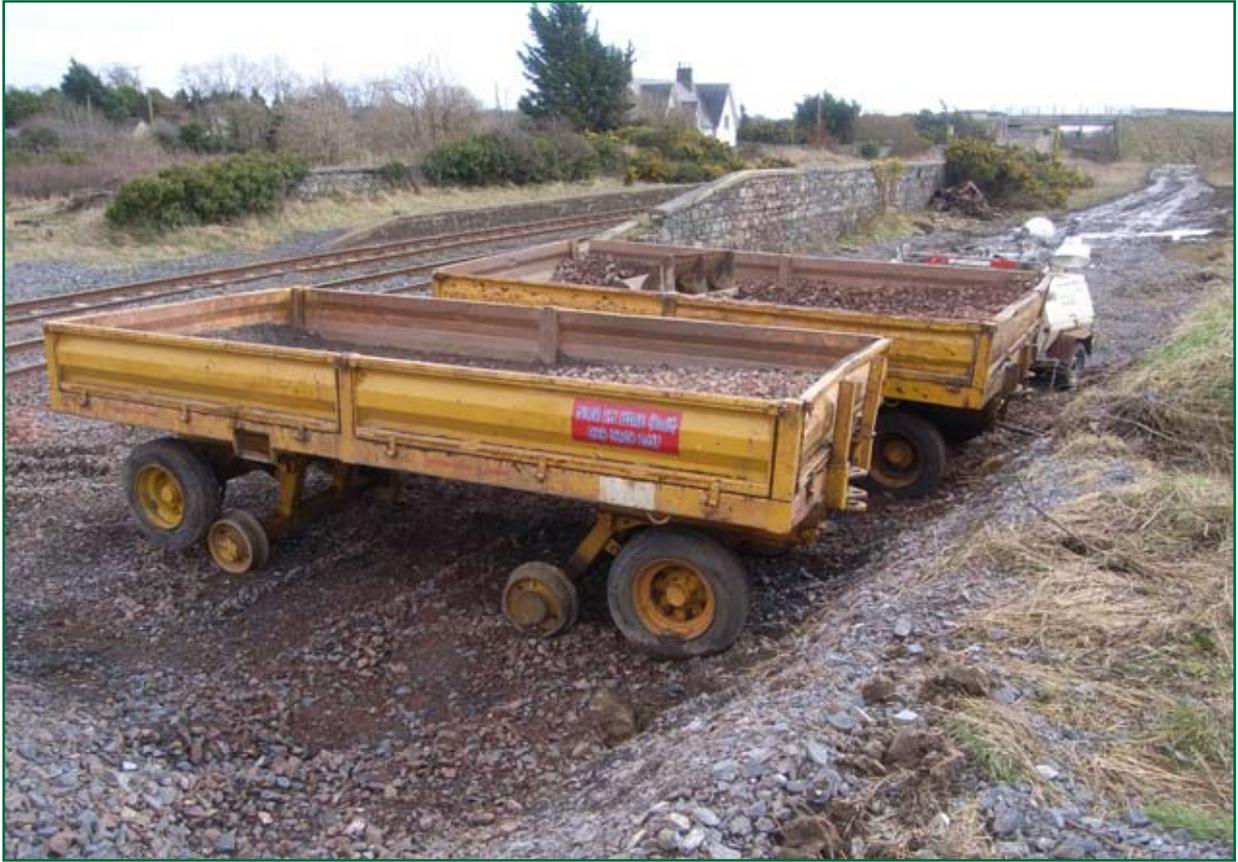
- the wagons were in a dangerous state because their parking brakes were either missing or inoperable (Figures 15 and 16).
- 59 As the wagons were neither causal nor contributory to the derailment, the RAIB handed responsibility for them to the Health and Safety Executive Northern Ireland (paragraph 72).

Figure 15: The wagons involved in the derailment, on hard standing at Tandragee station

- 4 Northern Ireland Railways should put in place a process for the periodic inspection and assessment of road rail vehicles and their associated wagons that they or their contractors undertake before permitting operation on their infrastructure (paragraph 70).

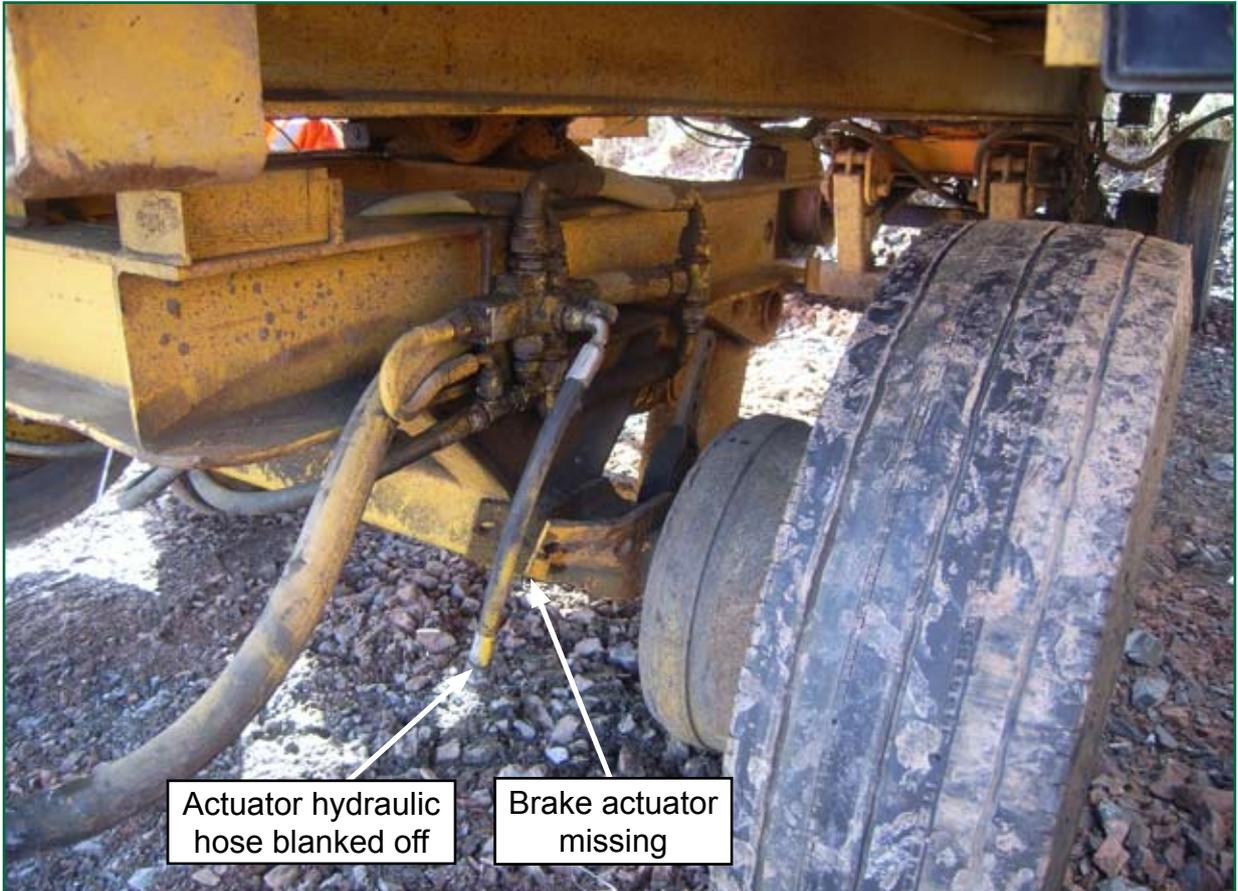
Figure 16: Defective brake on the leading wagon
