Rail Accident Investigation Branch

Rail Accident Report

Derailment of a passenger train at Gysgfa, Ffestiniog Railway 3 May 2008

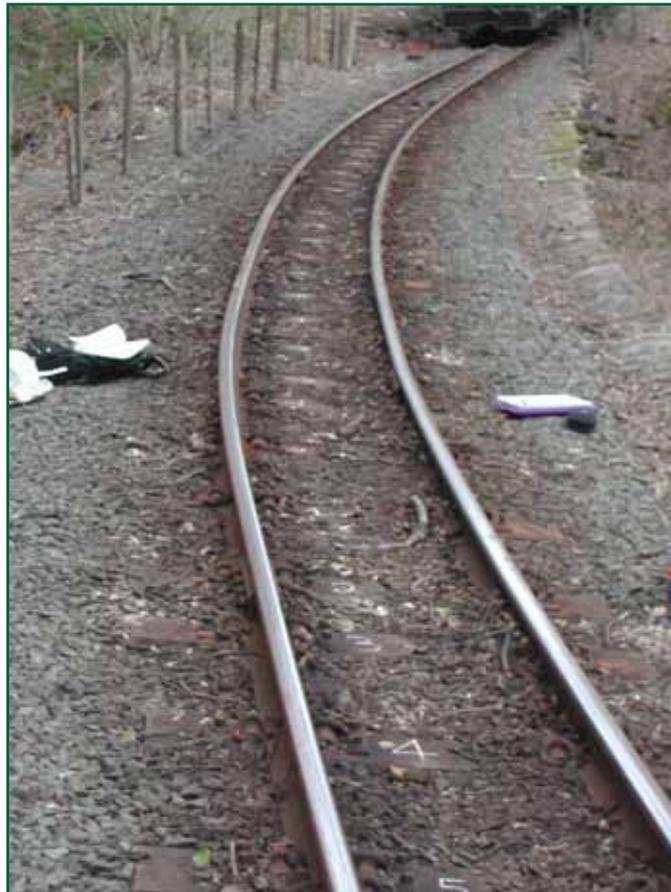
- 13 On 3 May 2008, the 15:00 hrs departure from Porthmadog to Tan-y-Bwlch was running through the curves at Gysgfa when the rear two vehicles derailed. These vehicles were a passenger coach and a luggage van.
- 14 One of the passengers in the derailed passenger coach pulled the emergency cord and this applied the brakes. When he saw that the train brakes were starting to apply, the driver fully applied the brakes and brought the train to a stand. The guard was unable to apply his brake as he had been thrown about the luggage van by the derailment.
- 15 The location of the derailment was in a heavily wooded hillside area and the passengers were rescued from the derailed train onto another train brought to site for this purpose.
- 16 Figure 2 shows the track immediately after the derailment.

Figure 2: Gysgfa curve following the derailment

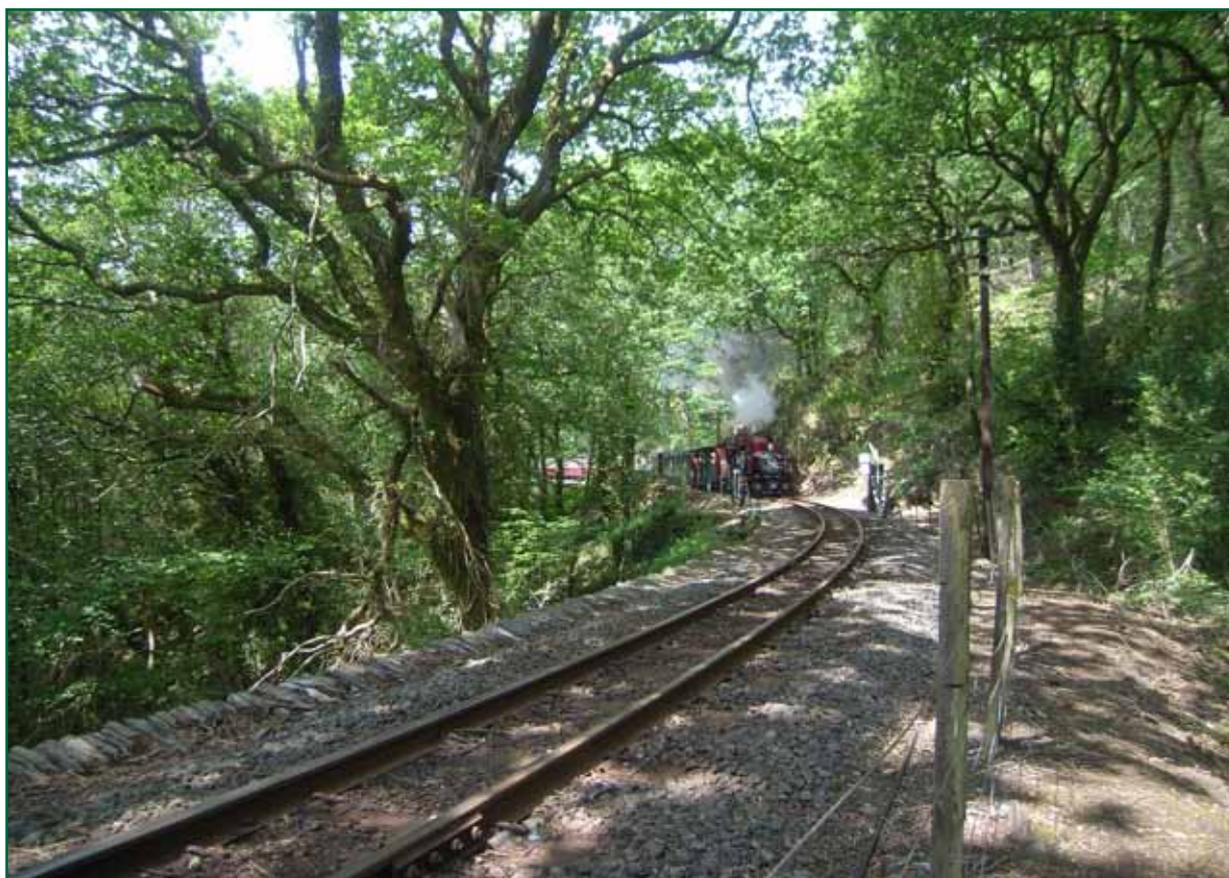
Figure 3: Gysgfa curve after recovery of the train and repair of the track

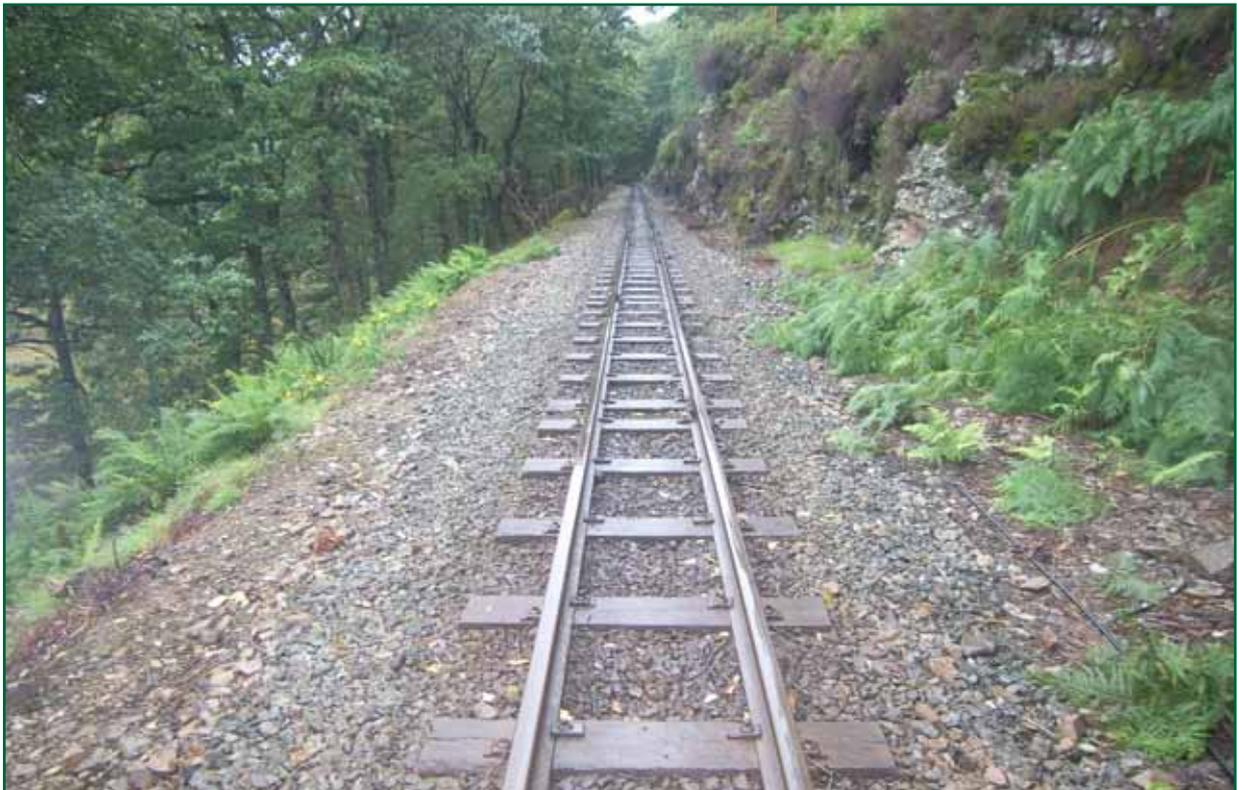
Figure 4: Ffestiniog railway track without baseplates, as originally fitted at Gysgfa

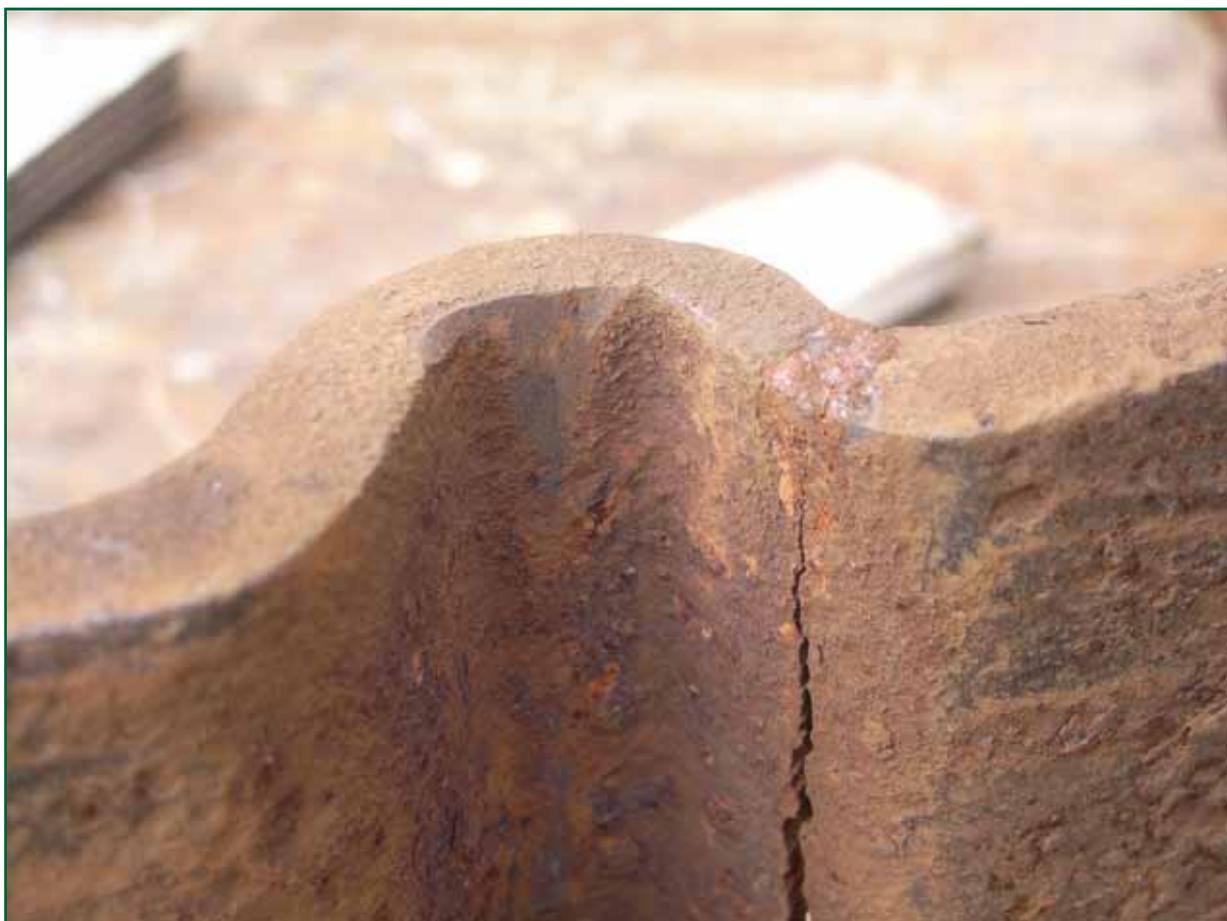
- 21 The weather at the time of the derailment was fine and dry.
- 22 The Festiniog Railway Company was operating a special train service on 3 May 2008 in connection with the Ffestiniog Railway Society's AGM. This service included additional special trains. One of these trains was the incident train and was made up of Victorian coaches.

- 45 The RAIB recovered the broken baseplates and the last intact baseplate prior to the derailment site in the direction of travel of the train. Four of the broken baseplates and the intact one were subjected to metallurgical examination. This examination confirmed that the plates had been manufactured from mild steel and found that the fractures had two distinct regions. The initial cracking of the plates occurred at the bend on the outside of the rail foot and had propagated slowly downwards into the plate thickness (Figure 5). At a later stage fatigue cracks had initiated from the underside of the plate at the same location and had propagated upwards at a faster rate, meeting the first set of cracks and causing complete failure of the cross section. The fracture surfaces of all of the plates were heavily corroded and indicated that failure occurred at least 3 months before the derailment. All of the baseplates had failed in the same way.

Figure 5: Failed baseplate after removal from the track

- 46 The intact baseplate was subjected to magnetic particle inspection and found to have cracking on its top surface in the same location as the broken baseplates but did not have fatigue cracks on its underside. This plate was broken open to reveal the extent of the crack from the top surface. The depth of fracture was small and the crack surface was corroded. When cleaned, examination of the surface indicated that it was a fatigue crack.

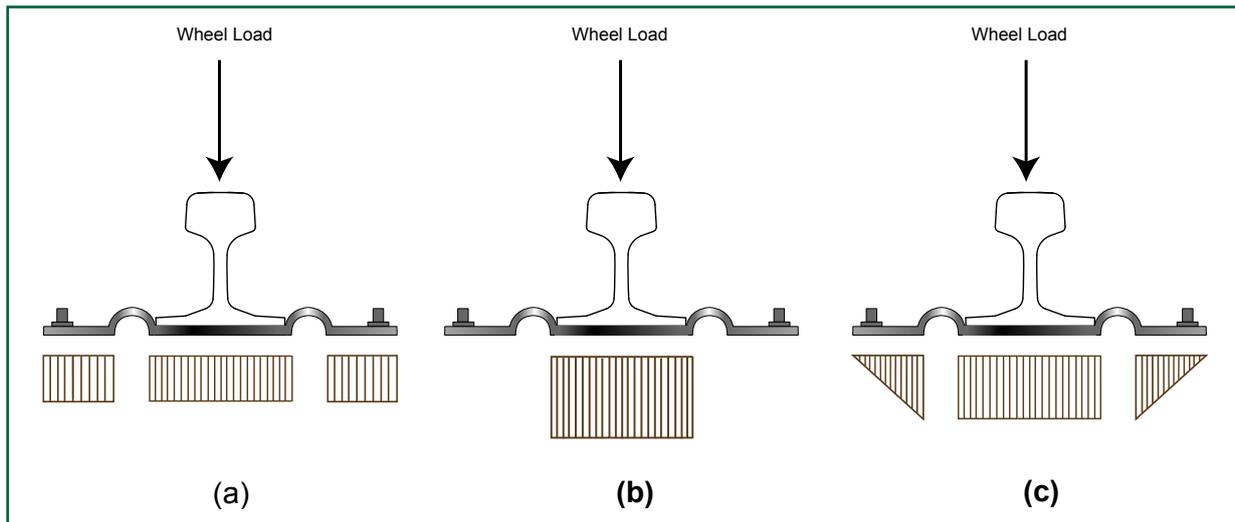
- 48 Consideration of the 'hard' load case shows that the baseplate is only subjected to compression and there is negligible stress at the bends. The stresses in the root of the bends in the 'soft' case were found to be beyond the yield stress of the steel. Both of these support cases represent the credible extremes and the actual support conditions will be between these extremes.

Figure 6: Pressure distributions beneath baseplate

- 49 The support conditions on a real sleeper are likely to be somewhere between the hard and soft cases, similar to that shown in Figure 6(c). Analysis of this loading gives a maximum stress at the root of the bend which is within the yield stress but is of such a magnitude that, based on the Ffestiniog railway traffic, the fatigue life is of the order of a few years.

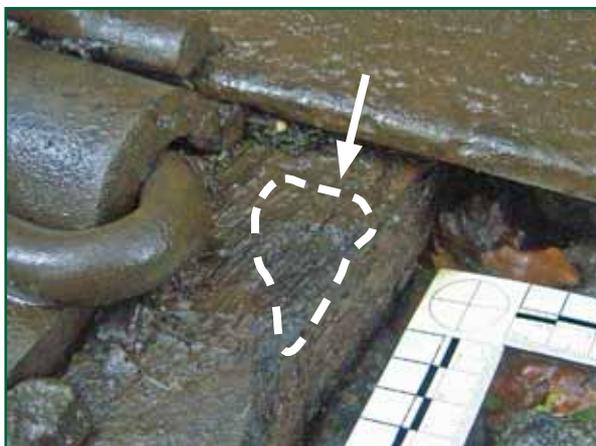
- 50 The support provided to the baseplates by the sleepers was investigated by examination of the derailment site and of a number of sites on the Ffestiniog railway where failed baseplates had been found. The sites examined were Gysgfa, where the derailment occurred, Dingle, where 30 broken baseplates had been replaced, and Power Station. The Power Station curve site was included for comparison with the other sites as it is in the open with no tree cover and three broken baseplates were found there.
- 51 The highest proportion of broken baseplates was at Gysgfa, where a total of 19 baseplates had been replaced over a distance of 60 m. Although a greater number of baseplates were replaced at Dingle (30), the curve there (200 m long) is longer than at Gysgfa. Power Station curve is slightly longer than Dingle but only had three broken baseplates.

Figure 7: Timber surface adjacent to baseplate - damaged surface shown arrowed

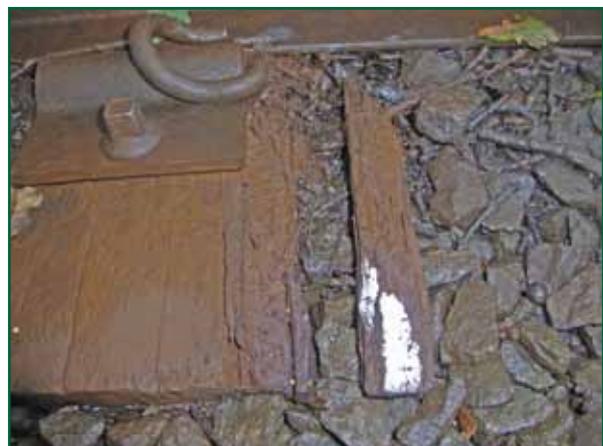
Figure 8: Timber sleeper affected by decay

- 53 The susceptibility of the baseplate design to overstress if supported on a soft surface (paragraphs 47 to 49) makes the issue of decay of the surface of the timber sleepers an important factor. It is considered that the combination of the baseplate design and sleeper condition was a causal factor to the derailment.
