Rail Accident Investigation Branch

Rail Accident Report

**Incident at Greenhill Upper Junction, near
Falkirk
22 March 2009**

Report 04/2010
March 2010

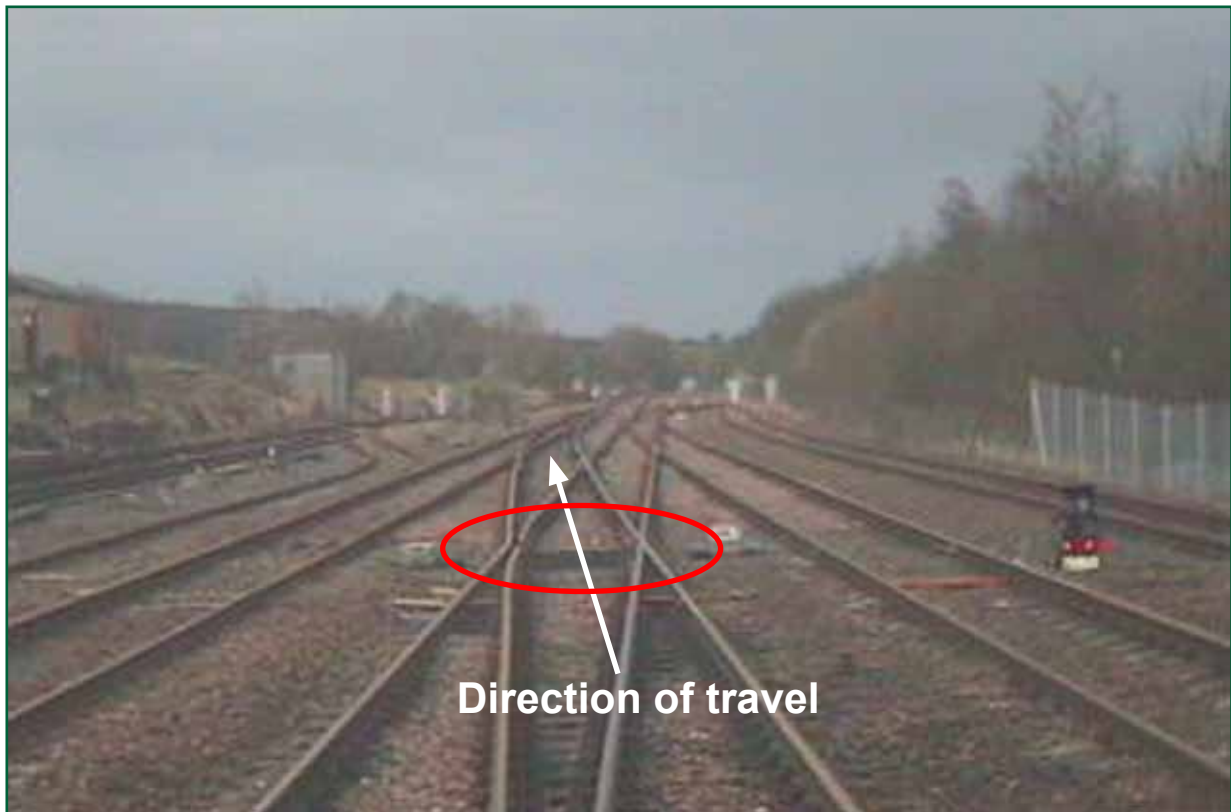
- 31 Train 2N50 trailed through 125C point ends at 64 mph (103 km/h) causing damage to them. This became apparent to the signaller because he received an '*out of correspondence*' indication on the panel indicating that 125 points had lost detection. Figure 4, taken from the train's forward facing CCTV equipment, shows the position of the switch diamonds as the train approached them.

Figure 4: Forward view of Greenhill Upper Junction as train 2N50 approached showing the position of 125C point ends (normal) and 125B point ends (reverse)

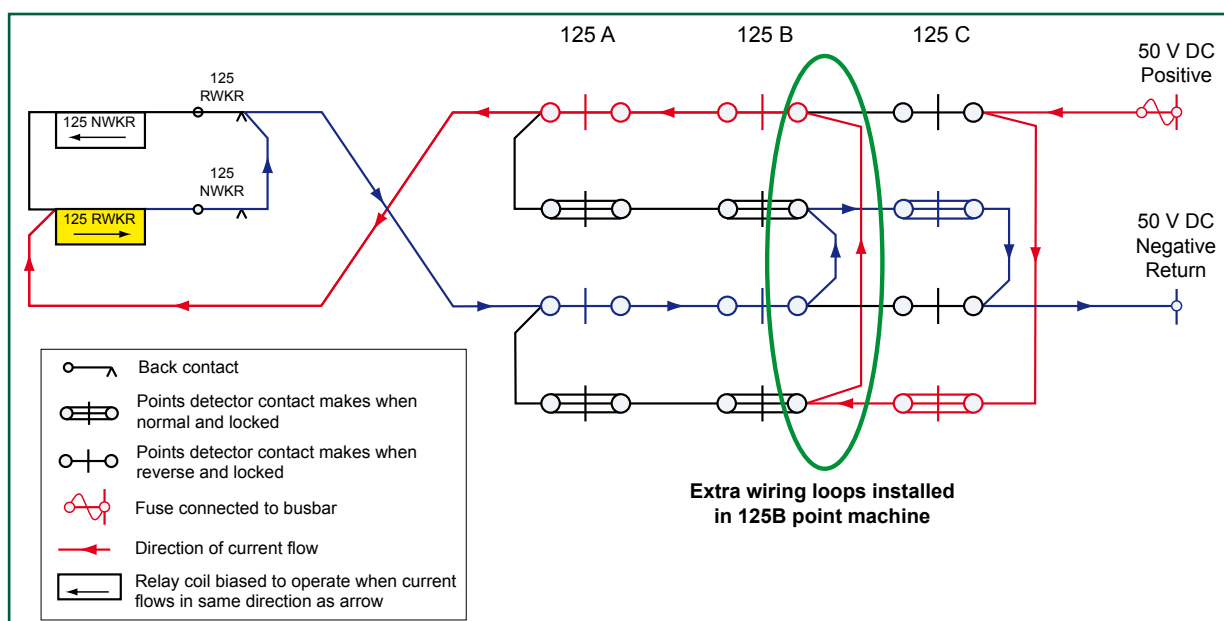
- 93 A single drawing (appendix D) showing the wiring for both 125B and 125C point machines was used to wire up the tail cables and fit additional wiring that was required in 125C point machine. 125C point machine was wired correctly, but 125B point machine was incorrectly wired the same as 125C. This resulted in additional wiring being installed in 125B point machine (figure 6).

Figure 6: Simplified diagram of 125 points detection circuit showing the wiring error

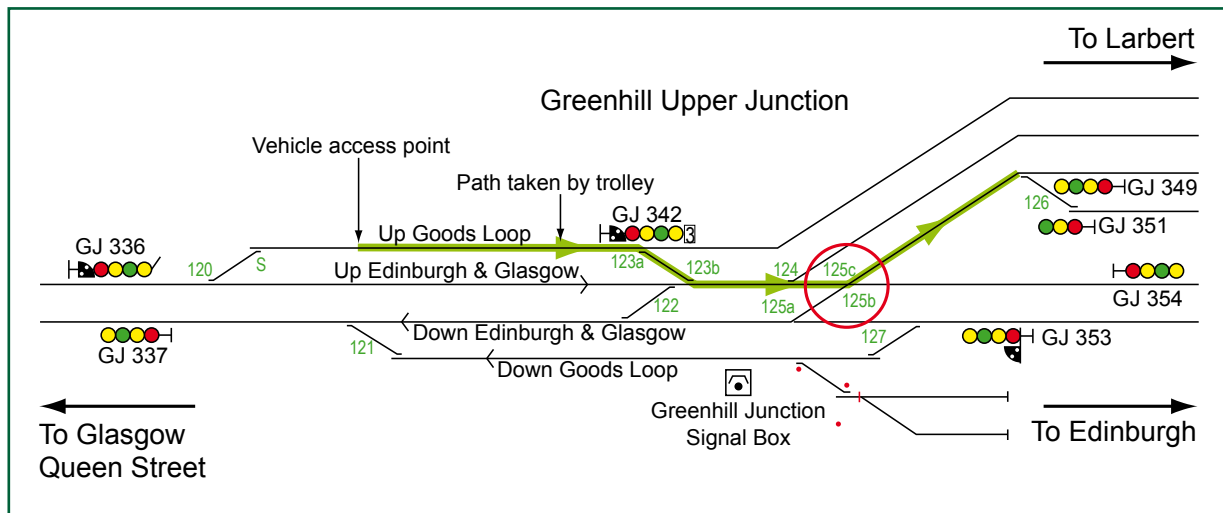
126 Figure 8 shows the route that was taken by the trolley used to transport the point machine from the access point to 126A point ends. This required 125C point ends to be manually operated to the reverse position.

Figure 8: Route taken by trolley over 125C points on 21/22 March 2009

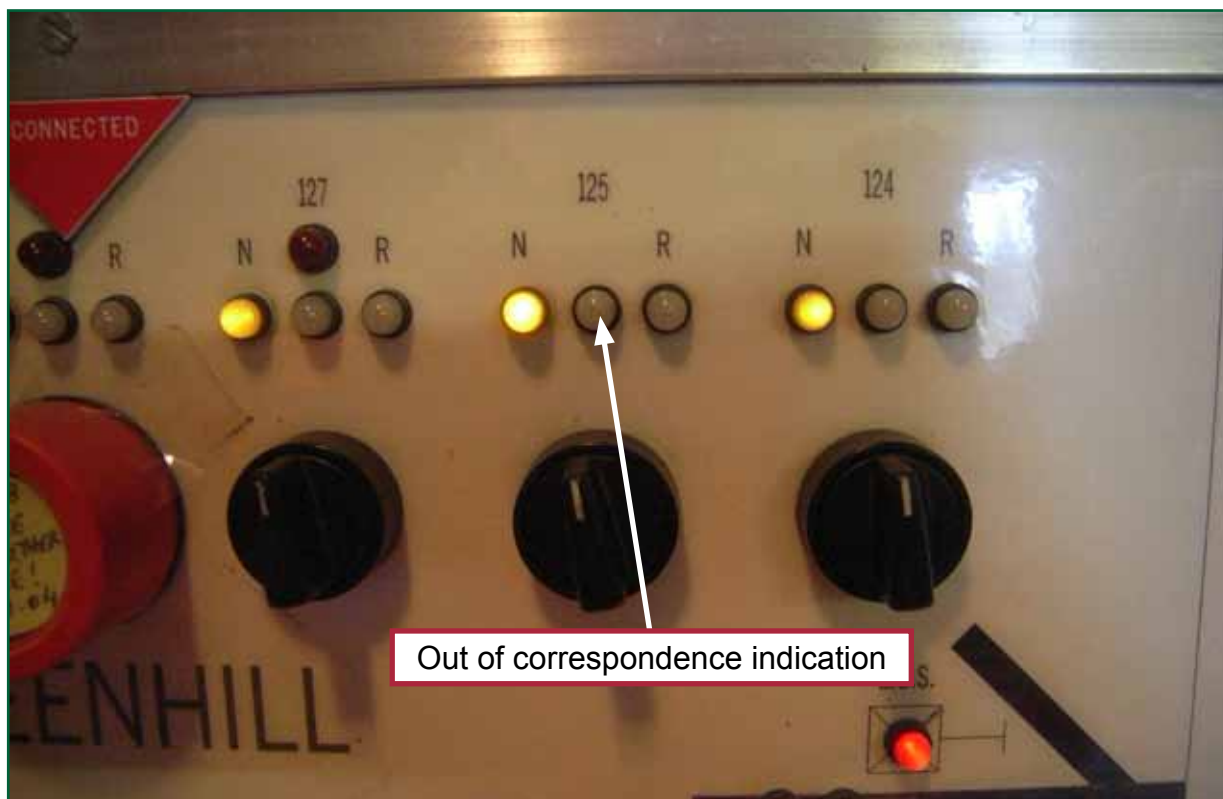
127 Manually operating 125C point ends to the reverse position, with the other ends normal, should have caused the out of correspondence light to flash on the signaller's panel (figure 9), when 125C point ends were detected in the reverse position. The wiring fault would have prevented this indication of out of correspondence occurring, but the signaller did not notice this (there was no requirement that he had to check this).

Figure 9: Panel indications relating to points detection

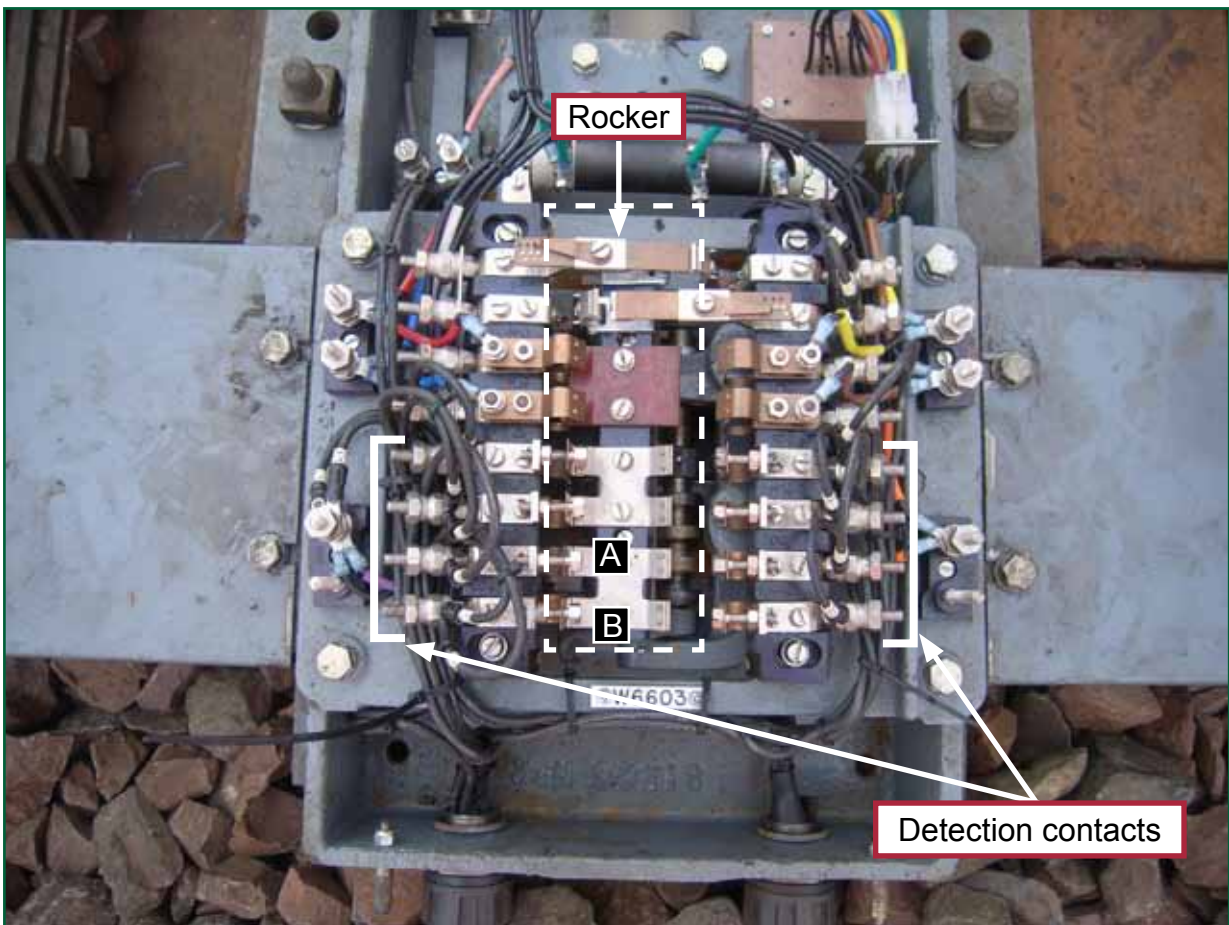
- 89 The records show that the staff who carried out the work at Greenhill on 17/18 January 2009 signed to confirm that they had been briefed and also signed against the relevant maintenance test plan list entries confirming the work they had carried out.

Pre-work carried out at Lionverge's Falkirk depot

Figure 14: HW2000 point machine detection contacts
