Rail Accident Report

Fatal accident at Whitehall West junction, Leeds 2 December 2009

Report 15/2010
September 2010

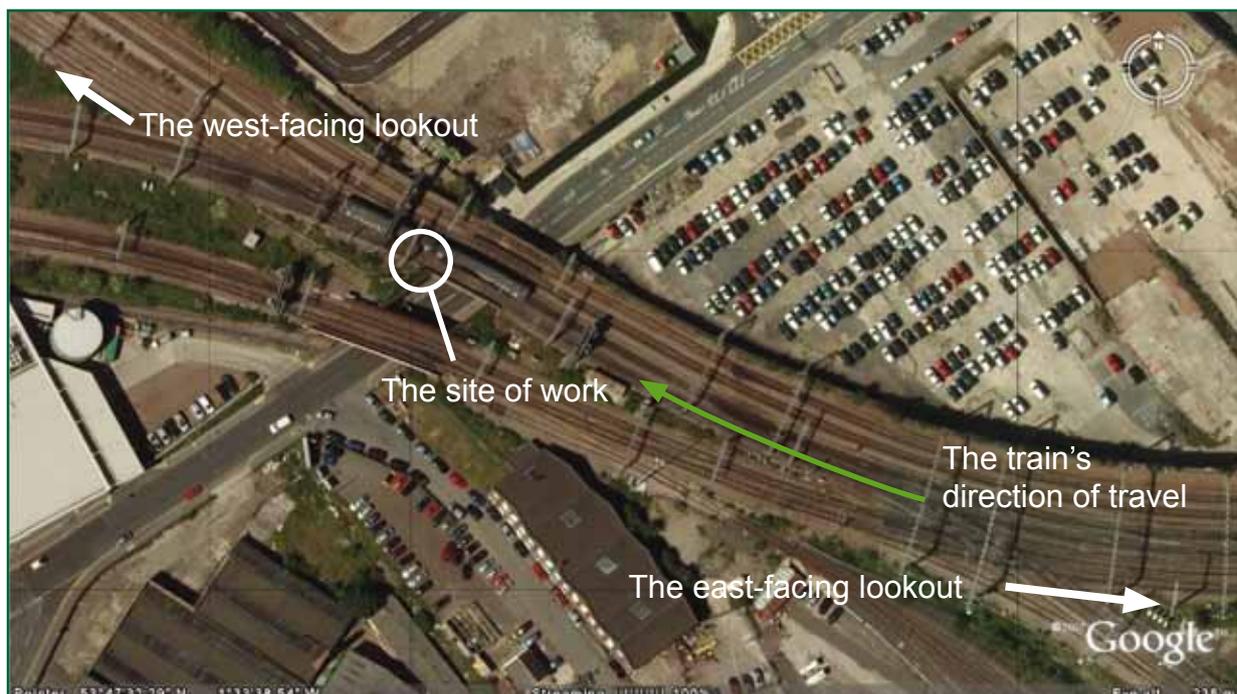
Figure 3: The positions of the east and west-facing lookouts and the worksite (Courtesy of Google Earth)

- 15 One of the track workers was assigned to be the 'controller of site safety' and in this role he was responsible for setting up and maintaining a safe system of work. He assigned two track workers to act as lookouts sighting for trains approaching the site of work from east and west respectively and a third track worker to act as site lookout (see figure 3).

- 16 All three lookouts were instructed to do their work from a 'position of safety' which is 1.25 metres or more away from the closest rail and thus beyond the path of passing trains. The system of work was set up as follows:

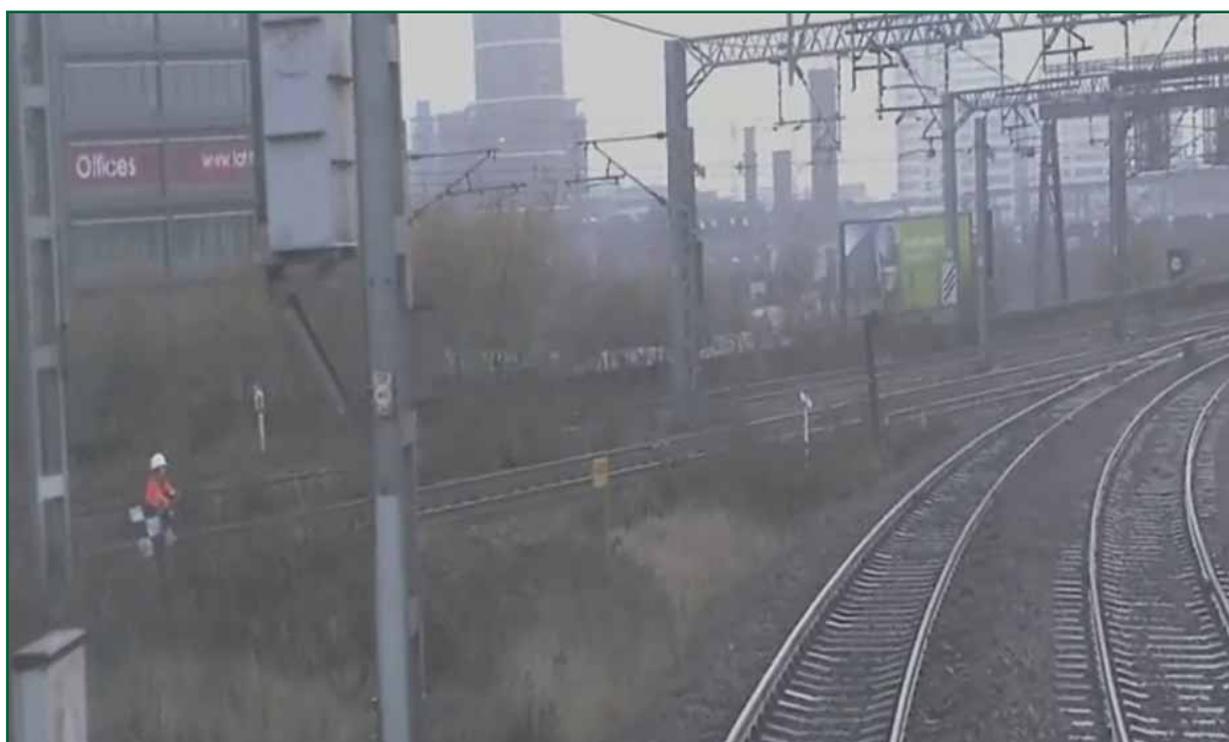
Figure 4: The west-facing lookout viewed from the Leeds-bound train

- 20 Figure 4 is a still image taken from the forward facing video camera of the 06:35 hrs London King's Cross to Leeds service as it approached the site of work at 08:52 hrs; it shows the west-facing lookout a short time after he had acknowledged the train's horn warning. Unit number 333013, the train involved in the accident, was not fitted with a forward facing camera.

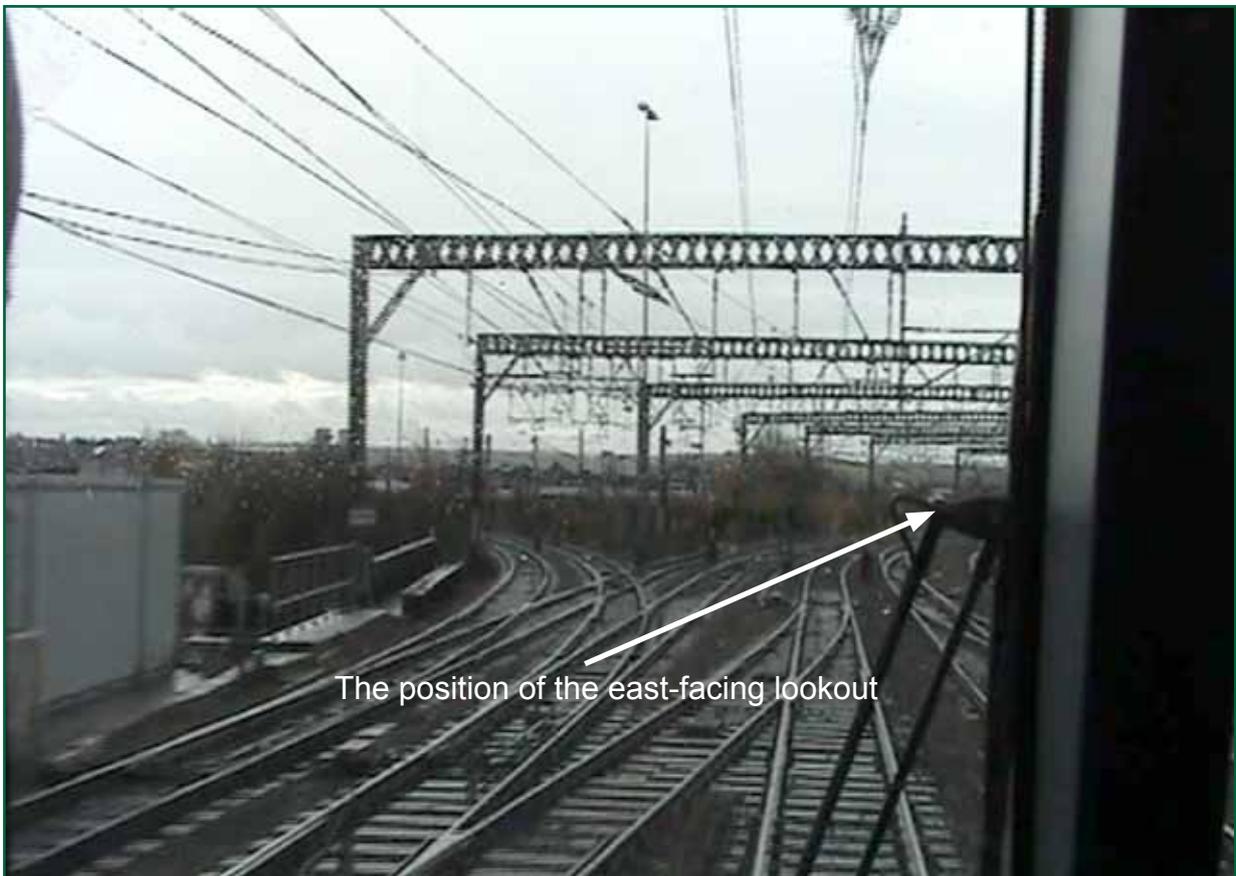
Figure 8: The driver's view when he saw the east-facing lookout and sounded the train's warning horn

- 26 The trainee saw the east-facing lookout and sounded the warning horn at 09:36:53 hrs, 56 seconds into the journey and as the train curved to the right; the east-facing lookout acknowledged the warning by raising one arm and waving his blue and white flag. The trainee and supervisor drivers could not see the work group or the west-facing lookout at this location as they were obscured by track curvature, vegetation, overhead line equipment and the cab's structure (figure 8).

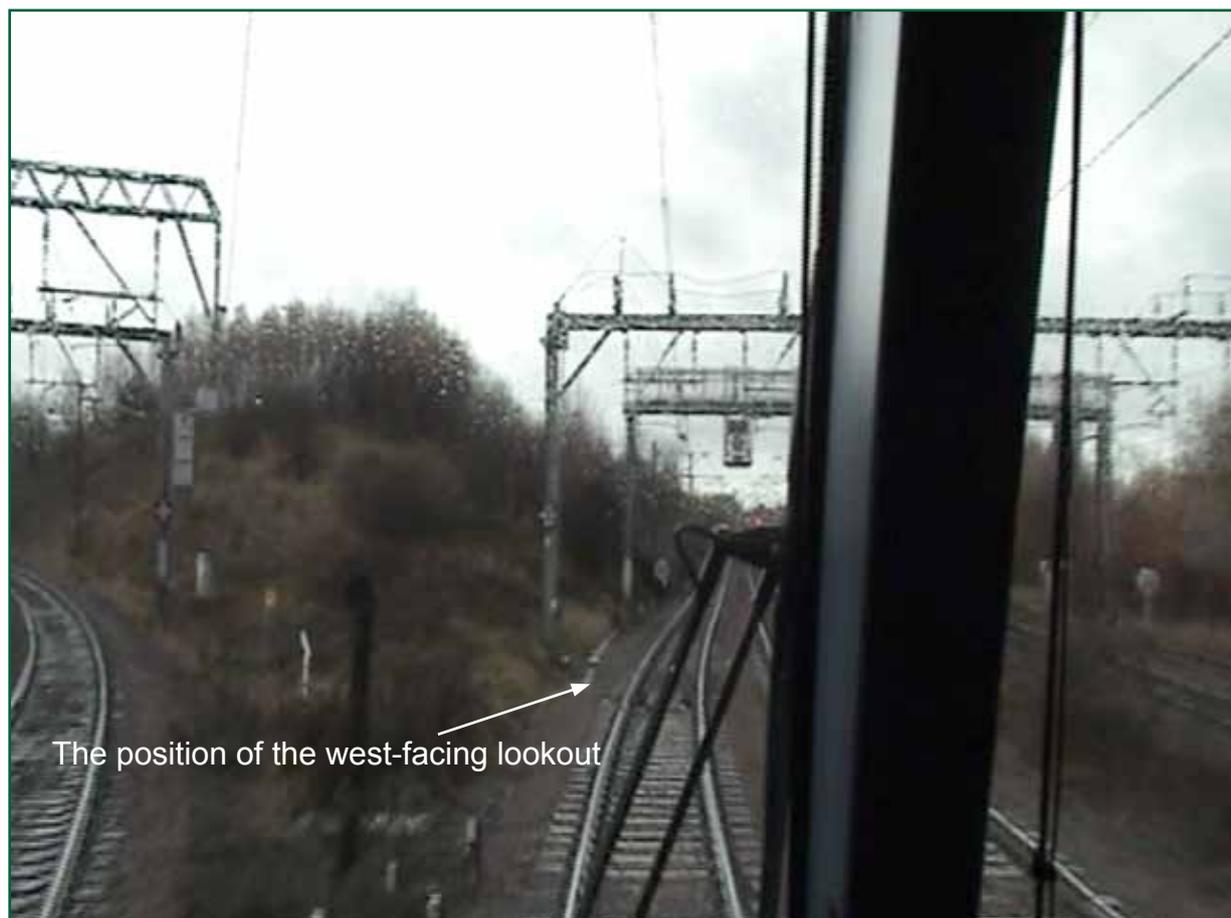
Figure 10: The driver's view of the west-facing lookout

- 30 At 09:37:32 hrs the train was travelling at 24 mph (39 km/h) and was approximately 10 metres from the west-facing lookout when the trainee remarked that he looked close to the line; neither he nor the supervisor had time to react as the west-facing lookout was struck approximately a second later; the lookout faced west, away from the train and had not moved throughout its approach (figure 10).

- 31 The trainee made an emergency brake application at the same time as the train struck the west-facing lookout, which brought the train to a stop at 09:37:46 hrs.

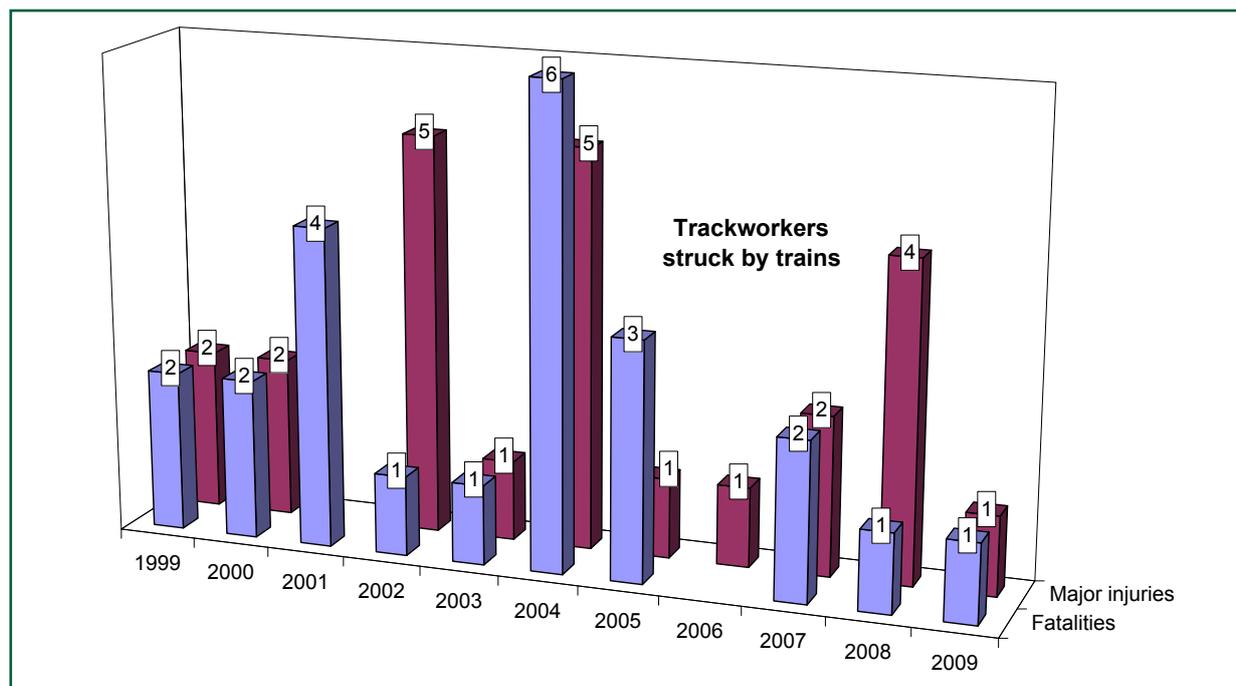
Figure 11: Track worker fatalities and major injuries. Information courtesy of the Rail Safety and Standards Board

- 38 Figure 11 summarises the accidents in which trains struck track workers resulting in fatalities and major injuries in years 1999 to 2009. These accidents are described in RAIB report 30/2009 into the accident at Dalston junction and so they are not described again in this report. Figure 11 shows that in this period:

- Trains struck and killed 23 track workers, four of whom were acting as lookout at the time of the accident. These accidents happened on 10 October 2000 at Bradford Mill Lane, on 18 July 2001 at Purley Oaks, on 5 April 2005 at Newbridge and on 2 December 2009 at Whitehall West junction.

- Trains struck 24 track workers who sustained major injuries, one of whom was acting as a lookout. This accident happened at Dalston junction on 30 March 2009 and is the subject of RAIB report 30/2009.

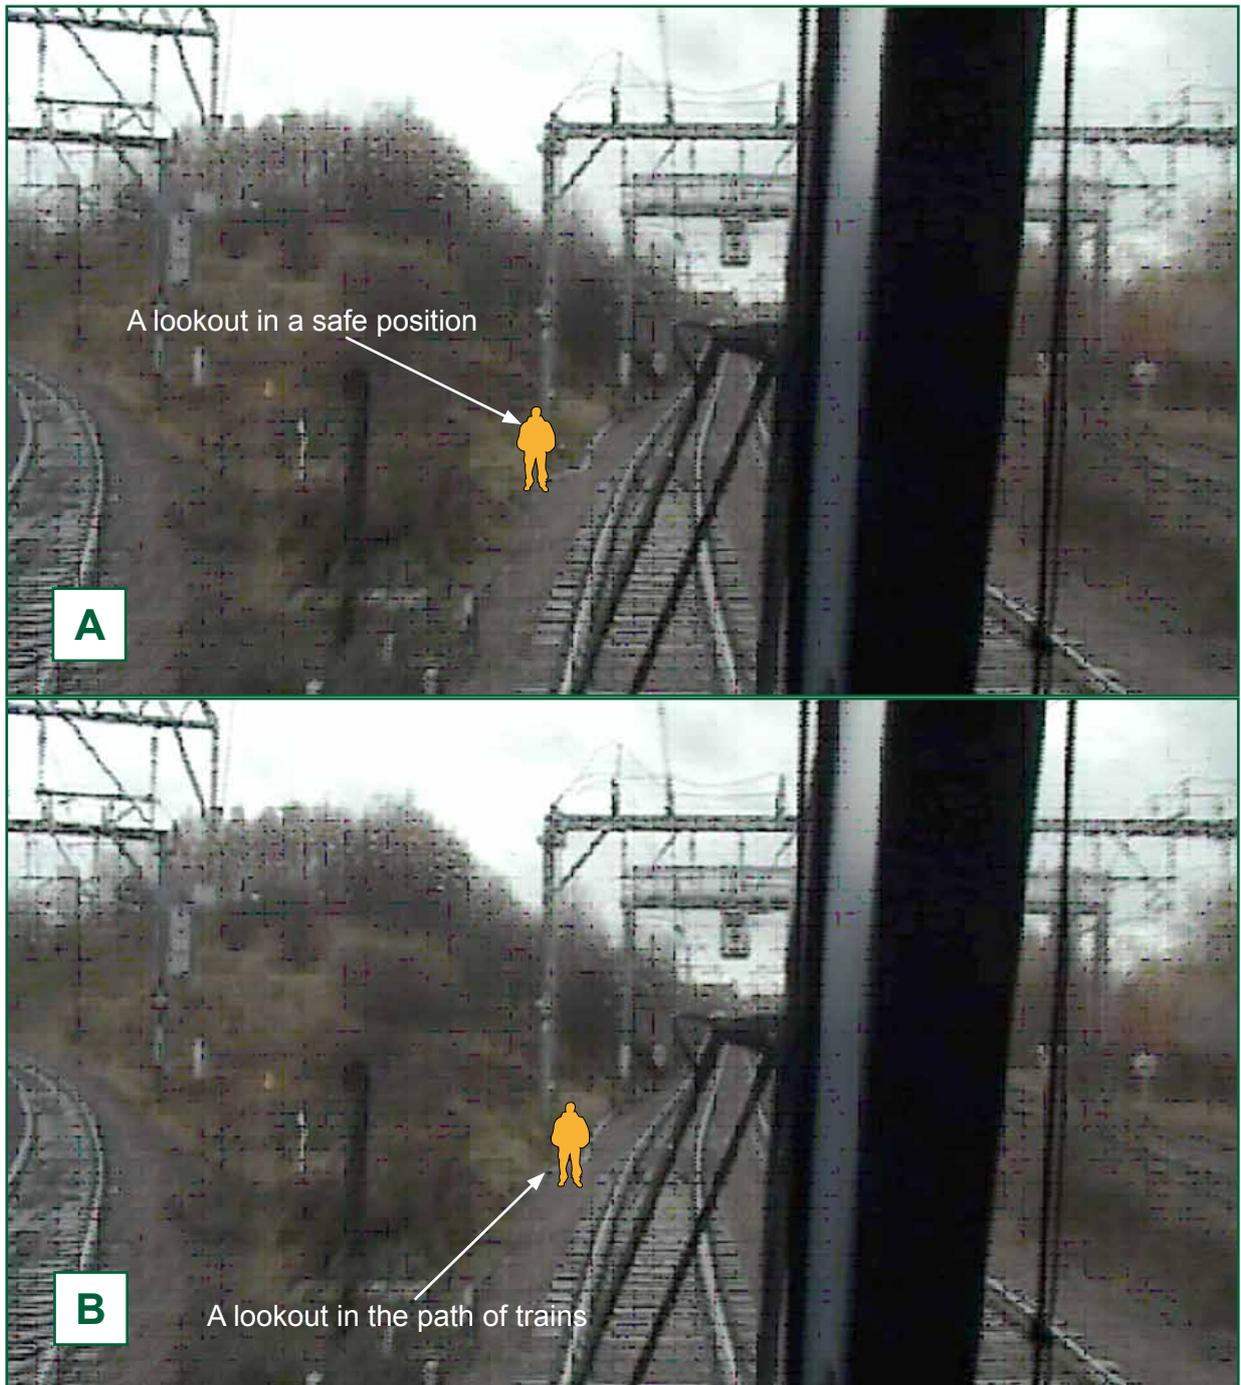
Figure 12: The view from the cab showing a lookout in a safe position (A) and in the path of trains (B)

- 60 The train was approximately 10 metres from the west-facing lookout when the trainee remarked that he appeared to be close to the line. Figure 12 is a reconstruction of the trainee driver's view from the cab at this location. It shows, to scale, a figure representing a lookout in a safe position and another in the path of trains; both may appear to be safe positions because of the figures' nearness to curved track and overhead line equipment which is clear of passing trains.

- 62 The west-facing lookout was in a safe position when the westbound freight train passed him from behind without incident at 09:18 hrs (paragraph 21) so he had moved from this position, possibly to keep warm, physically comfortable and alert, while he carried out his duties on a cold morning (paragraph 12).

- 63 He was perhaps unaware that he had moved from a safe position as there had been little to attract his attention to the adjacent line; in the hour and 22 minutes from starting work until the accident, only the westbound freight train had travelled on this line and there was no trackside feature to warn that he was dangerously close to the line. At Purley Oaks in 2001, the investigation report⁷ concluded that a factor in the accident was that the limit of the safe position was not marked.

- 1 *The intention of this recommendation is to reduce the likelihood of lookouts moving from a safe position.*
