# Rail Accident Report

**Near-miss on Victory level crossing, near  
Taunton, Somerset  
19 December 2009**

# Near-miss on Victory level crossing, near Taunton, Somerset, 19 December 2009

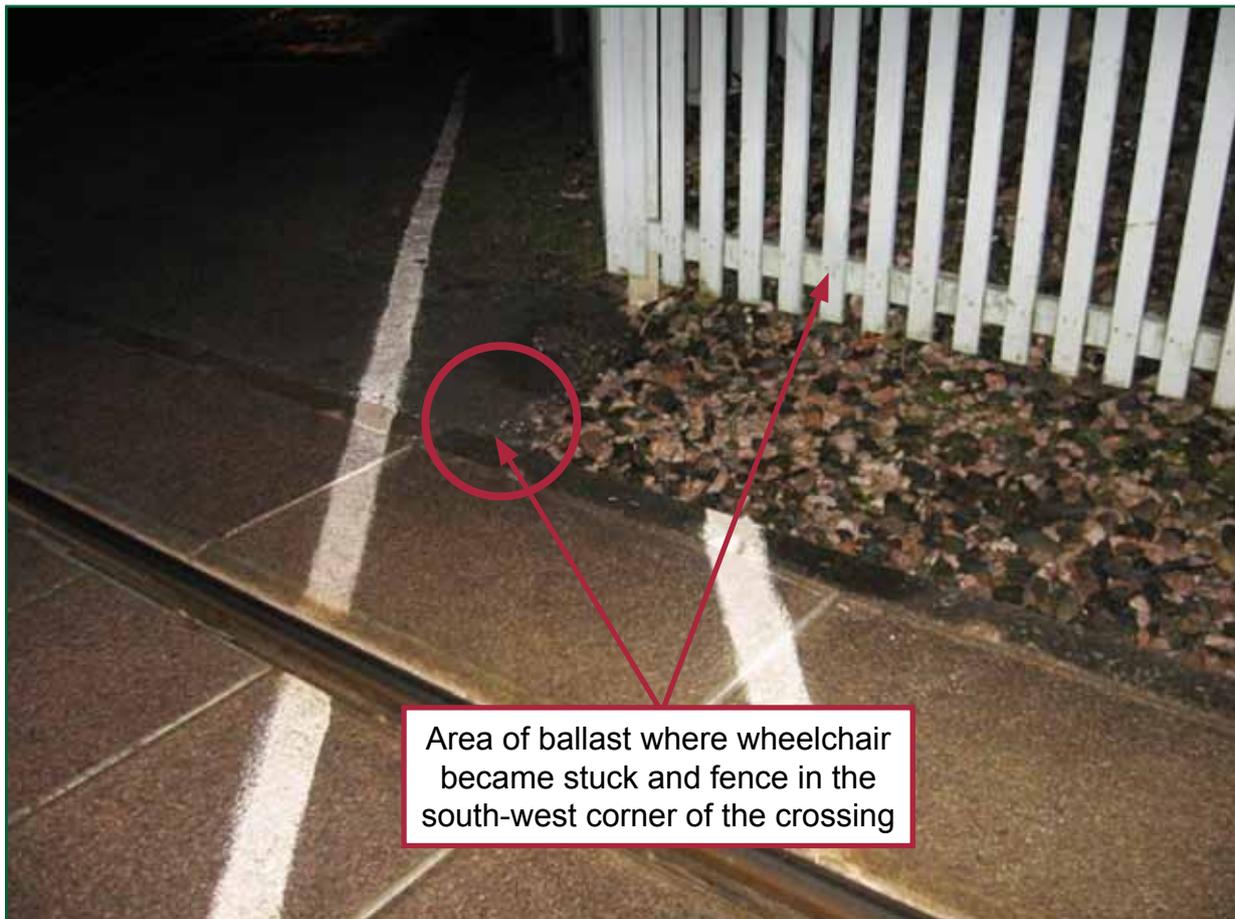
Figure 2: Area of ballast and fence in south-west corner of the crossing (photograph courtesy of Network Rail)

- 38 **One of the front wheels of the wheelchair became stuck in an area of ballast in the south-west corner of the crossing.**
- 39 Since March 2007, the crossing surface included an area of ballast approximately 1 metre wide and 2.4 metres long at the south-west corner (figures 2 and 3). The wheelchair user had used the crossing on most days since then. On this occasion, the course taken by the wheelchair user directed him towards it and he either misjudged his position or was distracted and his front wheels encountered the ballast.

- 40 **When the down line through Victory level crossing was re-laid in March 2007, the asphalt strip on the south side of the crossing was not replaced along the full length of the crossing. A section of ballast was left in the south-west corner. The non-application of asphalt to the full length of the south side of the crossing is a causal factor in this incident.**

- 63 **After the work undertaken on 17/18 March 2007, the crossing was left in a suboptimal condition with an uneven interface in the south-west corner between the crossing surface, asphalt and ballast. The uneven interface was not identified during a number of crossing inspections that took place between March 2007 and December 2009 and no remedial action was taken. This was a causal factor in the incident.**

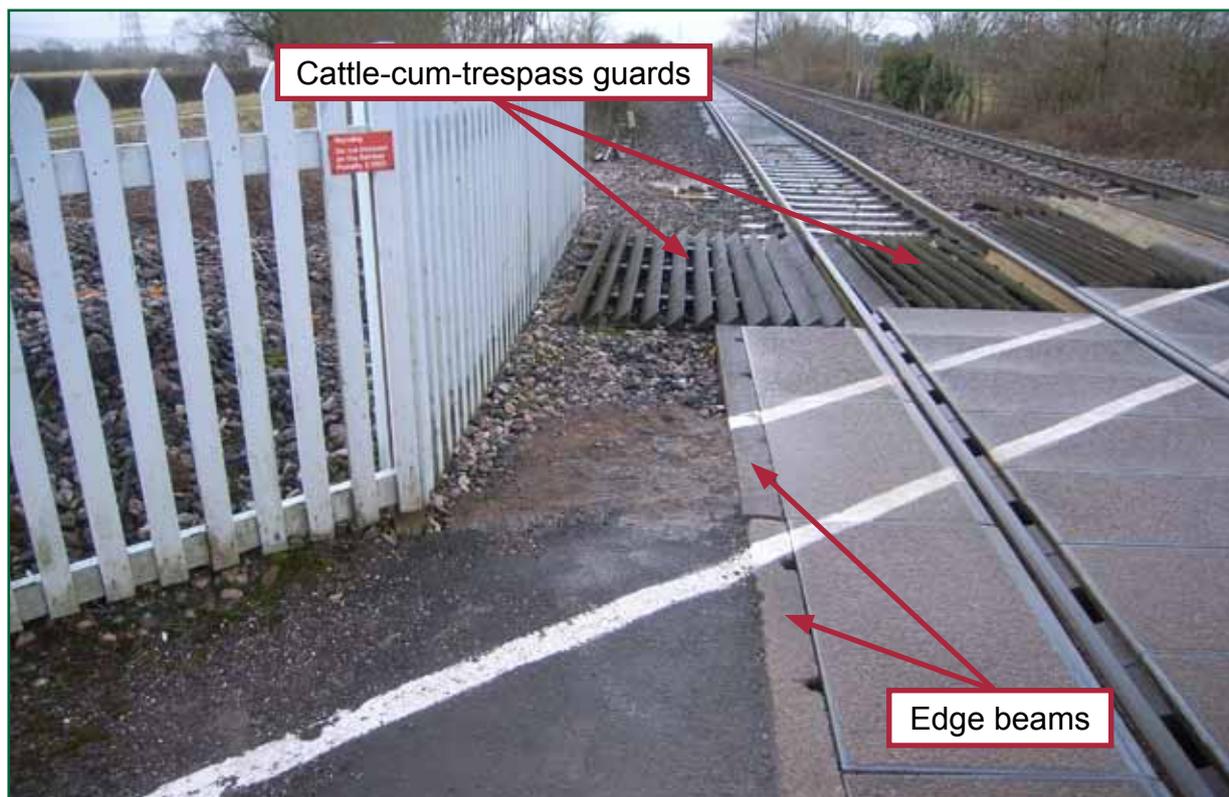
Figure 4: Position of edge beams and cattle-cum-trespass guards

- 21 At Victory level crossing the flangeway gaps were measured to vary between 55 and 62 mm.
- 22 Edge beams (figure 4) are installed on the north and south sides of the crossing to secure the outer crossing panels and to provide an edge for the asphalt section that is used to fill the gap between the crossing panels and the road approaches.

- 23 A footway for pedestrians is marked out over the level crossing surface to provide a walking area clear of the road carriageway. Cattle-cum-trespass guards (figure 4) are installed along the east and west sides of the crossing panels to deter animals and trespassers from gaining access to the railway lines.

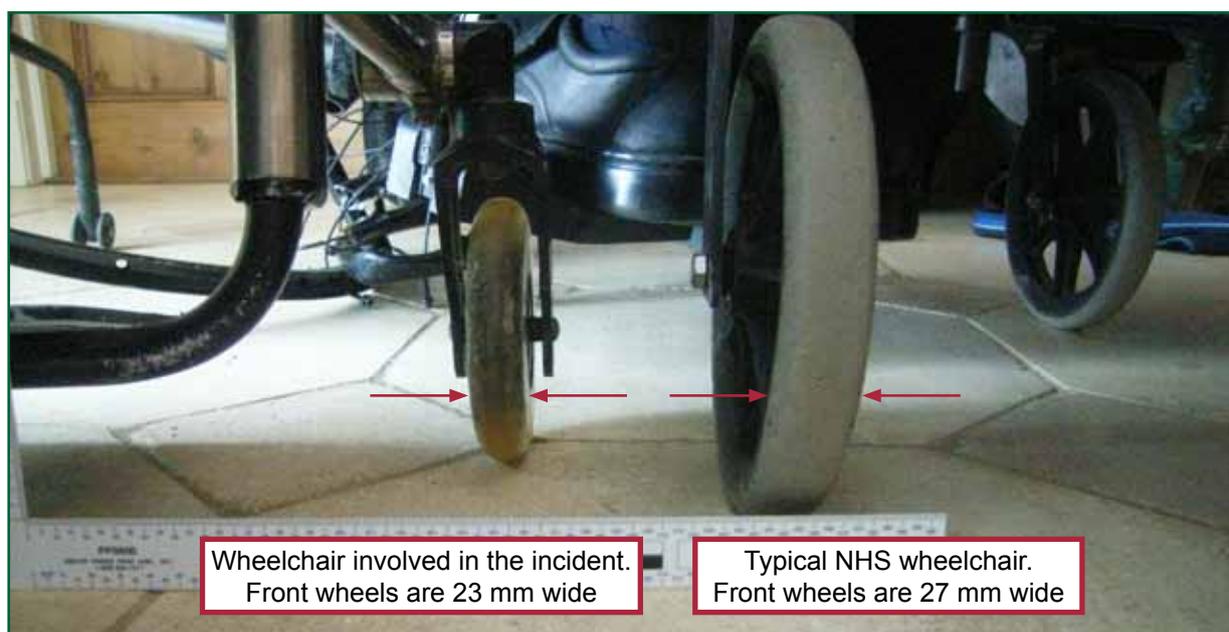
Figure 5: Wheels of wheelchair involved in incident (left) and standard NHS wheelchair (right)

- 24 There is no lighting and no footpath on either road approach to the level crossing, and no lighting on the level crossing itself.
- 25 The wheelchair that was struck by the train was a specialist light-weight wheelchair of titanium construction. The front wheels are free to swivel through 360°. The front wheels are smaller than a typical National Health Service (NHS) wheelchair, and are approximately 23 mm wide (figure 5). Typically, the front wheels of a NHS wheelchair are approximately 27 mm wide and are also free to swivel through 360°.

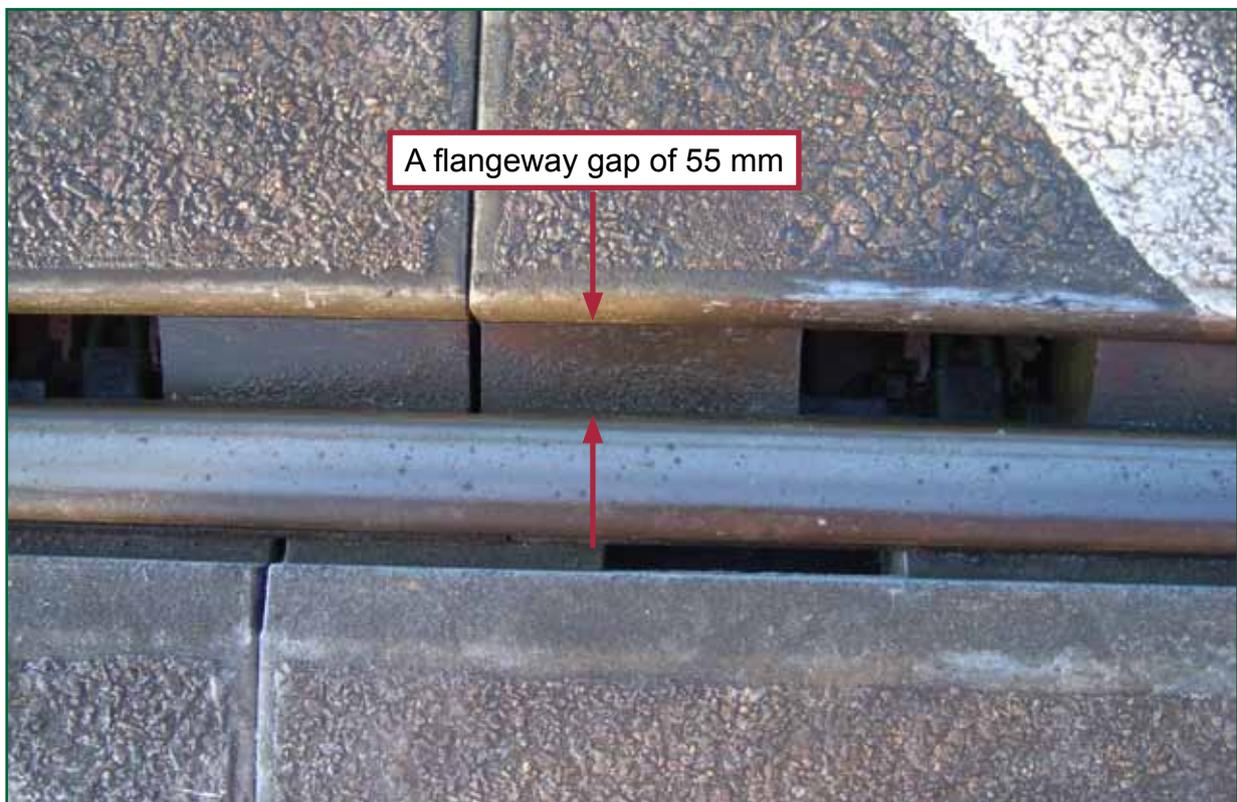
Figure 6: Example of the flangeway gap at Victory level crossing

- 27 He approached Victory level crossing on the left-hand side of the road (in the normal direction of road traffic). As he made his way over the crossing, the wheelchair user reported that he had negotiated the four flangeway gaps (two for the up line and two for the down line) by lifting the front wheels slightly and moving the wheelchair forward on its rear wheels, before setting the front wheels down again. In order to minimise the risk of the front wheels of the wheelchair becoming trapped in the flangeway gaps, he reported that he had elected to cross over them at right angles. Since the crossing was skewed in relation to the railway lines this approach meant that the wheelchair moved progressively towards the south-west corner of the level crossing.

Network Rail should, taking account of research in this country and developments overseas (paragraph 83), review methods for minimising the hazards from the flangeway gap at level crossings, particularly those that are skewed relative to the roadway or path, to users with small-wheeled equipment, such as wheelchairs and pushchairs, with a view to evaluating the costs and benefits of options for improving the safety of users of level crossings (paragraph 95d).

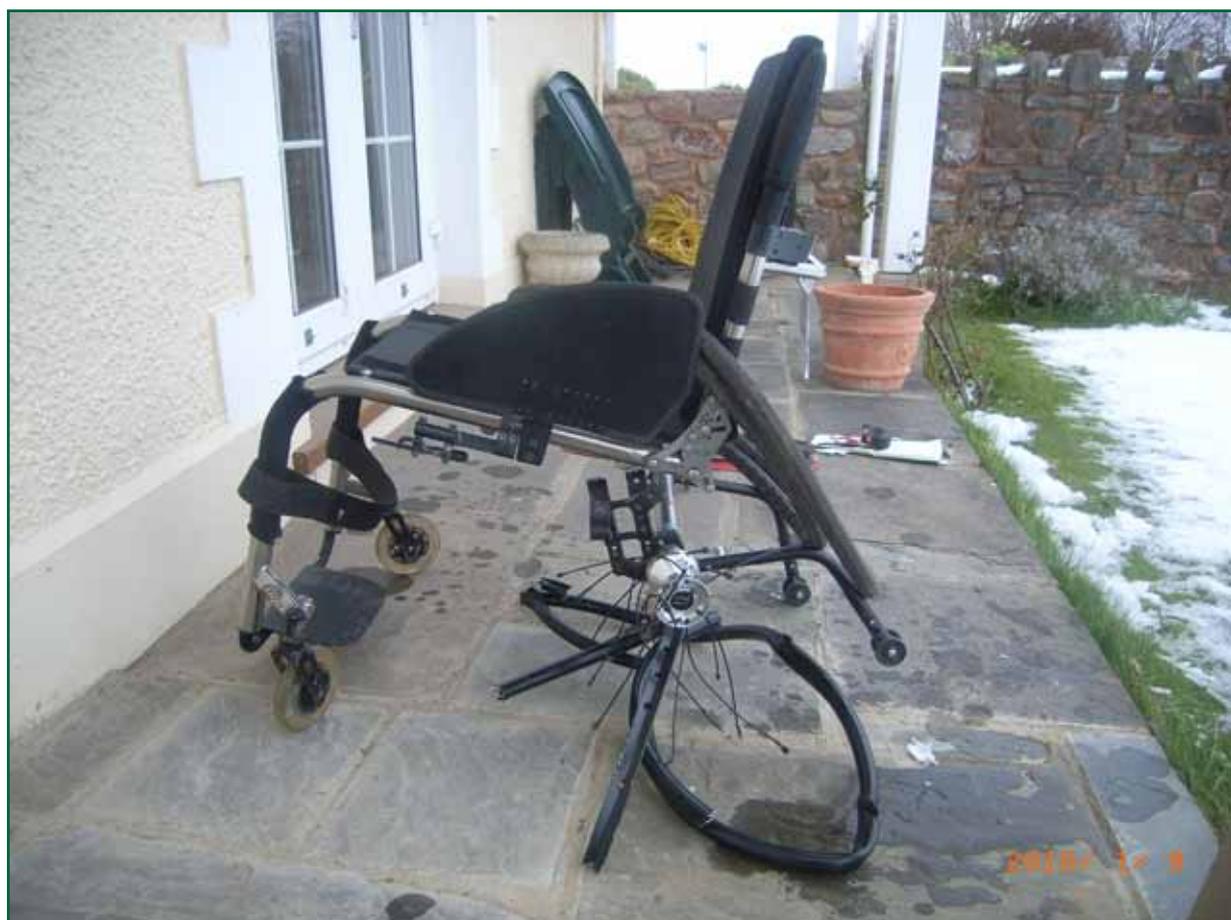
Figure 7: The damaged wheelchair

- 31 The wheelchair suffered significant damage (figure 7). The wheelchair user suffered some bruising to his right leg when he pulled himself from the wheelchair and was left shocked by the incident.

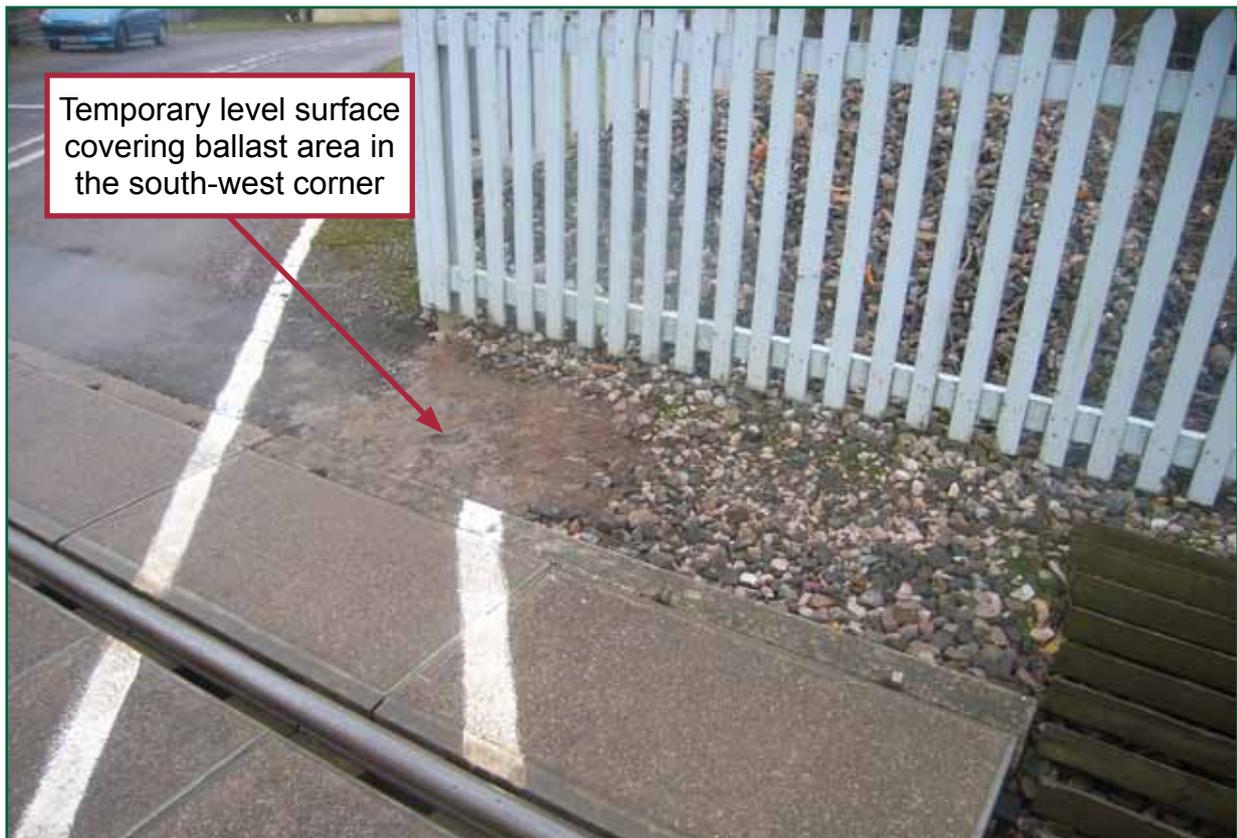
*Figure 8: Interim work carried by Network Rail following the incident to provide a level surface*

- 34 The signaller identified the train that struck the wheelchair as the 08:20 hrs Aberdeen to Penzance service. The signaller contacted the driver promptly. The train driver recalled feeling a slight bump but had not seen anything unusual when the train passed over Victory level crossing.
- 35 The wheelchair user was escorted back home following treatment by paramedics.
- 36 Workers from the local Network Rail off-track gang attended Victory level crossing later that night and laid concrete over the area of ballast where the wheelchair user had become trapped, to provide a temporary level surface (figure 8).

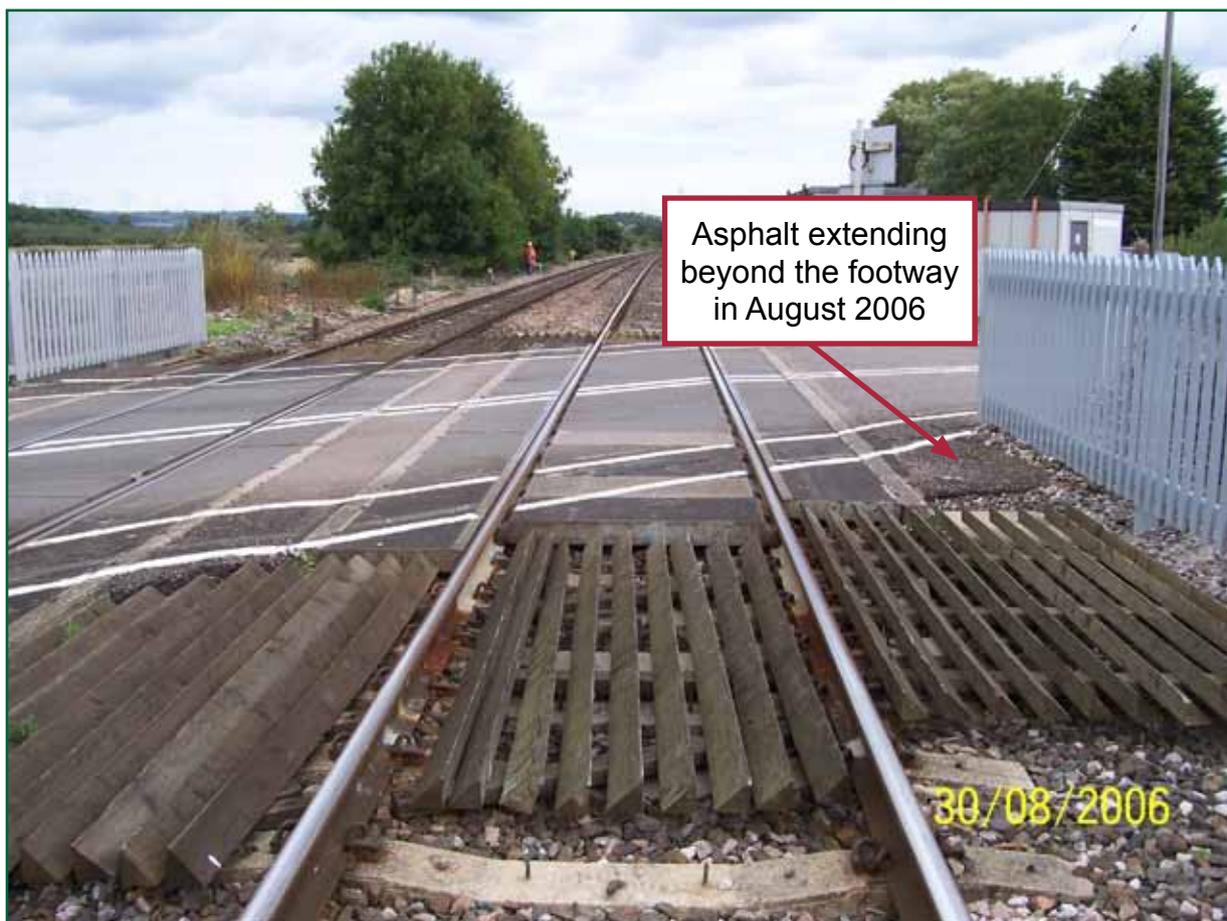
Figure 9: The asphalt section in August 2006 (photograph courtesy of Network Rail)

- 43 Photographic evidence from August 2006 shows the condition of the crossing before this work took place. It indicates that the asphalt that filled the gap between the level crossing surface and the road highway originally extended beyond the corner fence post towards the end of the edge beam on the south side (figure 9).

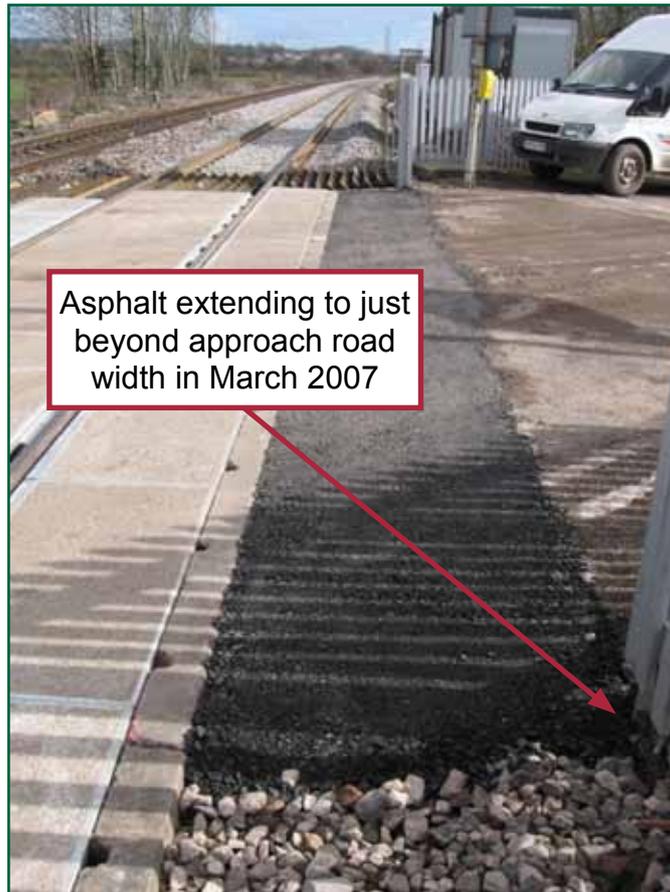
Figure 10: The asphalt section following the work in March 2007 (photograph courtesy of Network Rail)

- 47 The following week, on the night of 17/18 March 2007, the local Network Rail off-track gang fitted new crossing panels to recreate the down side section of the level crossing. The down line edge beams were also re-installed. A sub-contractor laid asphalt to the level of the crossing surface and adjoining road approach. Photographs taken by the HOTR department during the work (figure 10) indicate that the asphalt installed at this stage did not extend beyond the left-hand side of the carriageway (in the direction of travel) on the south side of the crossing and did not correspond with what had been present previously. A short section of ballast remained at the south-west corner of the crossing (figure 2).

- 48 The Network Rail off-track gang had completed two long shifts on 17 and 18 March 2007 and had left site before Dean and Dyball and the sub-contractor finished the asphaltting. Network Rail's representative on site from the HOCR department was not fully conversant with the requirements for level crossings: the off-track gang had been contracted for this purpose. Therefore, when the level crossing was handed back on the morning of 18 March 2007, nobody on site was competent to judge whether the asphalt at the interface with the crossing surface had been restored to its original length and no site plan was available as a reference source.
