Rail Accident Investigation Branch

Rail Accident Report

**Derailment in Summit tunnel, near Todmorden,
West Yorkshire
28 December 2010**

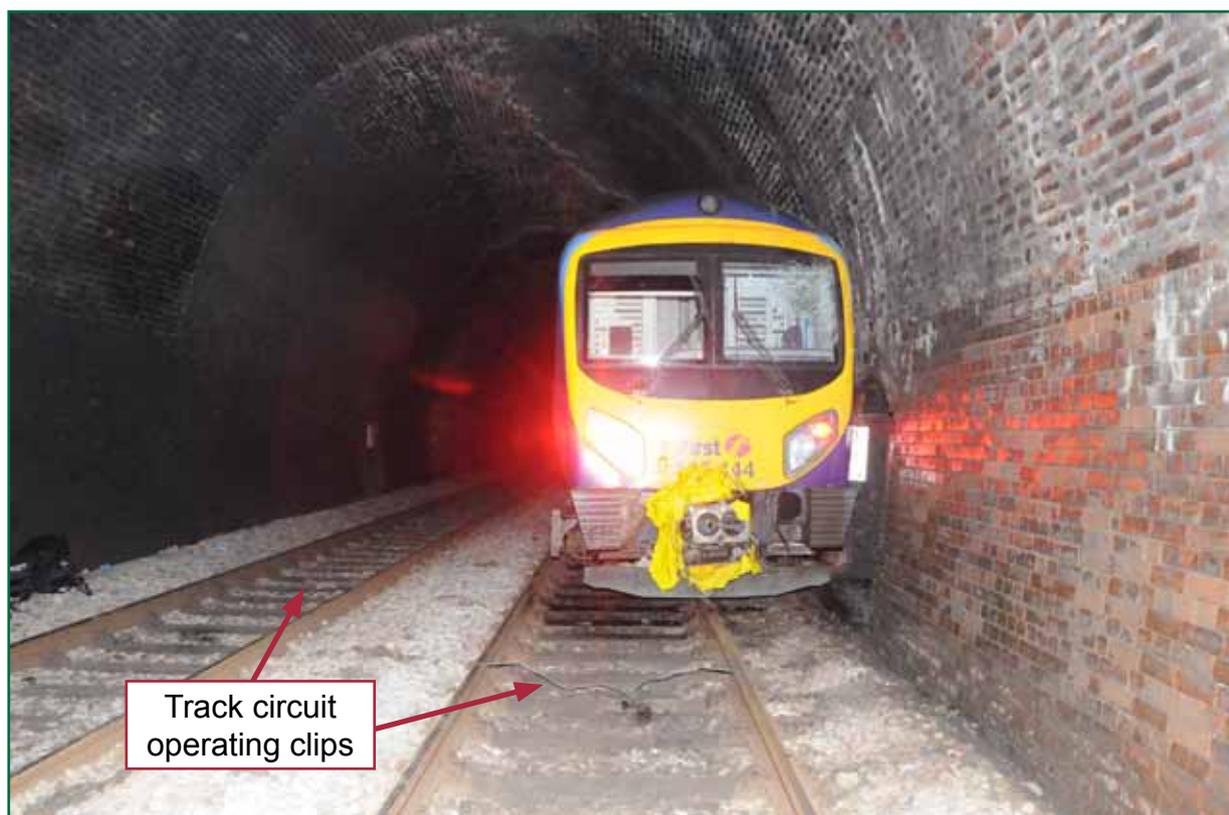
- 29 About four seconds after impact, the driver applied the train's *emergency brakes*. The train ran derailed for 254 metres, with the front left hand side of the train striking the tunnel wall in several places, before coming to a stop under ventilation shaft 11 (figure 6). The train remained coupled and upright, and it did not foul the adjacent line.

Figure 6: Train 1P02 after it had stopped (courtesy of British Transport Police)

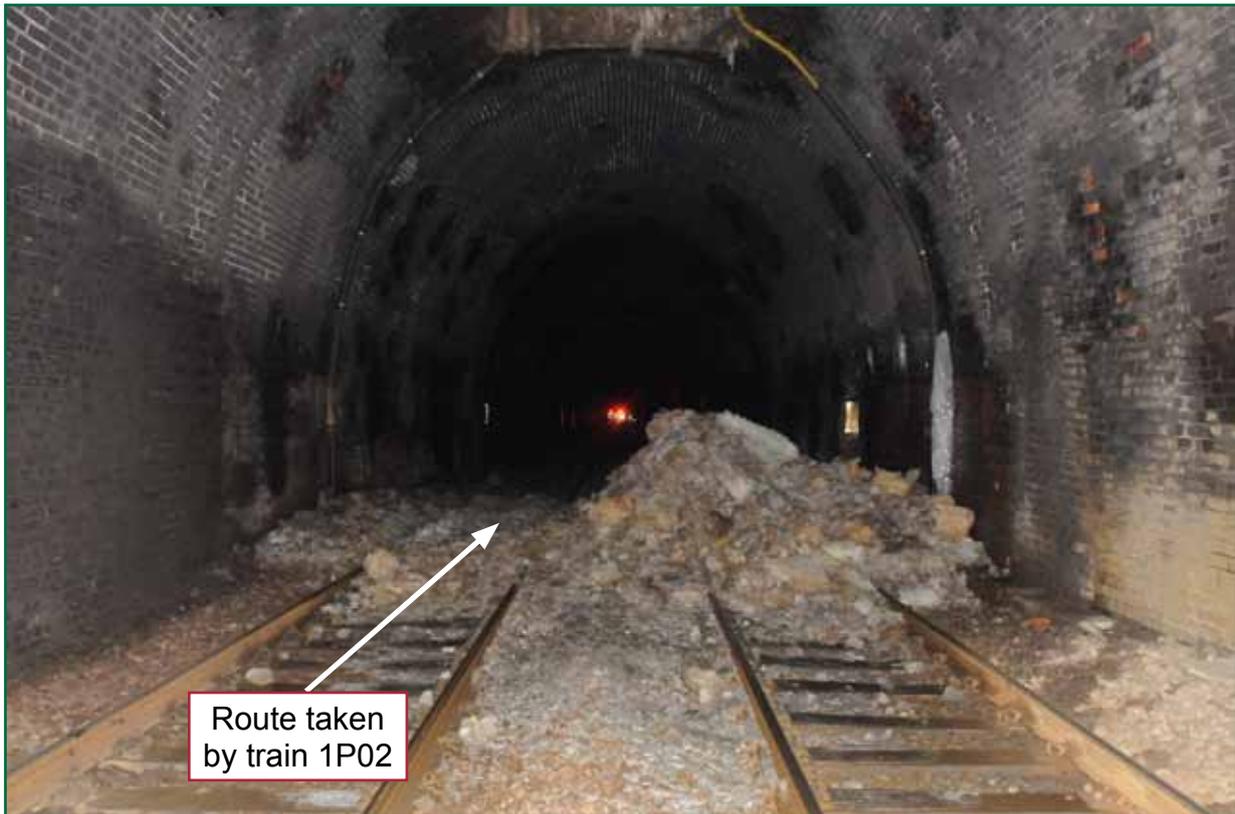
- 60 When the driver first spoke to the signaller after the accident, he reported that his train had derailed after hitting a large pile of ice on the track. Afterwards, a significant amount of ice was found underneath ventilation shaft 10 (figure 8). The RAIB estimated that there was between 20 and 25 tonnes of ice on the track (figure 9).
- 61 A smaller, although still significant, volume of ice was also found underneath ventilation shaft 11 (figure 10). After the accident, further ice could be seen in the bottom of both of these shafts (figure 11).

Figure 8: General view of the pile of ice found below ventilation shaft 10 after the accident (courtesy of British Transport Police)

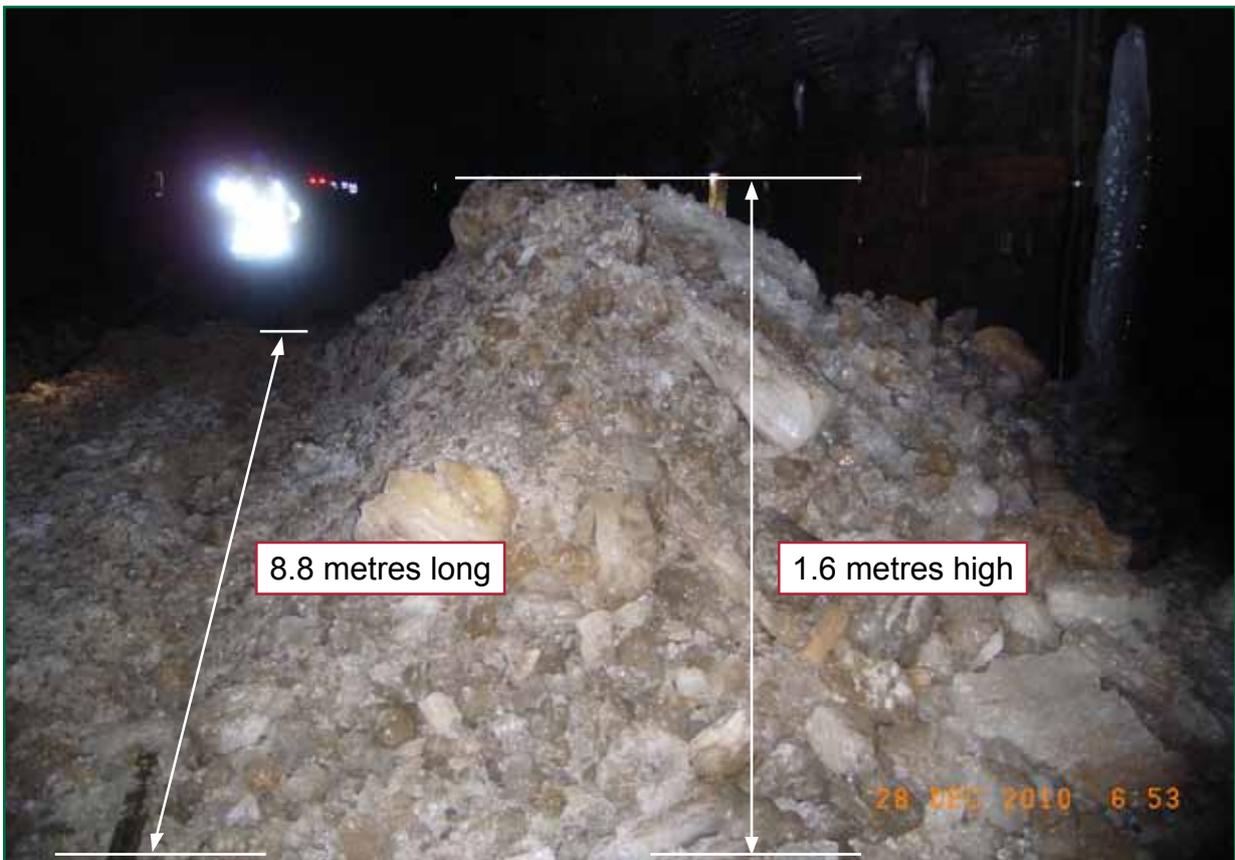
Figure 9: Close up view of the pile of ice after the accident, with height and length shown

- 65 A thaw began on 27 December when the ambient air temperature in the vicinity of the tunnel rose above 0°C at about 01:00 hrs. From about 04:30 hrs to the time of the accident, this outside air temperature stayed above freezing. The warmer outside air entered the tunnel over time but it is not known precisely how quickly the air temperature inside the ventilation shafts rose. As the air inside the ventilation shaft warmed up, the ice began to melt. Once it began melting, over a period of time it broke away and fell onto the tracks below. The pile was formed by many pieces of ice, of a range of sizes (figure 9).

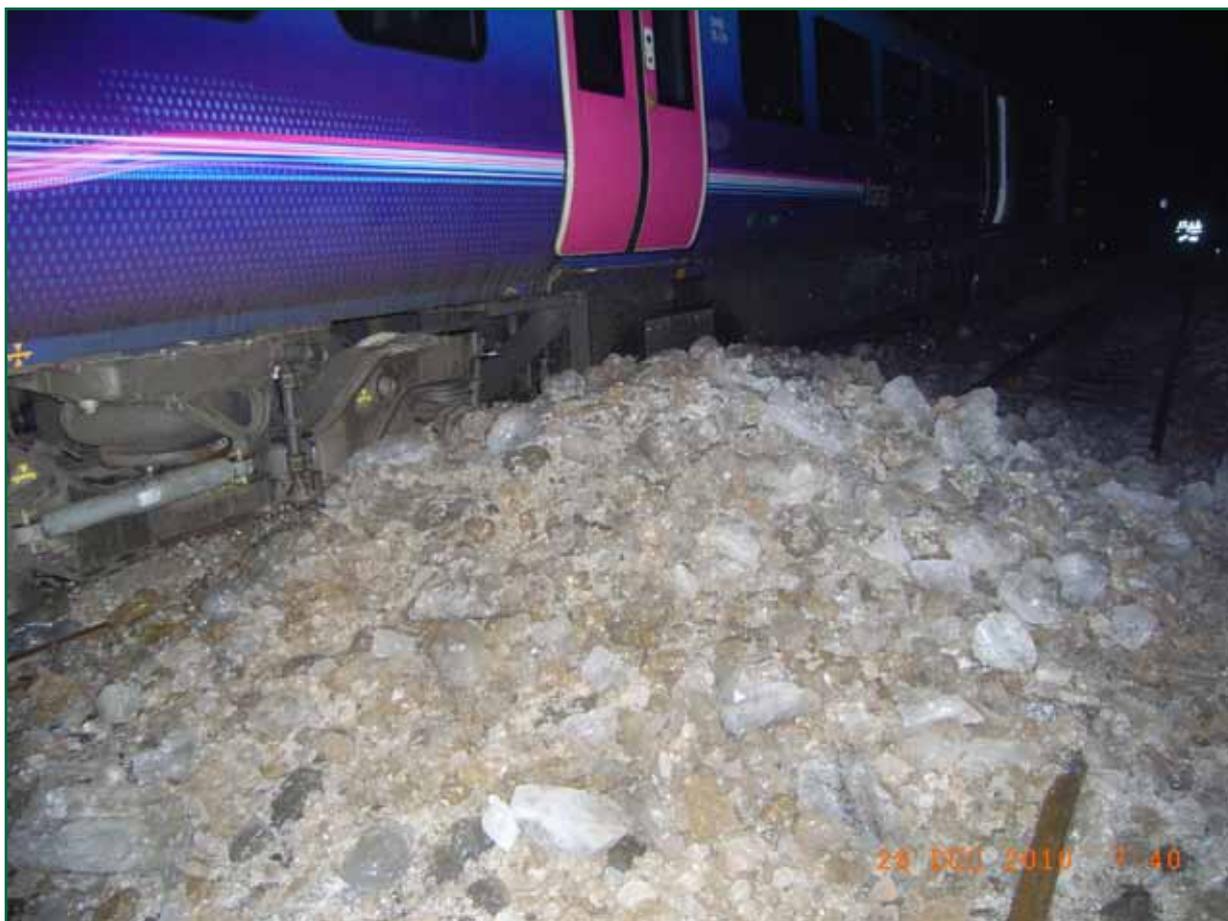
Figure 10: The pile of ice found under ventilation shaft 11 next to train 1P02

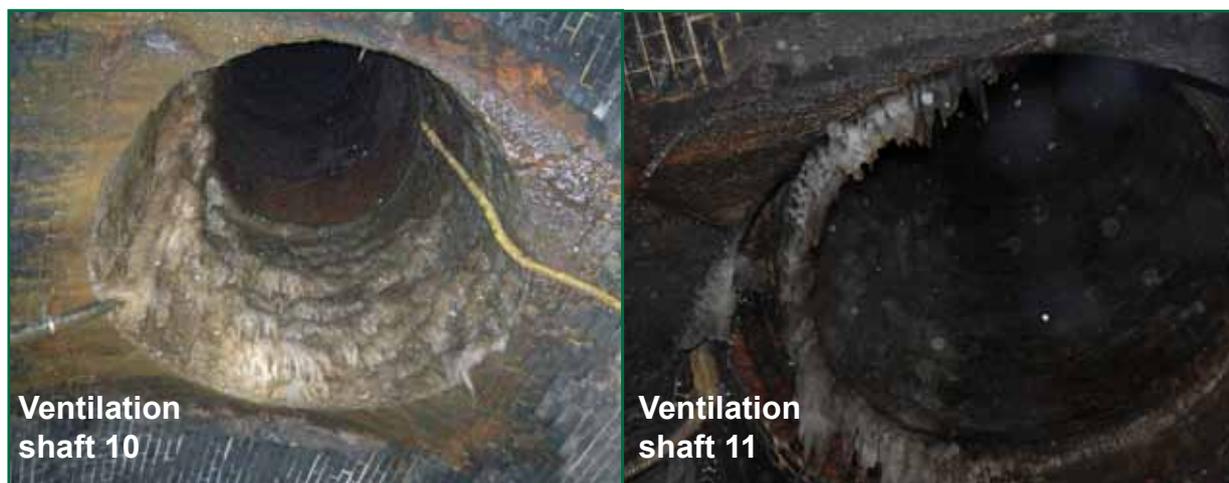
Figure 11: Views looking up at ventilation shafts 10 and 11 showing ice still present in the bottom of the shafts (ventilation shaft 11 photograph courtesy of British Transport Police)

- 66 It is not possible to be certain whether the ice found under ventilation shaft 10 was the result of one very large ice fall or whether it accumulated as a result of a number of smaller falls. The RAIB observed that ice was still present in ventilation shaft 10 after the accident (figure 11), so further falls were possible. Ice was also found under ventilation shaft 11, and more ice fell out of it and onto the top of the train while the passengers and train crew were waiting to be evacuated (paragraph 35). As the ice here was coming down as a series of falls, it is likely that the ice from ventilation shaft 10 fell in a similar way.

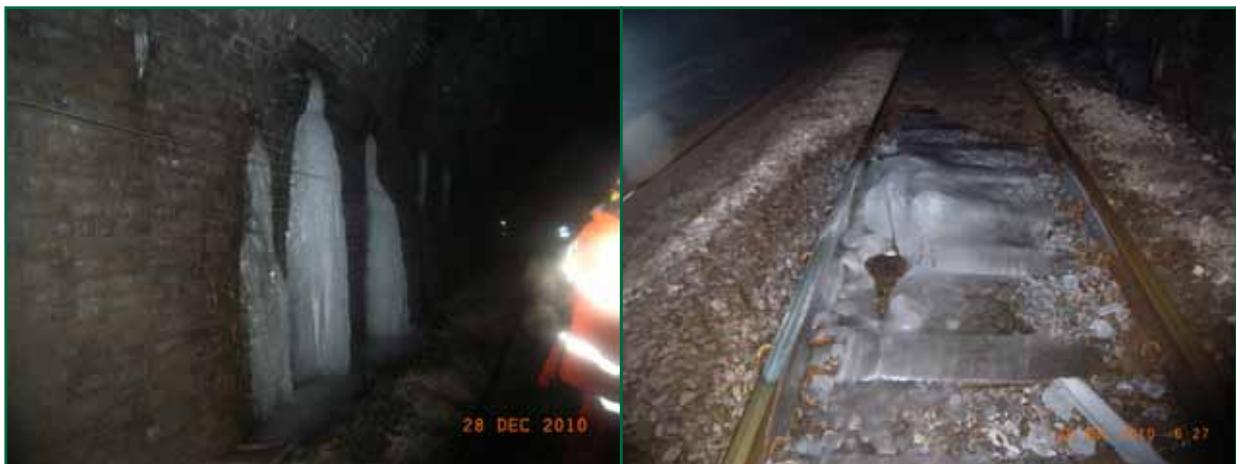
- 63 **Water running down the lining in ventilation shaft 10 froze and formed a large quantity of ice, which then began to thaw and fall onto the railway tracks below. This was a casual factor.**
- 64 The ice in ventilation shaft 10 was formed by water that froze as it ran down the lining of the shaft. This happened during a prolonged period of freezing weather conditions, when the ambient temperature fell below 0°C on 16 December and remained below freezing for the next 10 days. No trains ran through the tunnel for about 75 hours before the accident (paragraphs 24 and 25), so icicles that formed below the base of the ventilation shaft were undisturbed by trains. Also in other places where water was present, ice formed undisturbed on the tunnel walls and on the track (figure 12).

Figure 12: Ice formations found on the track and tunnel wall

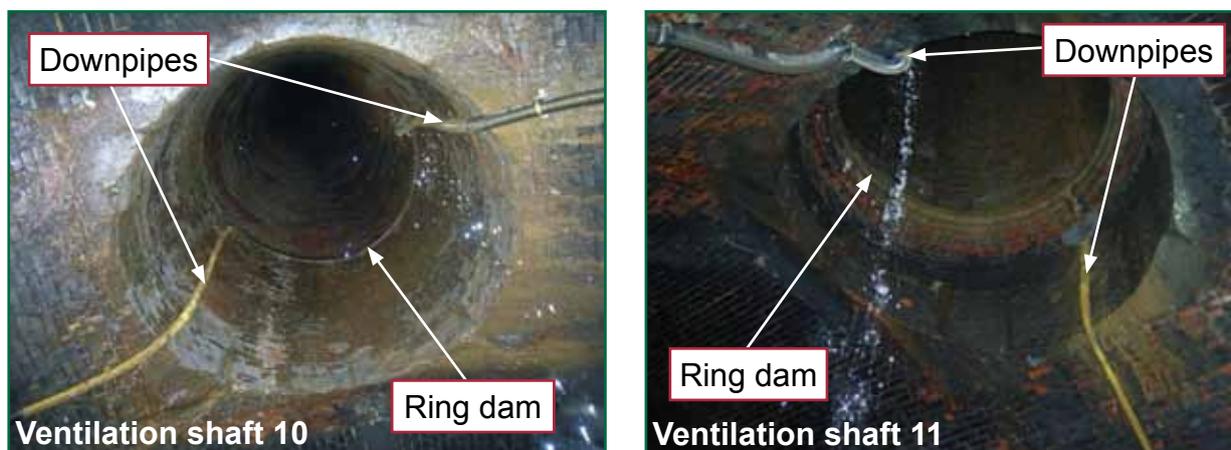
- 70 Witnesses told the RAIB that after the accident, water was pouring from ventilation shaft 11 onto the top of the train. While on site the RAIB also observed a lot of water flowing down the inside of ventilation shaft 10. During a follow-up site visit just over two weeks later, the RAIB observed water pouring from both of these ventilation shafts (figure 13). This water was overflowing the *ring dam*, running down the shaft's lining into the tunnel, and onto the tracks from the base of the shaft. Water was also cascading onto the tracks from a broken *downpipe* (paragraphs 140 to 143).

Figure 13: Water cascading from ventilation shafts 10 and 11 onto the tracks below

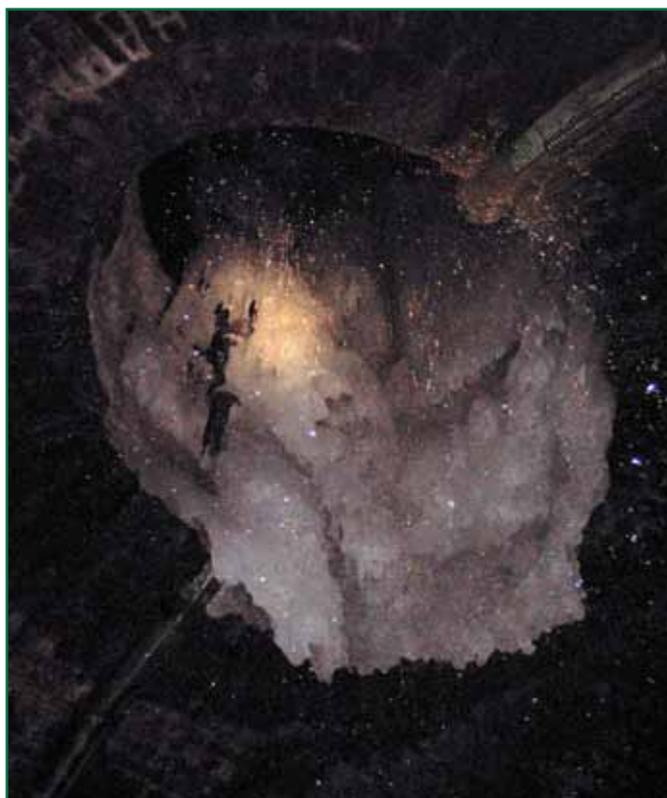
- 95 During the period of extreme cold weather at the start of December 2010, the Appleby track maintenance engineer noted ice forming in Blea Moor tunnel. He invited structures management staff to see the ice that had formed in one of the ventilation shafts (figure 15). The structures management staff looked at the ice formation and assisted the Appleby track maintenance engineer in deciding what the best way was to remove it without damaging the structure. The Appleby track maintenance engineer continued his contact with the structures management staff to actively look at ways to reduce ice formation in this tunnel and the methods of removing ice once it is found.

Figure 15: The ice formation seen hanging from the bottom of a ventilation shaft in Blea Moor tunnel in December 2010 (courtesy of Network Rail)

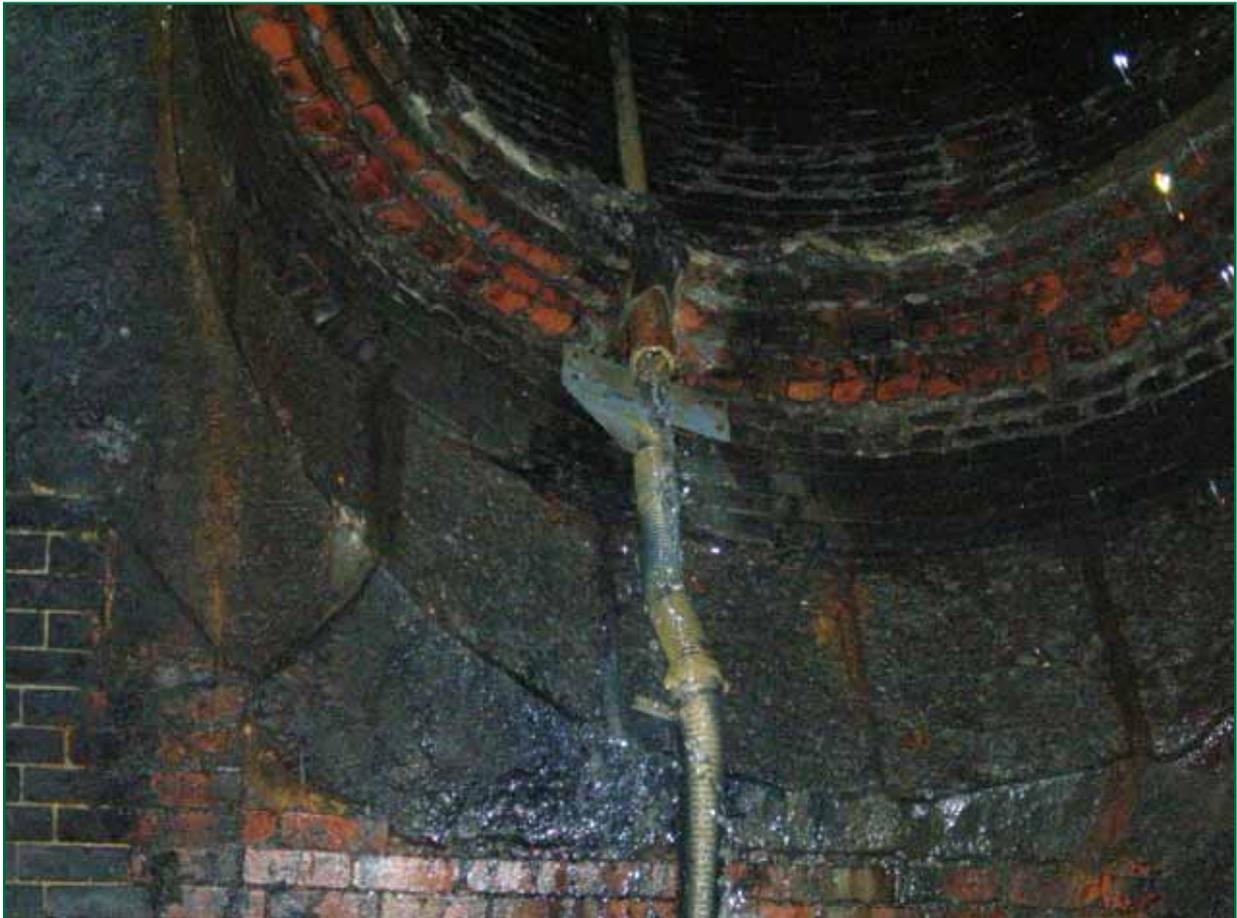
- 140 The last detailed examination of the tunnel bore by an examiner from Amey included a visual examination of the ventilation shaft drainage from below. This took place over two weekends at the end of July and the start of August in 2010. The examiner found the downpipe to the ring dam was broken in ventilation shaft 11 (figure 16) and called for it to be reinstated to prevent water being discharged onto the track. For ventilation shaft 10, the examiner found the ring dam was not collecting the water running down the shaft and called for a review of the existing drainage arrangements with actions to be taken to correct this.

Figure 16: The broken downpipe in ventilation shaft 11

- 141 The broken downpipe was noted by a senior structures management engineer who was on site at time of the examination, and he entered this defect as a minor works item on CARRS the following week. However, it was not repaired before the accident because it was not classified as an urgent repair. Network Rail buildings and civils – asset management had reprioritised all non-urgent repairs to the next financial year starting in April 2011, because the minor works budget for LNW route for that financial year was already fully committed. The RAIB observed during a site visit in January 2011 that neither defect had been repaired.
