Rail Accident Investigation Branch

# RAIB Bulletin 03/2013

## Signal NW36 passed at danger at Norton-on-Tees West, 16 January 2013

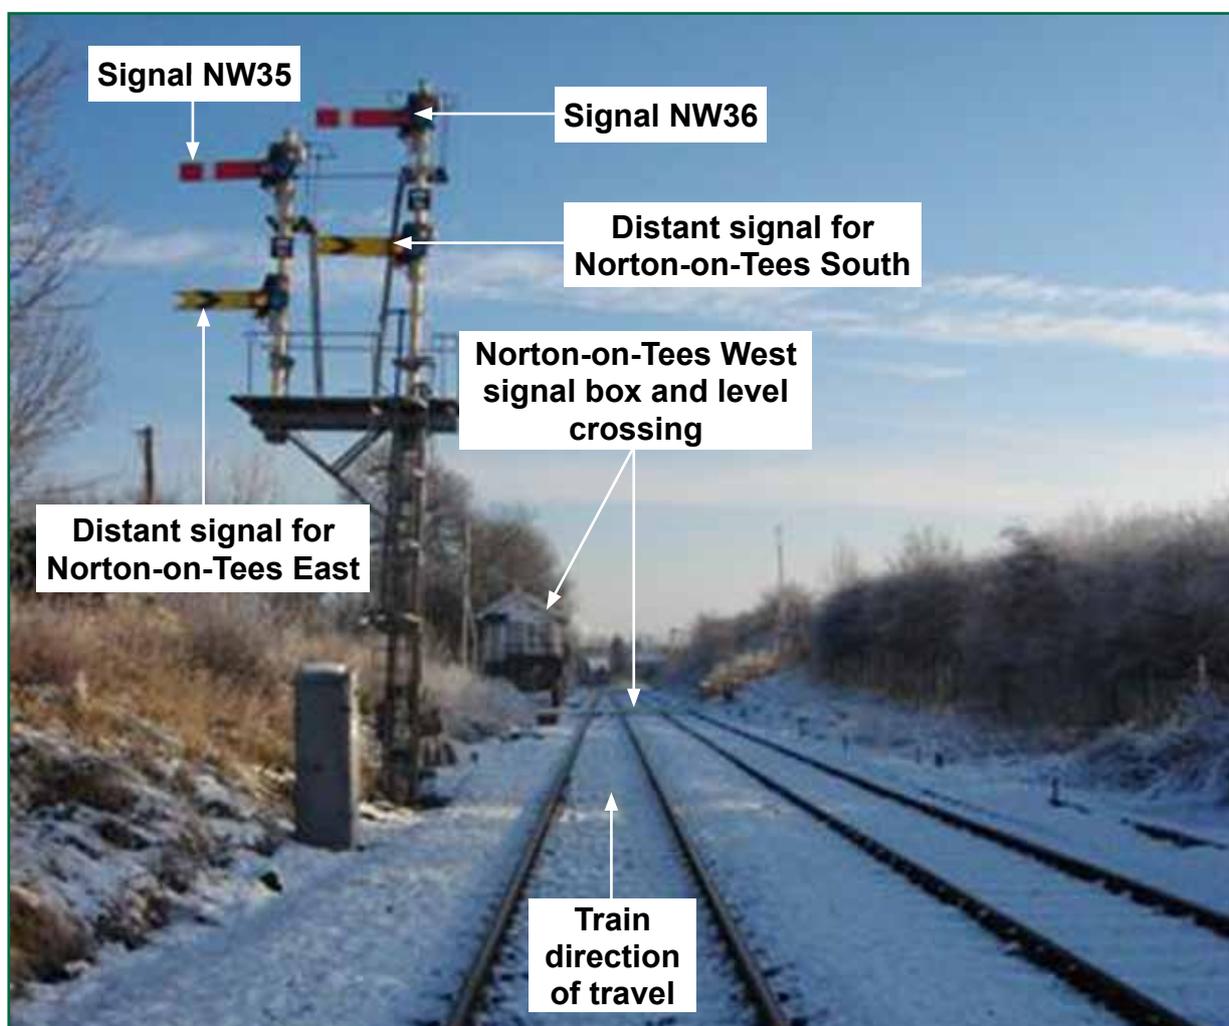
Figure 3: The signal structure at Norton-on-Tees West. Signal NW36 is the top right-hand signal. The distant signal for Norton-on-Tees South is directly below it.

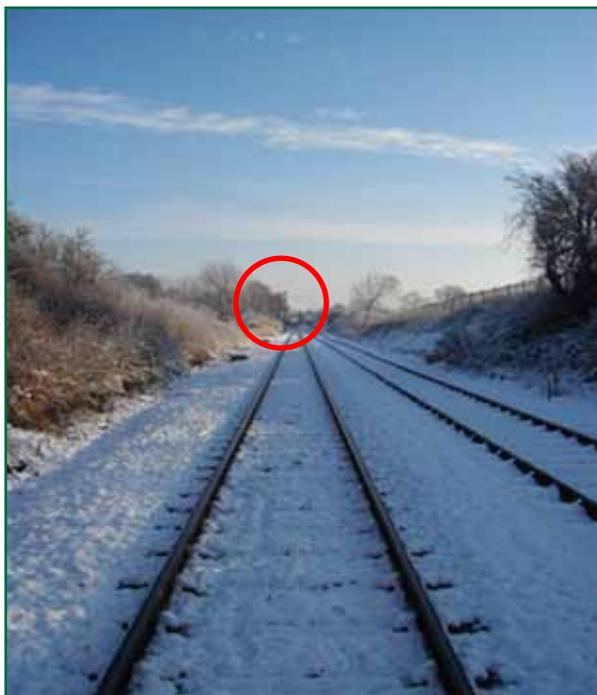
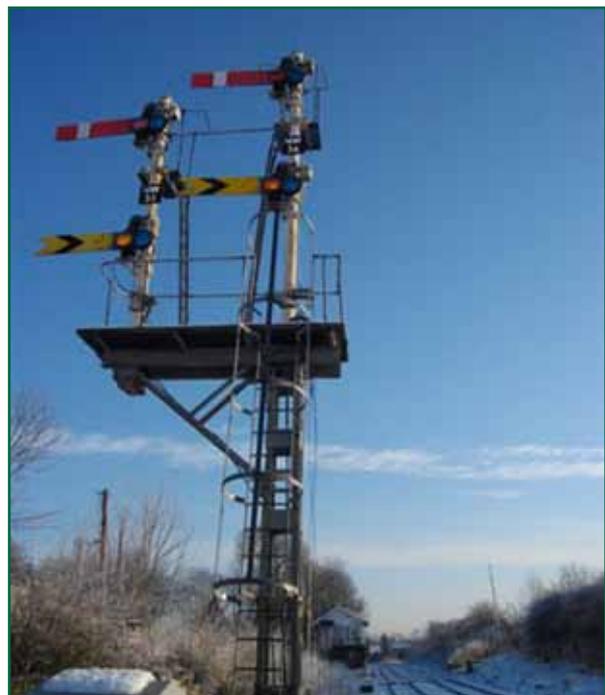
<sup>4</sup> A block instrument is a device which often incorporates a tapper used by the signaller to send a defined code on a single-stroke bell (referred to as a 'bell-code') to the signaller at the next signal box, and a three-position indicator that describes the status of the line between the two signal boxes. The indicator is operated by a switch in the block instrument at the other signal box. The status of the line shown on the indicator can be 'normal' (no train present), 'line clear' (the signallers have agreed that a train can pass between the two boxes, but it has not yet arrived) and 'train on line' (a train is occupying the section between the two boxes).

- 17 The driver misread signal NW36, focusing on the yellow light displayed on the distant signal rather than the red light displayed on the stop signal mounted above. It is possible that he approached signal NW36 with a pre-conceived idea that his train would be routed past it and towards Norton-on-Tees South and signal NS19. When he saw the yellow light, he misunderstood this to mean that he was able to proceed towards signal NS19.

- 20 The incident occurred before sunrise (which was at 08:17 hrs on 16 January at nearby Stockton), so the driver was largely dependent on seeing and understanding the meaning of the lights displayed by the signals rather than the orientation of the arms. The RAIB observed that from 300 - 400 metres, the yellow light of the distant signal appeared brighter than the red light of signal NW36 above it and, even in daylight, the trees behind the signal structure had the effect of making the lights stand out more than the actual orientation of the signal arms (figure 4).

*Figure 4: Trees providing a dark background behind the signal structure (left) and the red and yellow light lenses of signal NW36 and the distant signal below (right). Note that the photographs are taken during daylight and not at drivers' eye level.*

- a) Areas currently signalled using semaphore signals are being progressively converted to colour light signalling, and drivers may thus be exposed to semaphore signalling, and its operational characteristics, less often. This emphasises the importance of train operating companies reviewing training and route assessments for drivers on semaphore signalling, and importantly, how that competence is maintained. Factors for consideration include drivers' understanding of the meanings of semaphore signals where a stop signal for one signal box and the distant signal for the next signal box are located one above the other, and the differences in interpreting these signals in daylight and darkness.
