Rail Accident Investigation Branch

Rail Accident Report

**Passenger dragged a short distance by a train
at Holborn station
3 February 2014**

Report 22/2014
October 2014

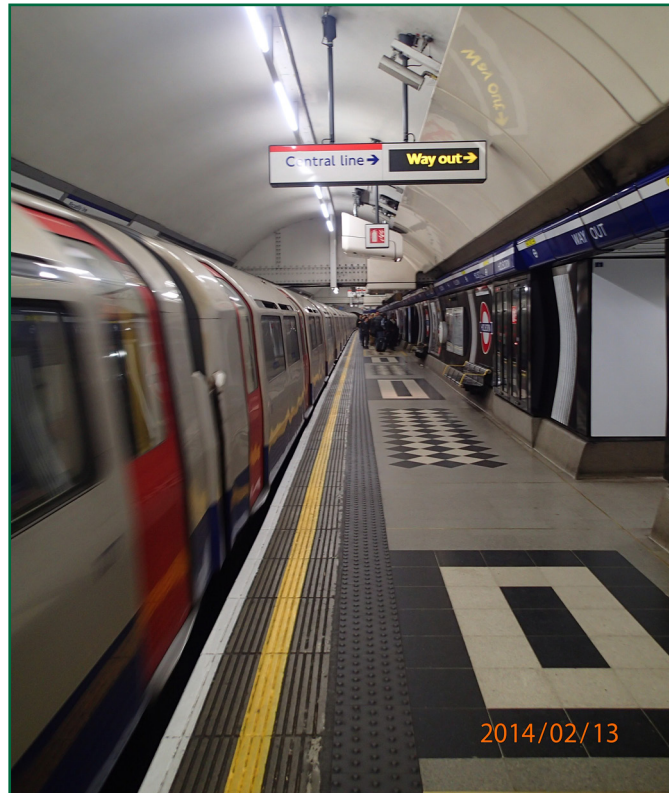
- Holborn station is an interchange between the Piccadilly and Central lines of London Underground. The Piccadilly line platforms were opened in 1906 and have remained substantially unaltered, although the station was rebuilt in 1933 when the Central line platforms were added. The westbound platform is on the left-hand side of the line in the direction of travel. There are three entrances to the platform in normal use, and the accident occurred opposite the entrance closest to the rear of trains

Figure 2: Westbound Piccadilly line platform at Holborn, viewed from the front of the train.

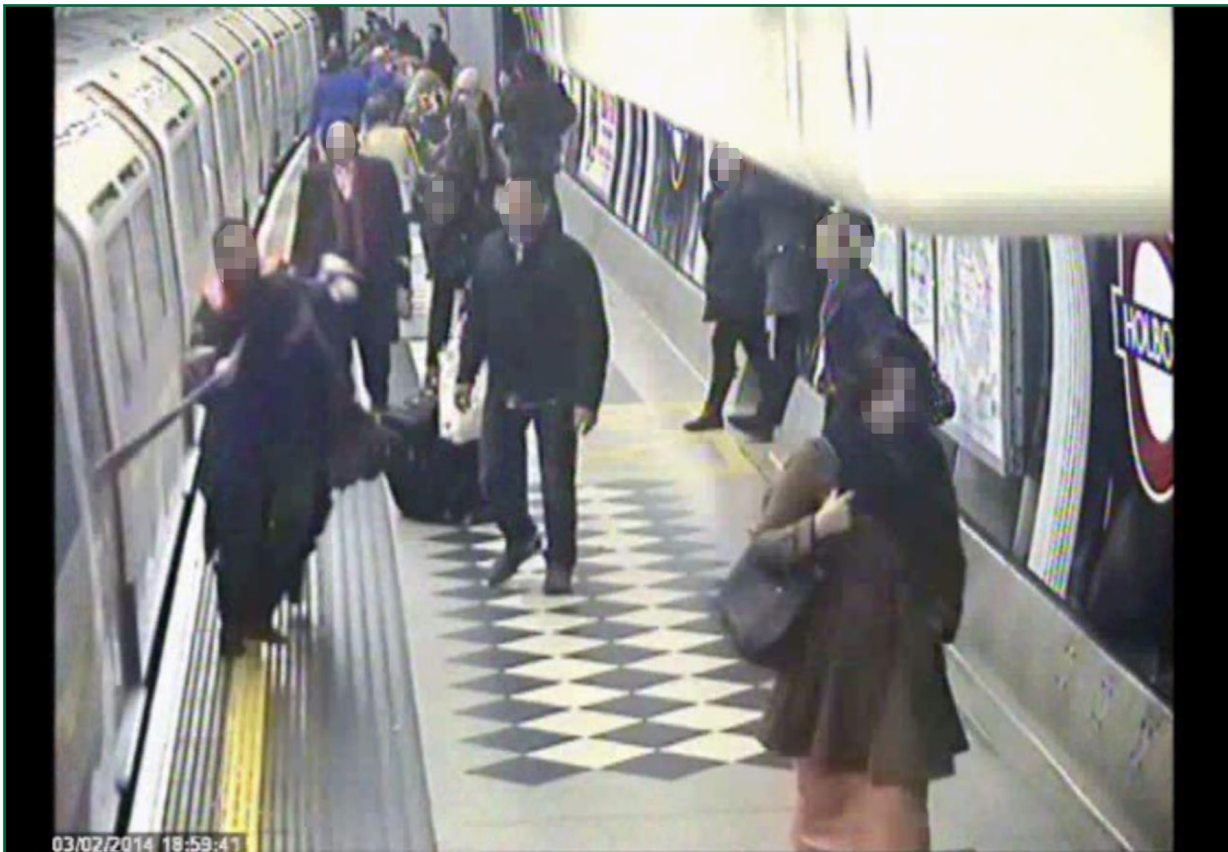
- 21 At 18:59:38, five seconds after the doors finished closing, the train began to move. The passenger started to move with it. Three seconds later the SATS, wanting to try and get the scarf free, leaped forward and made a grab for the passenger (figure 3), she fell to the ground, and the scarf unwound from her neck. The train continued into the tunnel, with the scarf still trapped in the doors.

Figure 3: the SATS pursues the trapped passenger as the train moves off (image courtesy LUL)

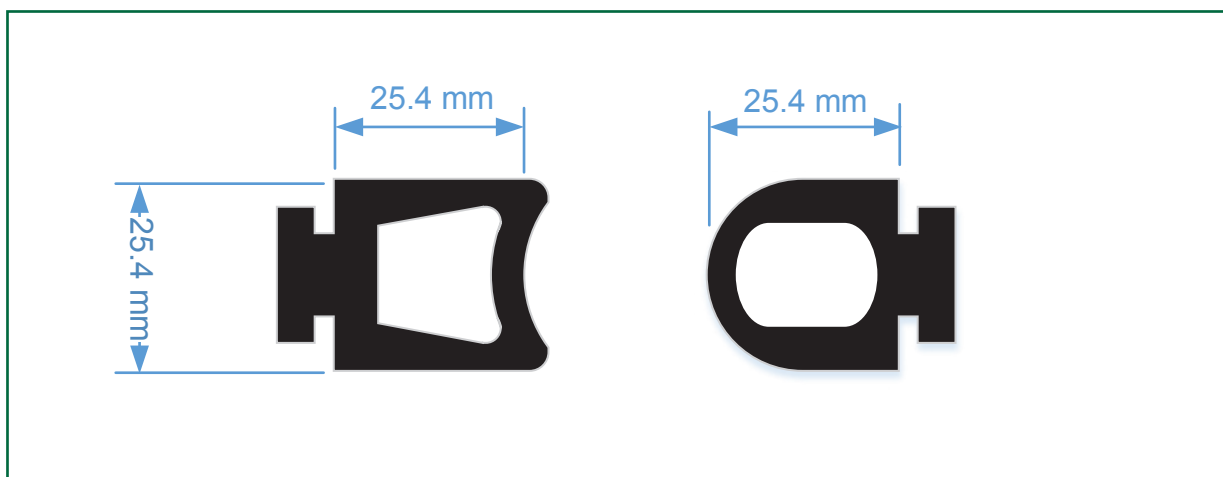
47 The door seal is made by rubber door edgings, which are shaped with convex (the fixed door) and concave (the pushback door) profiles. These interlock to make a weatherproof seal. Drawings of the seal profile are at figure 4. The door seals on the train involved in the accident were smooth and in good condition, with no irregularities or significant wear. In common with most¹⁴ other types of train doors on LUL, the doors will not re-open automatically if an obstruction is detected.

Figure 4: Profile of door edges

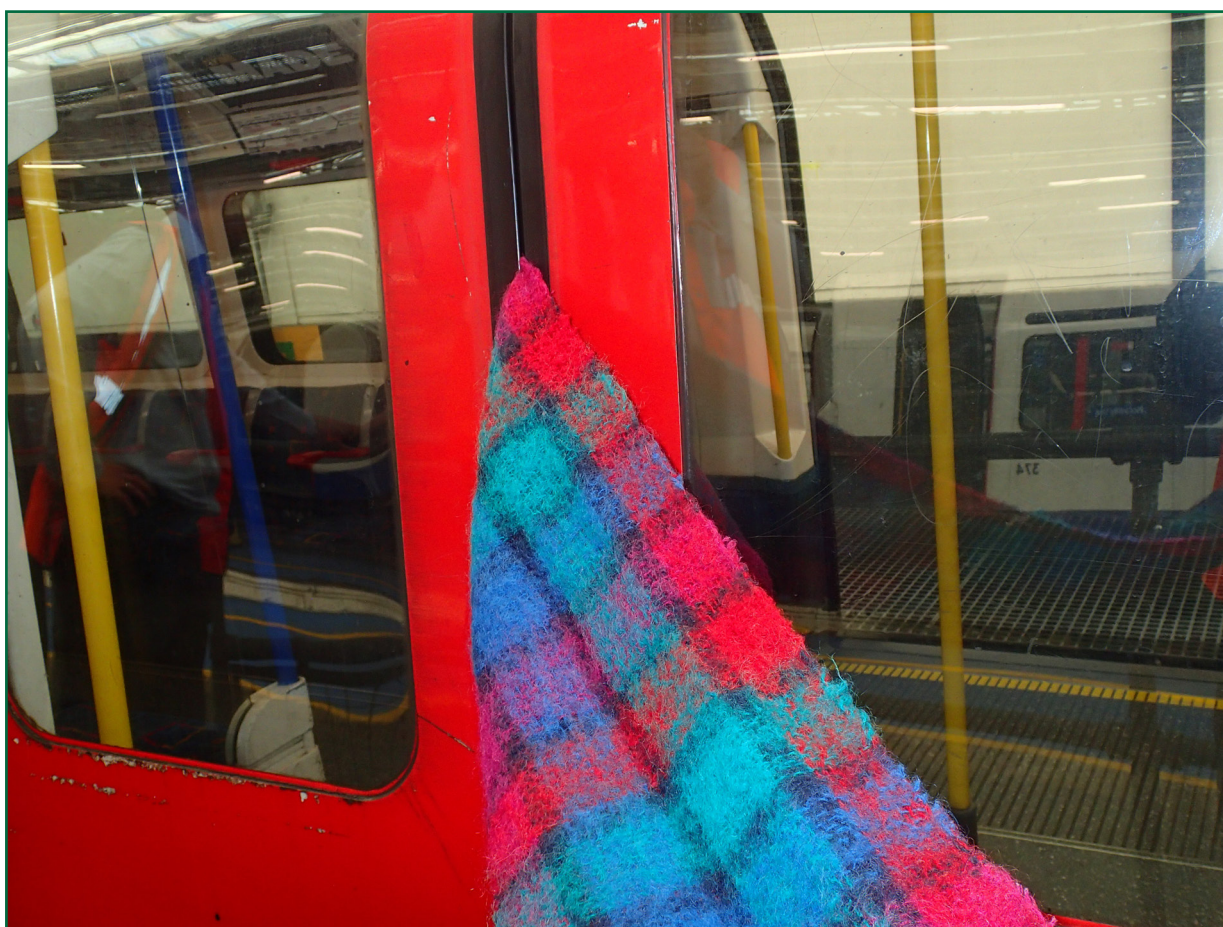
48 The scarf worn by the passenger was not recovered after the accident (paragraph 24), but it is known to have been knitted, and made from wool (it is likely that it had plain ends, without knots or tassels). RAIB carried out tests on the doors involved, using a loose-weave mohair scarf which was probably reasonably representative of the actual scarf involved in the accident (figure 5).

Figure 5: scarf during tests at Northfields depot

- 49 In these tests, the force required to pull out the scarf at right angles to the door leaf was approximately 70N. This is equivalent to 7 kgf (15 lbf), and could have been achieved by a sharp tug at right angles to the door (LUL's standard requires a maximum of 90N (9 kgf or 20 lbf) (paragraph 45)). However, in the accident, once the train started to move, the scarf was being pulled at an angle to the side of the train, and in the direction of travel, it was pulling against the fixed leaf of the closed doors. Replicating these conditions in tests, the RAIB found that the force required to pull out the scarf varied between 80 and 110N (8 to 11 kgf, or 18 to 24 lbf).

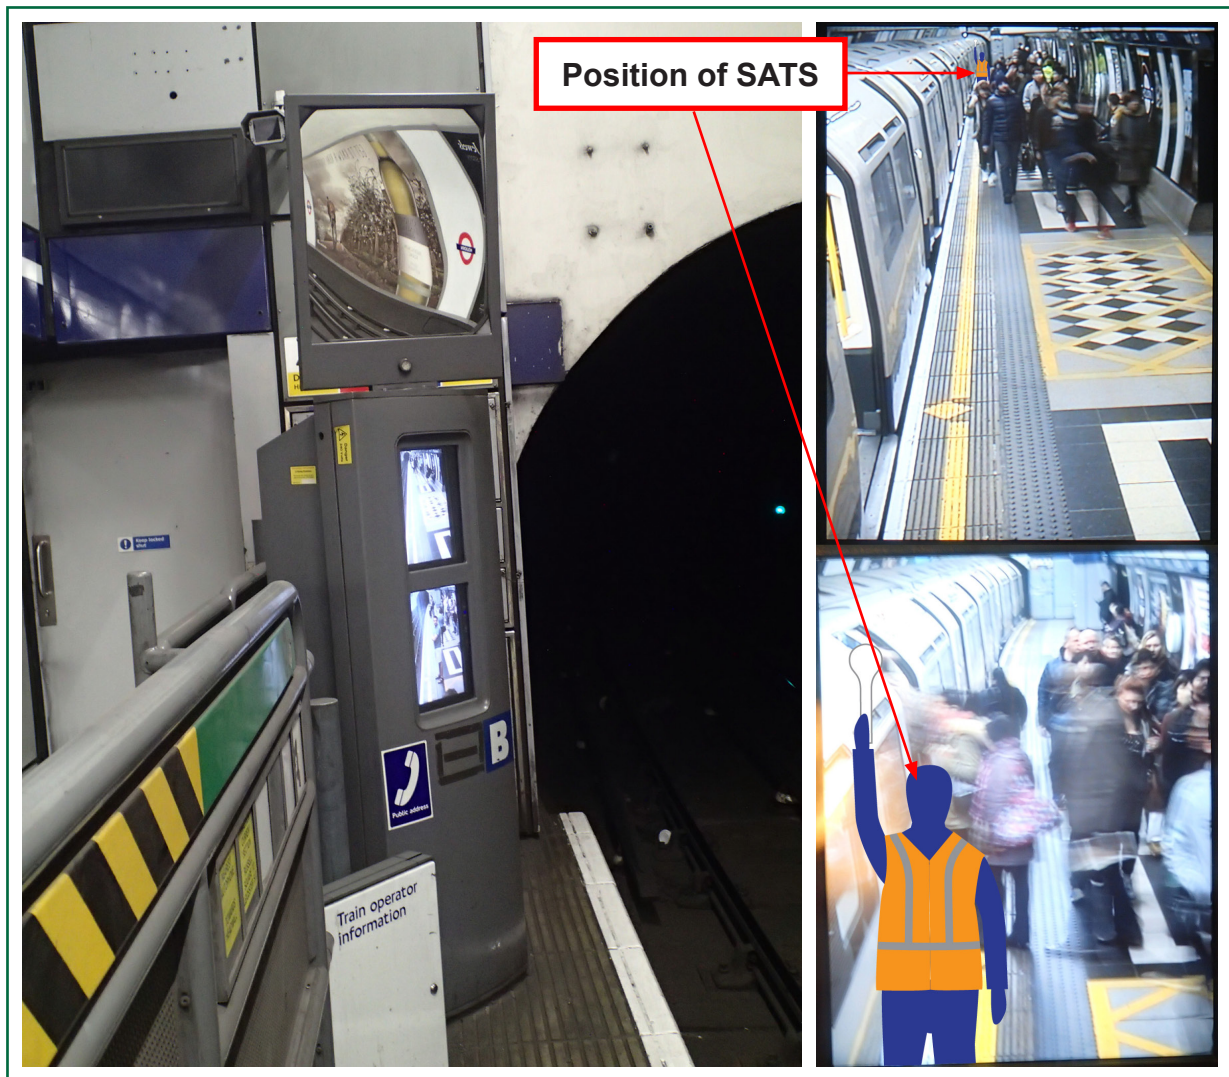
- 61 Because their role in assisting customers can cause them to move along the platforms, SATS are not required to stand at specific points on the platform to signal to train operators. Before the accident, the SATS stood in a position opposite the centre of the fourth car. In this position his head and raised bat would have appeared prominently in the lower monitor. The accident occurred immediately forward of this point, out of the view in the lower monitor, and towards the background of the view in the upper monitor and the mirror (figure 6). This CCTV is only shown on the train despatch monitors, and is not recorded, so it was necessary to reconstruct what would have appeared on the monitors by using the footage from the station CCTV, which is recorded by different cameras.

- 62 In the view on the upper CCTV monitor, the passenger would have been shown standing immediately in front of the SATS, and it would have been difficult to distinguish between the two people. The scarf appeared on the CCTV as a thin diagonal line between the two people and the train, and it is unlikely that it would have been at all obvious to the train operator, because the passenger and the SATS did not move in a way that would have been likely to attract the train operator's attention until after the train began to move.

Figure 6: Train despatch mirror and CCTV monitors on Holborn westbound Piccadilly line platform, showing position of SATS as he would have appeared on both monitors

- 1 *The intention of this recommendation is that staff performing the SATS role should be properly equipped to reduce risks at the platform/train interface by being able to take effective action to stop trains in an emergency . Consideration of how this can best be achieved should take into account the possibility that the waving of two hands in the 'emergency stop' signal is not sufficiently conspicuous on a crowded platform.*
