Rail Accident Investigation Branch

Rail Accident Report

**Collision at Black Horse Drove Crossing, near
Littleport, Cambridgeshire
19 October 2005.**

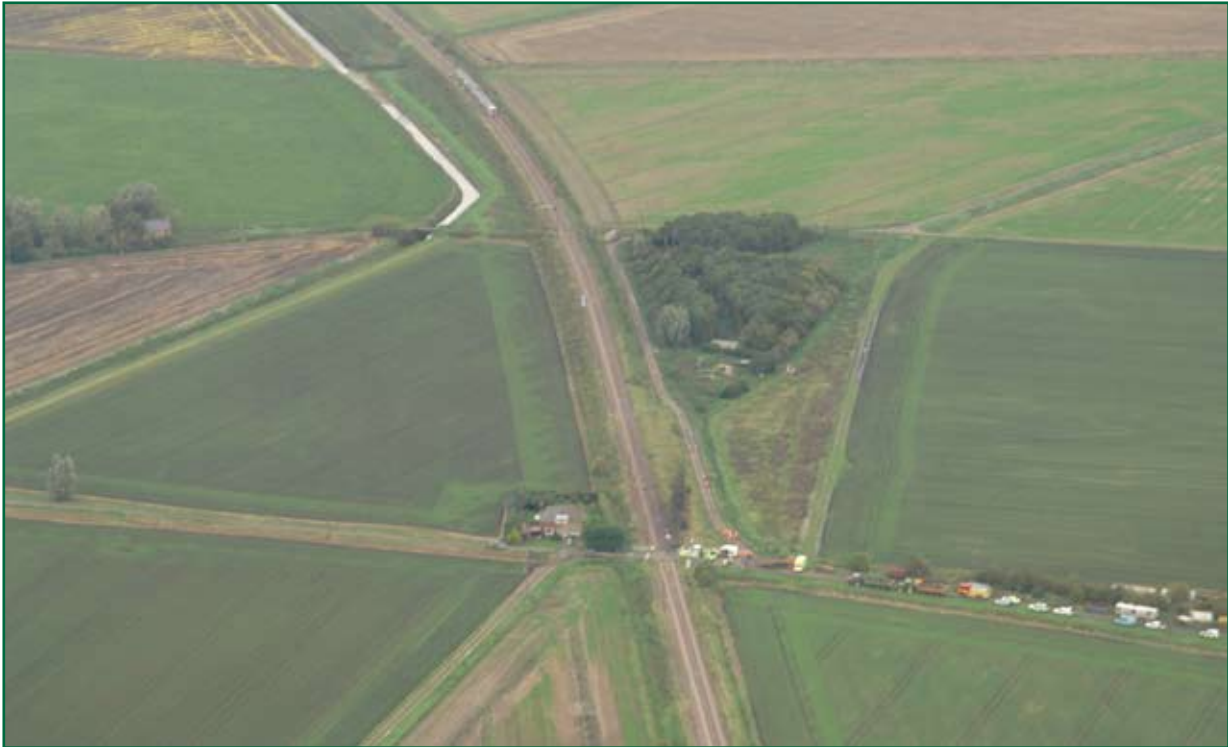
Figure 1: Aerial view of level crossing area

- 4 The accident occurred when a train travelling between Littleport and Downham Market collided with a tractor hauling a trailer over a user worked level crossing.
- 5 The accident took place at Black Horse Drove crossing in Cambridgeshire just after midday at 12:04 hrs on Wednesday 19 October 2005. Figure 1 shows an aerial view of the crossing and Figure 2 is a map of the area.

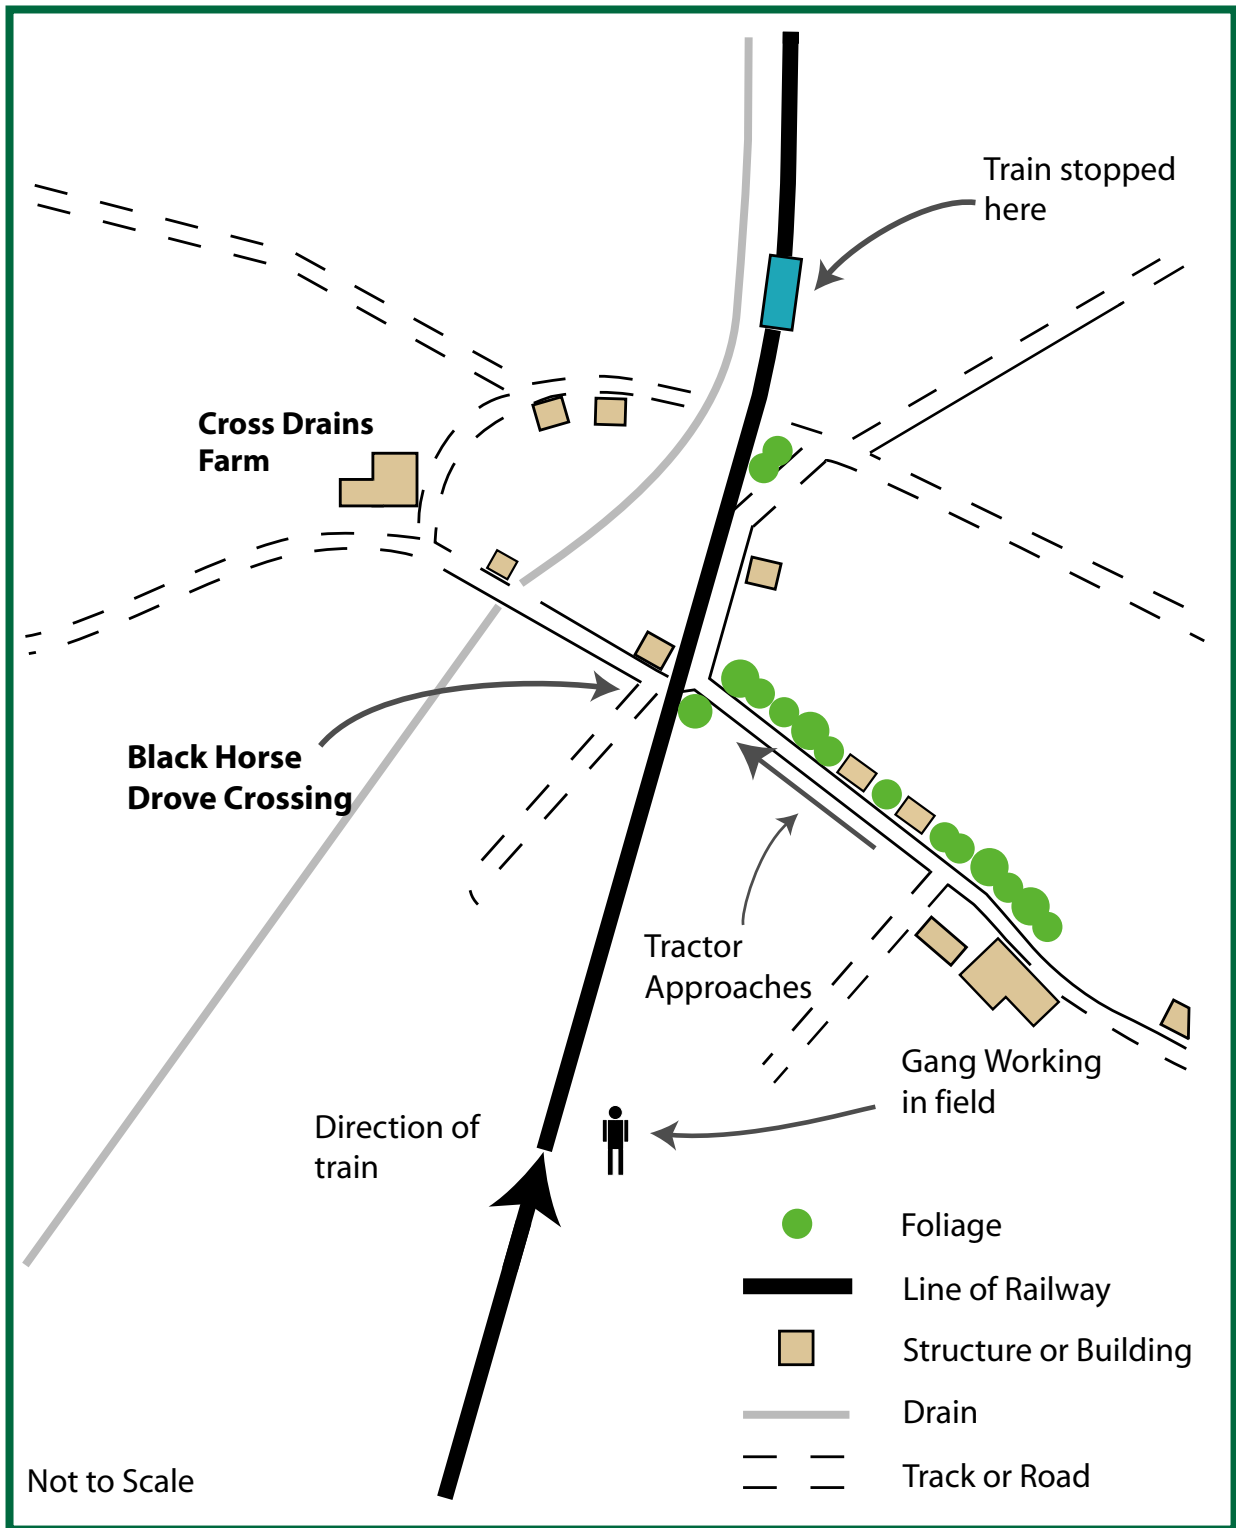
Figure 3: Plan of site

- 34 The railway consists of a single track on a former double track formation and the line is electrified with 25 kV overhead equipment. The level of the railway on a low embankment means that the road approaches to the crossing slope up towards the line. The east side approach has a gradient of 1 in 17. The railway on the Littleport side of the crossing is straight and the railway on the Downham Market side of the crossing is on a shallow radius curve. The *linespeed* at the crossing is 90 mph (144 km/h) for *electric multiple unit* (EMU) trains and 75 mph (120 km/h) for others. Figure 3 shows a plan of the site and Figure 4 shows the east side road approach.

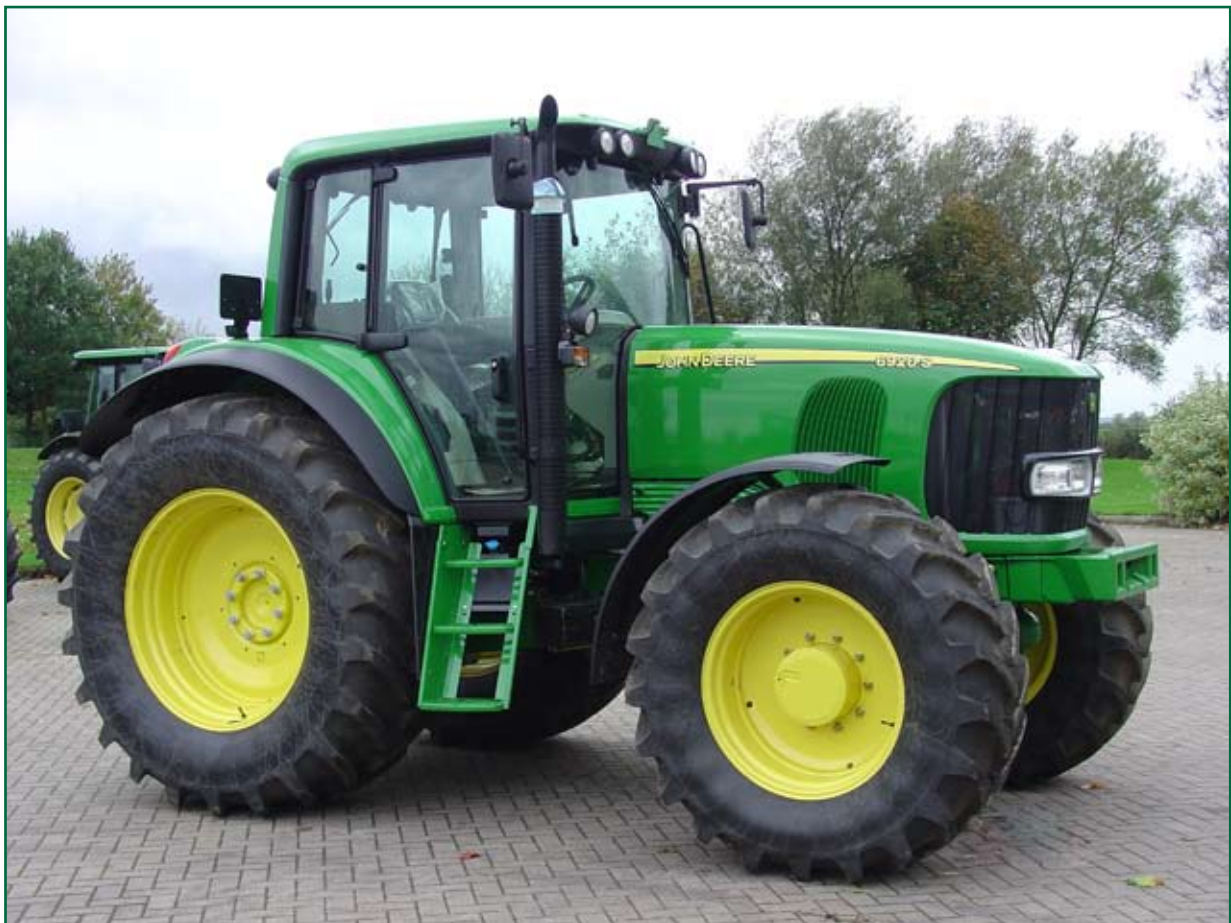
Figure 5: John Deere 6920 tractor

- 41 The tractor was a John Deere 6920 type delivered to its first owner on 28 April 2003. The tractor was fitted with a set of John Deere counterweights at the front and was towing a Richard Western ‘Suffolk rootcrop’ trailer. The tare weight of the tractor was 5.88 tonnes and the total weight, including an estimated amount of fuel, was 7 tonnes. The trailer was almost fully loaded with potatoes and its total weight was 16.5 tonnes. Figure 5 shows an identical tractor, but without the front counterweights fitted.
