Rail Accident Investigation Branch

# Rail Accident Report

## The blowback of a locomotive fire at Grosmont on the North Yorkshire Moors Railway 16 April 2006

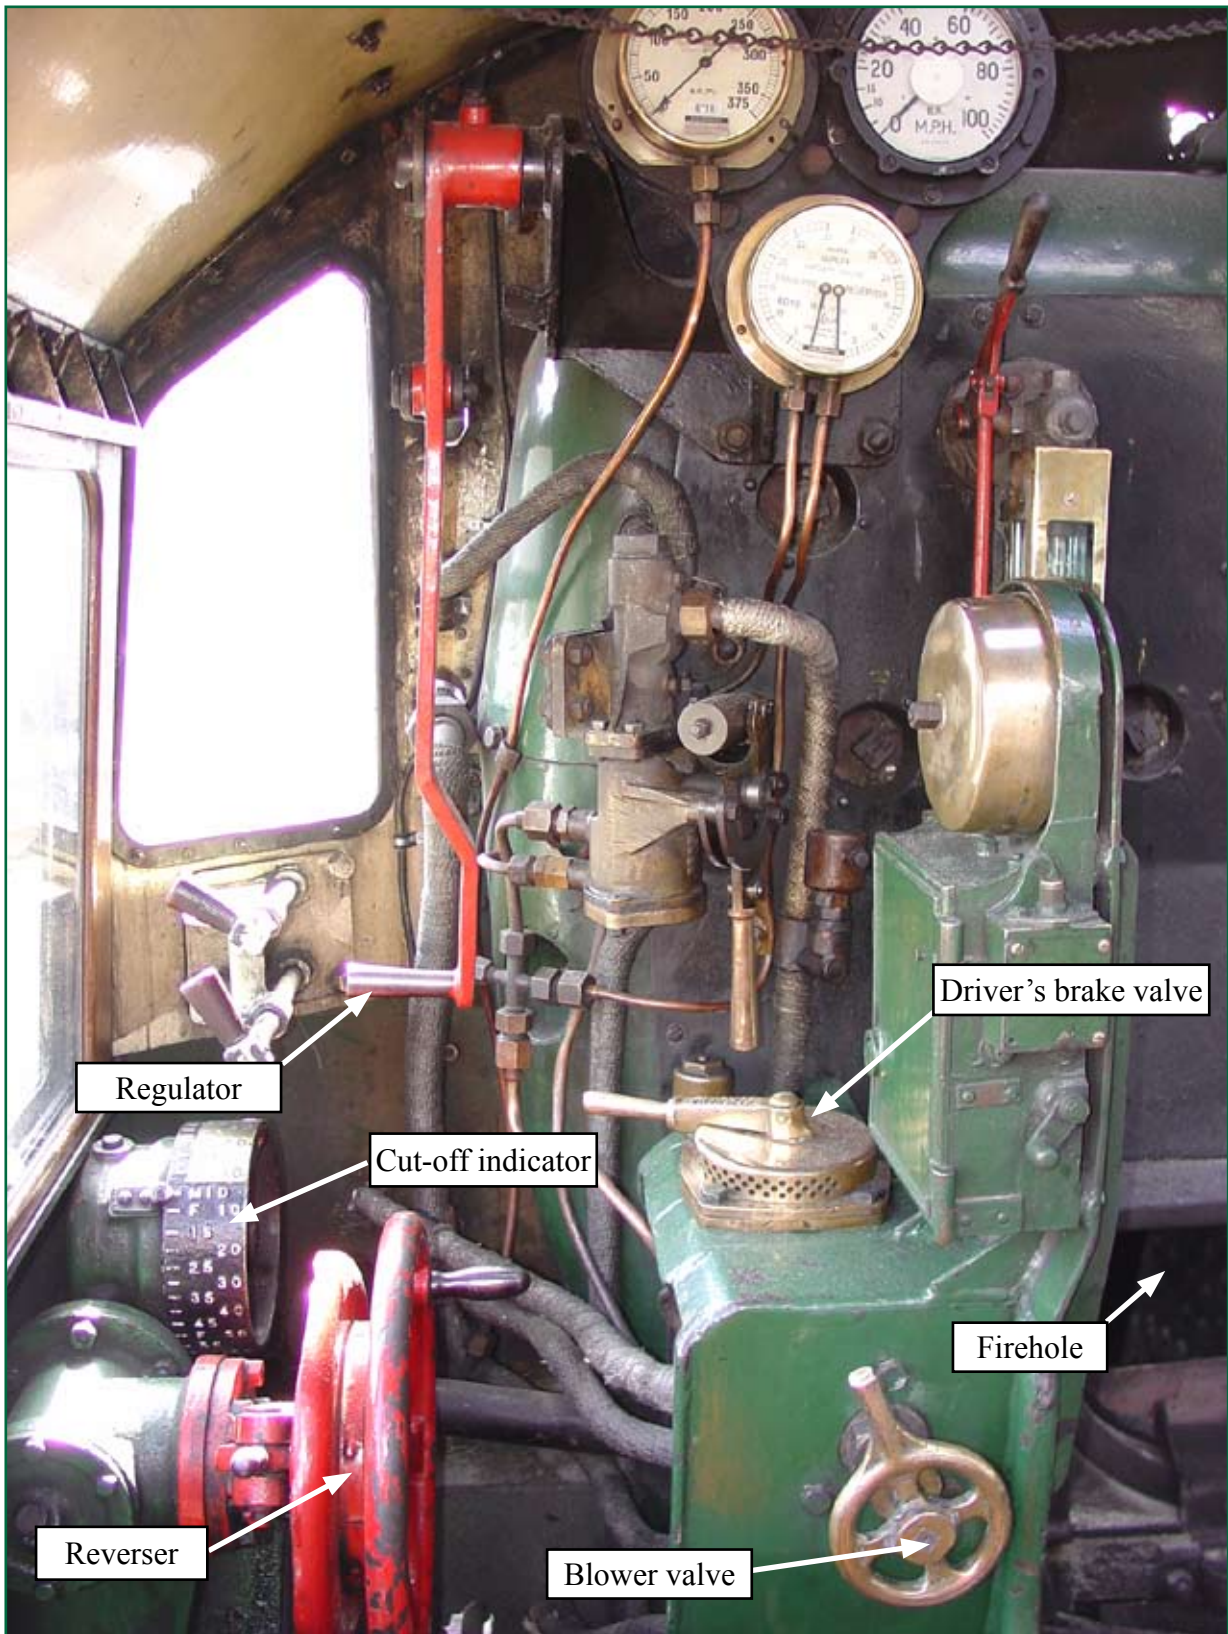
Figure 5: Locomotive 75029 footplate showing the driver's controls

- 44 On hearing the warning, the driver turned back towards the footplate and saw the flames. The driver immediately shut the regulator, opened the blower and applied the train brake, the last action causing him to receive a minor burn to his right hand. The flames started to abate and the fireman was then able to kick the firehole doors shut finally stopping the blowback. By the time the train had stopped, the blowback had finished. The firehole doors and driver's controls are pictured in Figures 4 and 5.

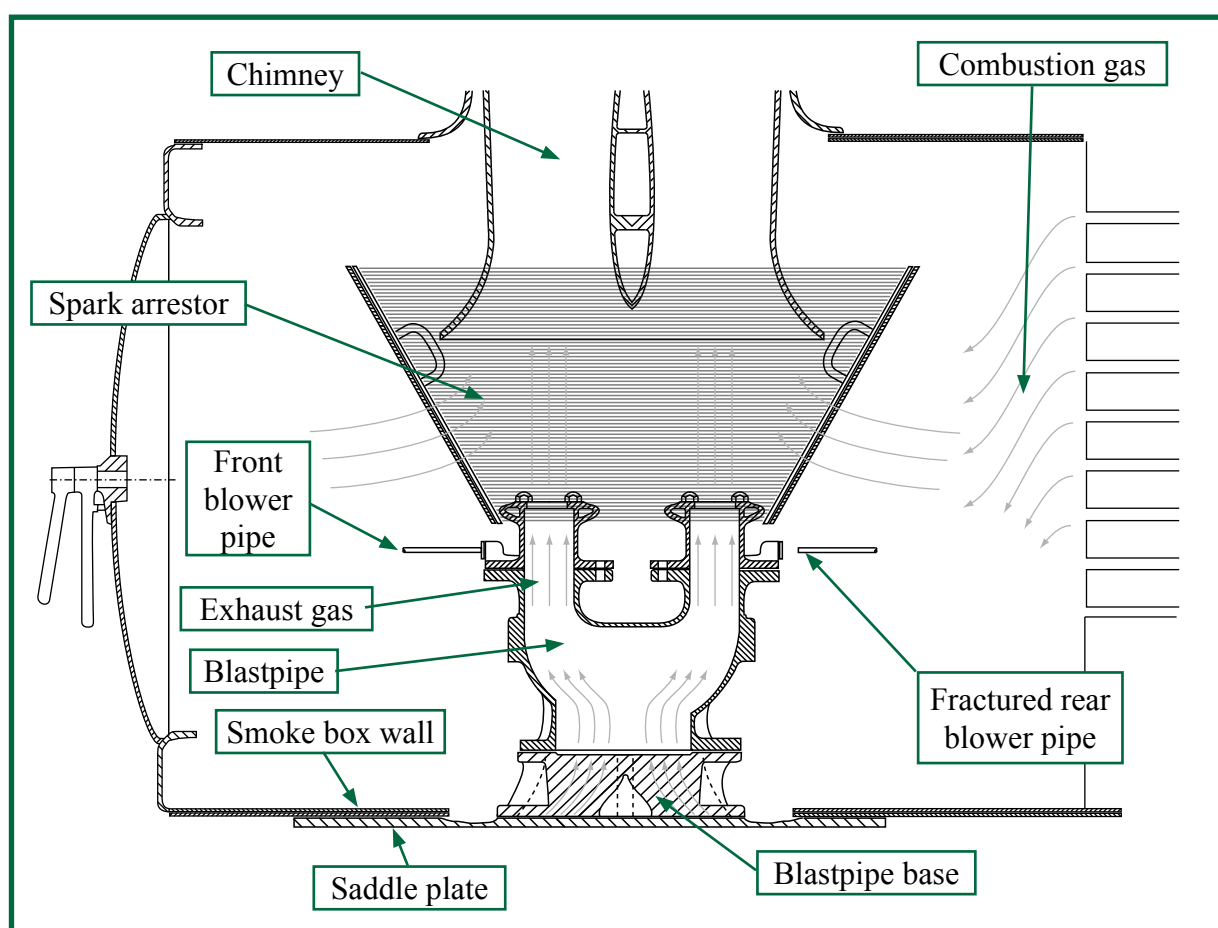
Figure 6: Simplified drawing of Locomotive 75029 blastpipe and associated smokebox components

- the blastpipe base/saddle plate weld was subject to long-term corrosion and erosion;
  - the condition of the weld was not easy to see;
  - no party involved in the recent overhaul and its associated inspections specifically inspected the blastpipe base/saddle plate weld;

- 57 Witness and documentary evidence, and examination of the locomotive indicate that before the incident:
- during manufacture or since, an area of saddle plate adjacent to the blastpipe base was exposed to the smokebox environment because the smokebox plates were cut back and not butted up to the blastpipe base as shown on the drawing. As a consequence, the blastpipe base/saddle plate weld sits in a 'dirt trap' making it difficult to clean around and difficult to see (this is shown in Figure 6);

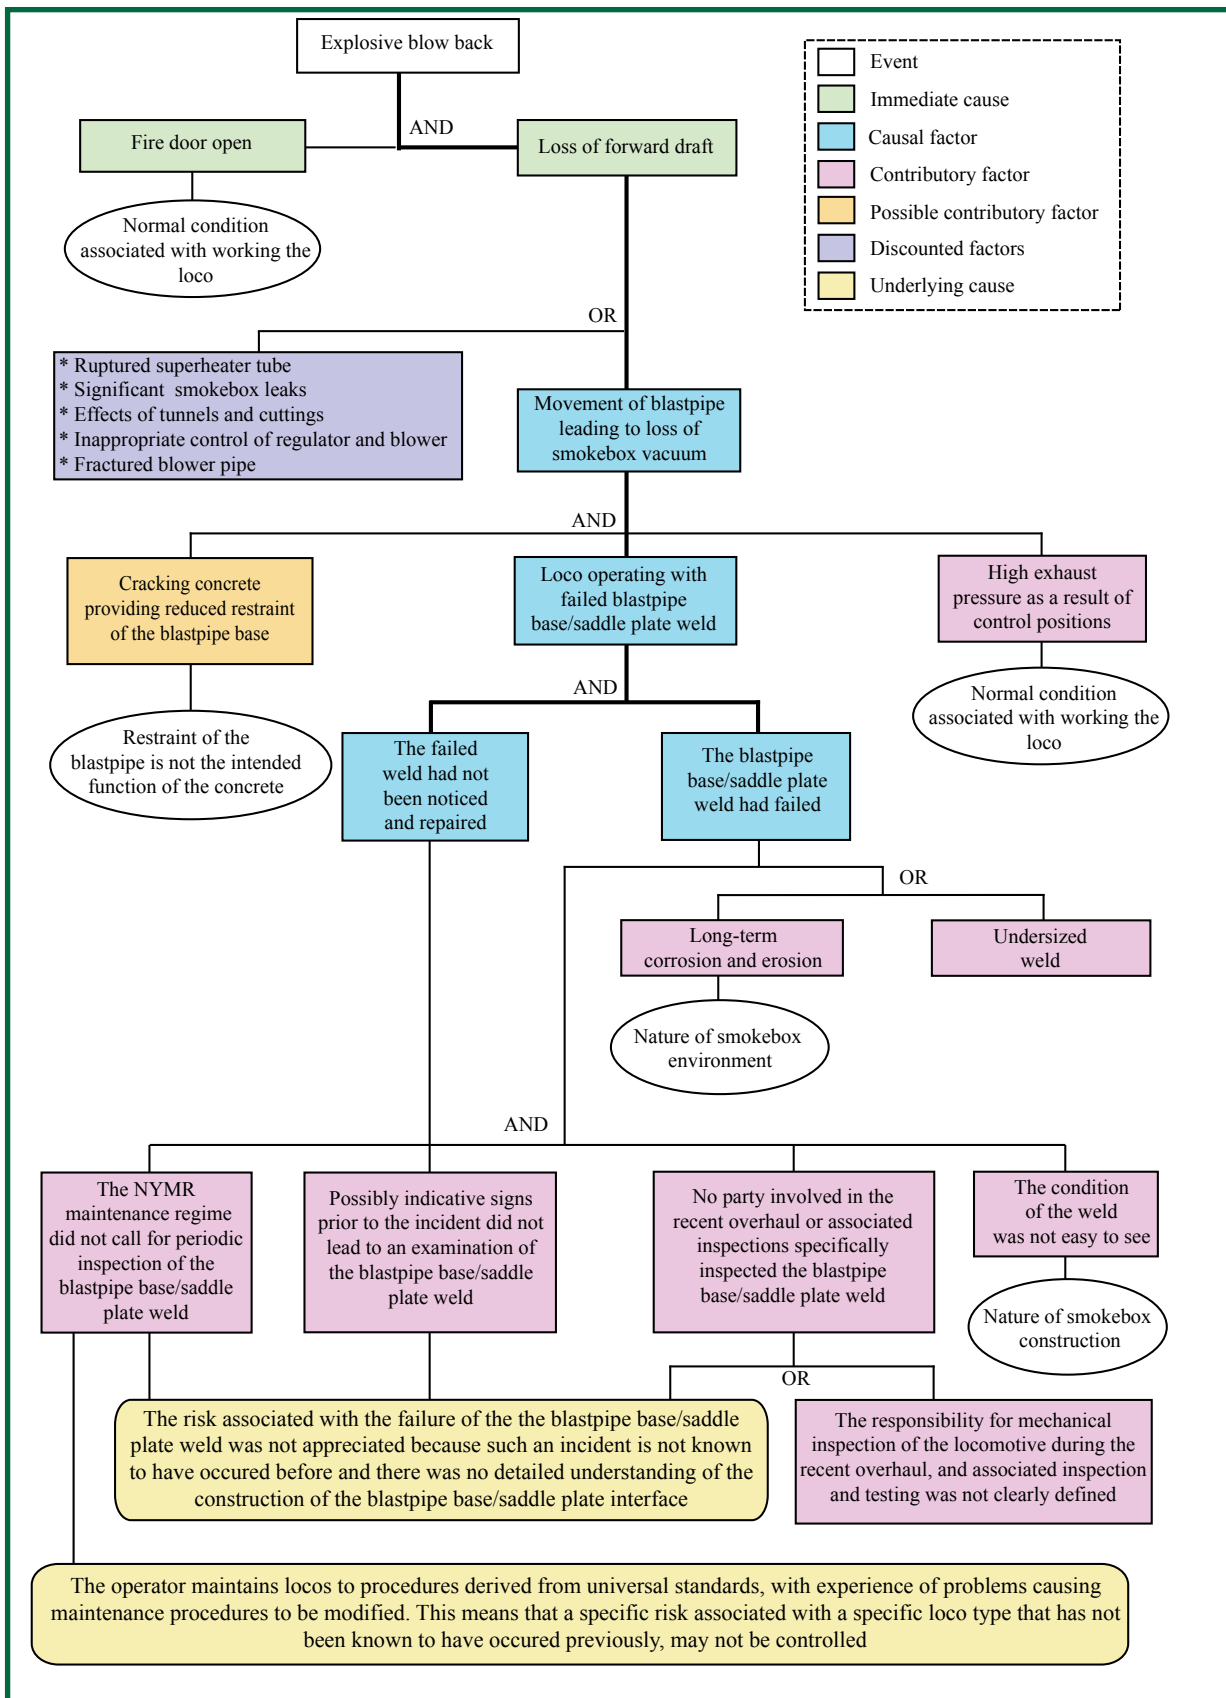
Figure 10: Diagram showing chain of events and factors

96 The diagram shown in Figure 10 illustrates the causal, contributory and underlying factors graphically.
