Rail Accident Investigation Branch

Rail Accident Report

**Detachment of containers from freight wagons
near Cheddington and Hardendale
1 March 2008**

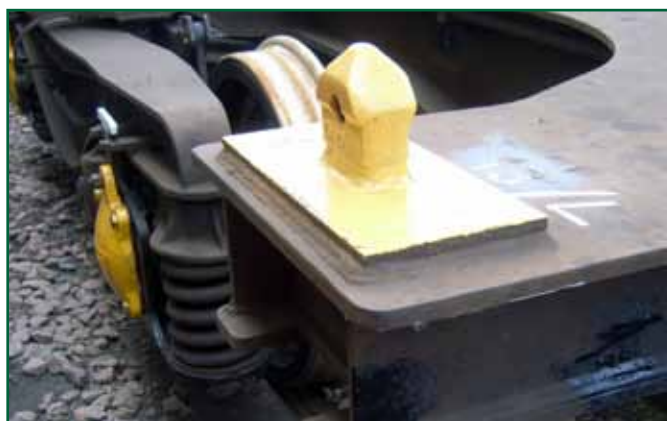
Figure 12: Example of fixed UIC spigot (FEA-A wagon)

- Fixed spigots (Figure 12) which are compliant with UIC 571-4 provide overturning restraint, those that are not compliant do not provide reliable restraint.
- Fold-down spigots with inboard hinges, as fitted to the FEA-B wagons do not offer any overturning restraint, even if the spacings are complaint, because the spigot rotation follows the rotation of the overturning container on the windward side.
- Fold-down spigots with outboard hinges (Figure 13), as fitted to most wagons with UIC spigots, may not reliably restrain overturning containers if there is sufficient play in the hinges to allow them to initially rotate inwards, pivoting about the inboard edge as shown in Figure 14. During testing, inward rotations of up to 4.5 degrees were measured; the maximum specified in the UIC 571-4 is 2 degrees.
