# Rail Accident Report

## Road-rail vehicle runaway incidents at Brentwood, Essex and at Birmingham Snow Hill 4 November & 31 October 2007

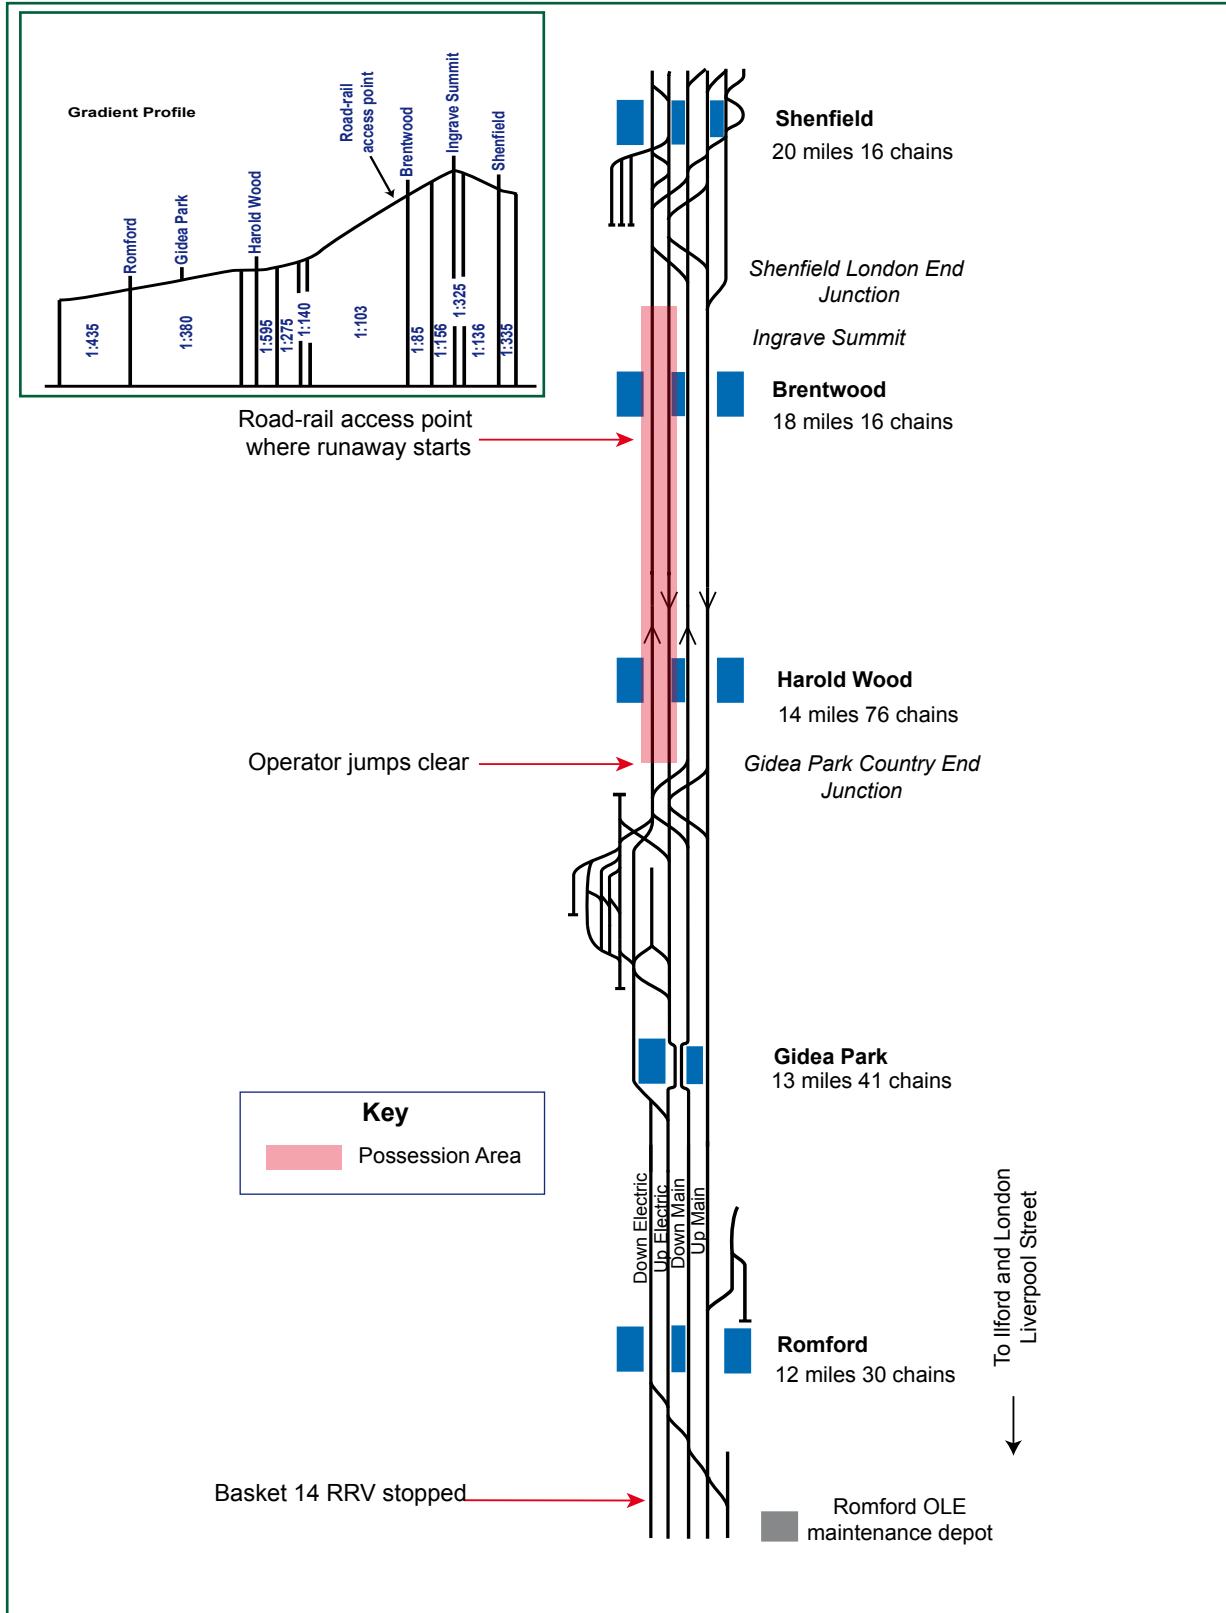
Figure 4: Site plan – incident at Brentwood

- 21 The road-rail access point was close to a summit on the railway, Ingrave Summit (19 miles 20 chains), Figure 4, and as the machine was being on-tracked it began to run away westward, towards Romford and London. The operator, who was in the machine's work basket, and the machine controller, who was trackside and had started to run alongside, were unable to stop the machine before it gathered speed.

35 There is a near constant downhill gradient of around 1 in 100 from the road-rail access point for around two miles (3.22 km) towards London. Then, on the approach to Harold Wood station, the gradient reduces. From there to the OLE maintenance depot it varies between 1 in 275 and level.

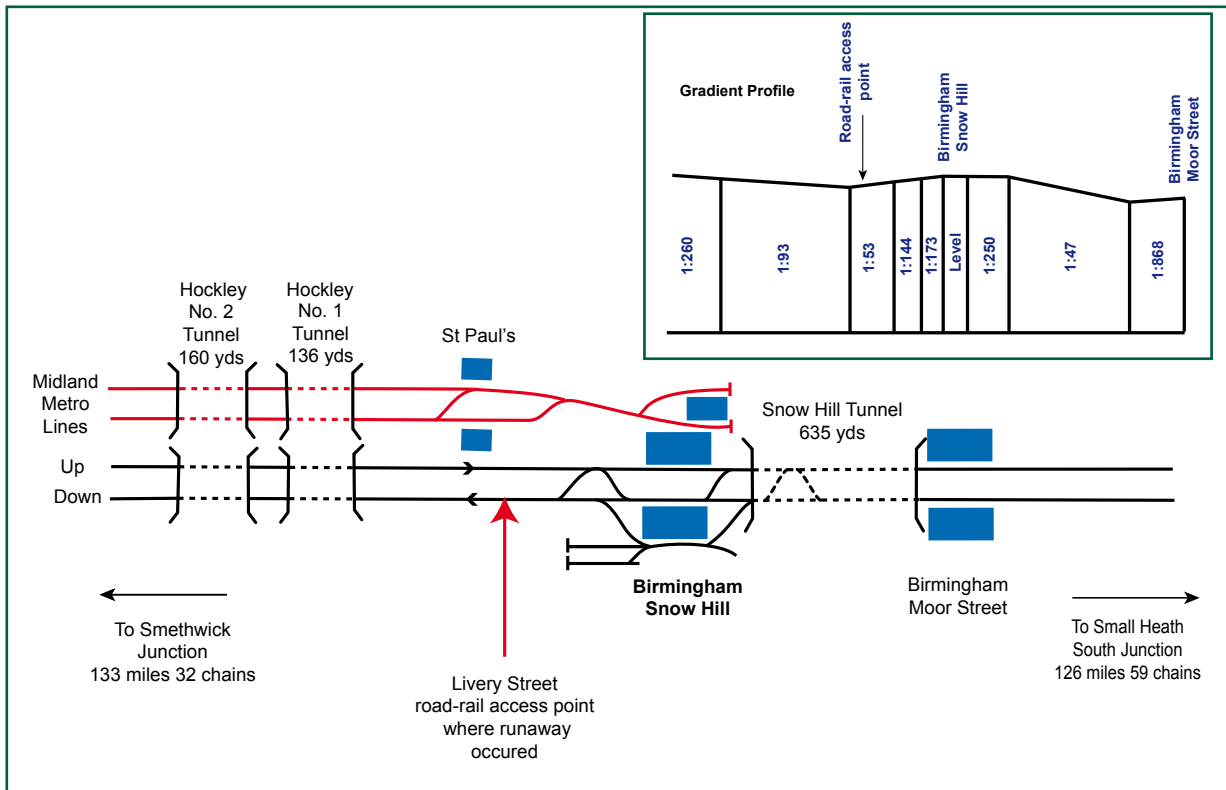
Figure 8: Site plan of incident at Birmingham Snow Hill

- 85 Figure 8 shows a plan of the site and the gradient profile of the line.

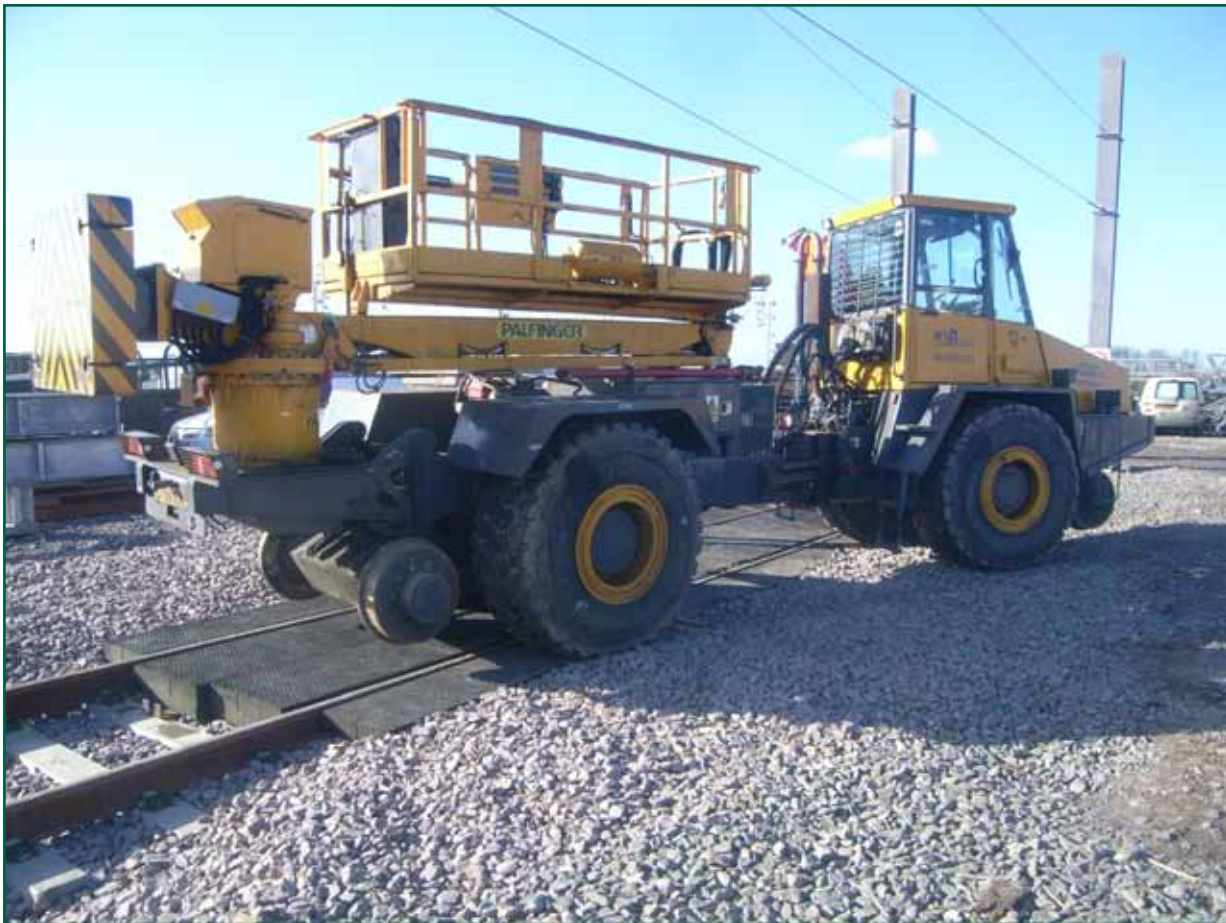
Figure 9: TD-18 RRV

- 87 The TD-18 RRV, the machine that ran away, was a converted articulated road dumper truck. It is a high ride RRV and has a *knuckle-boom* elevating work basket, Figure 9. Except when the work basket is being used, the TD-18 RRV is operated from a chassis-mounted driving cab.

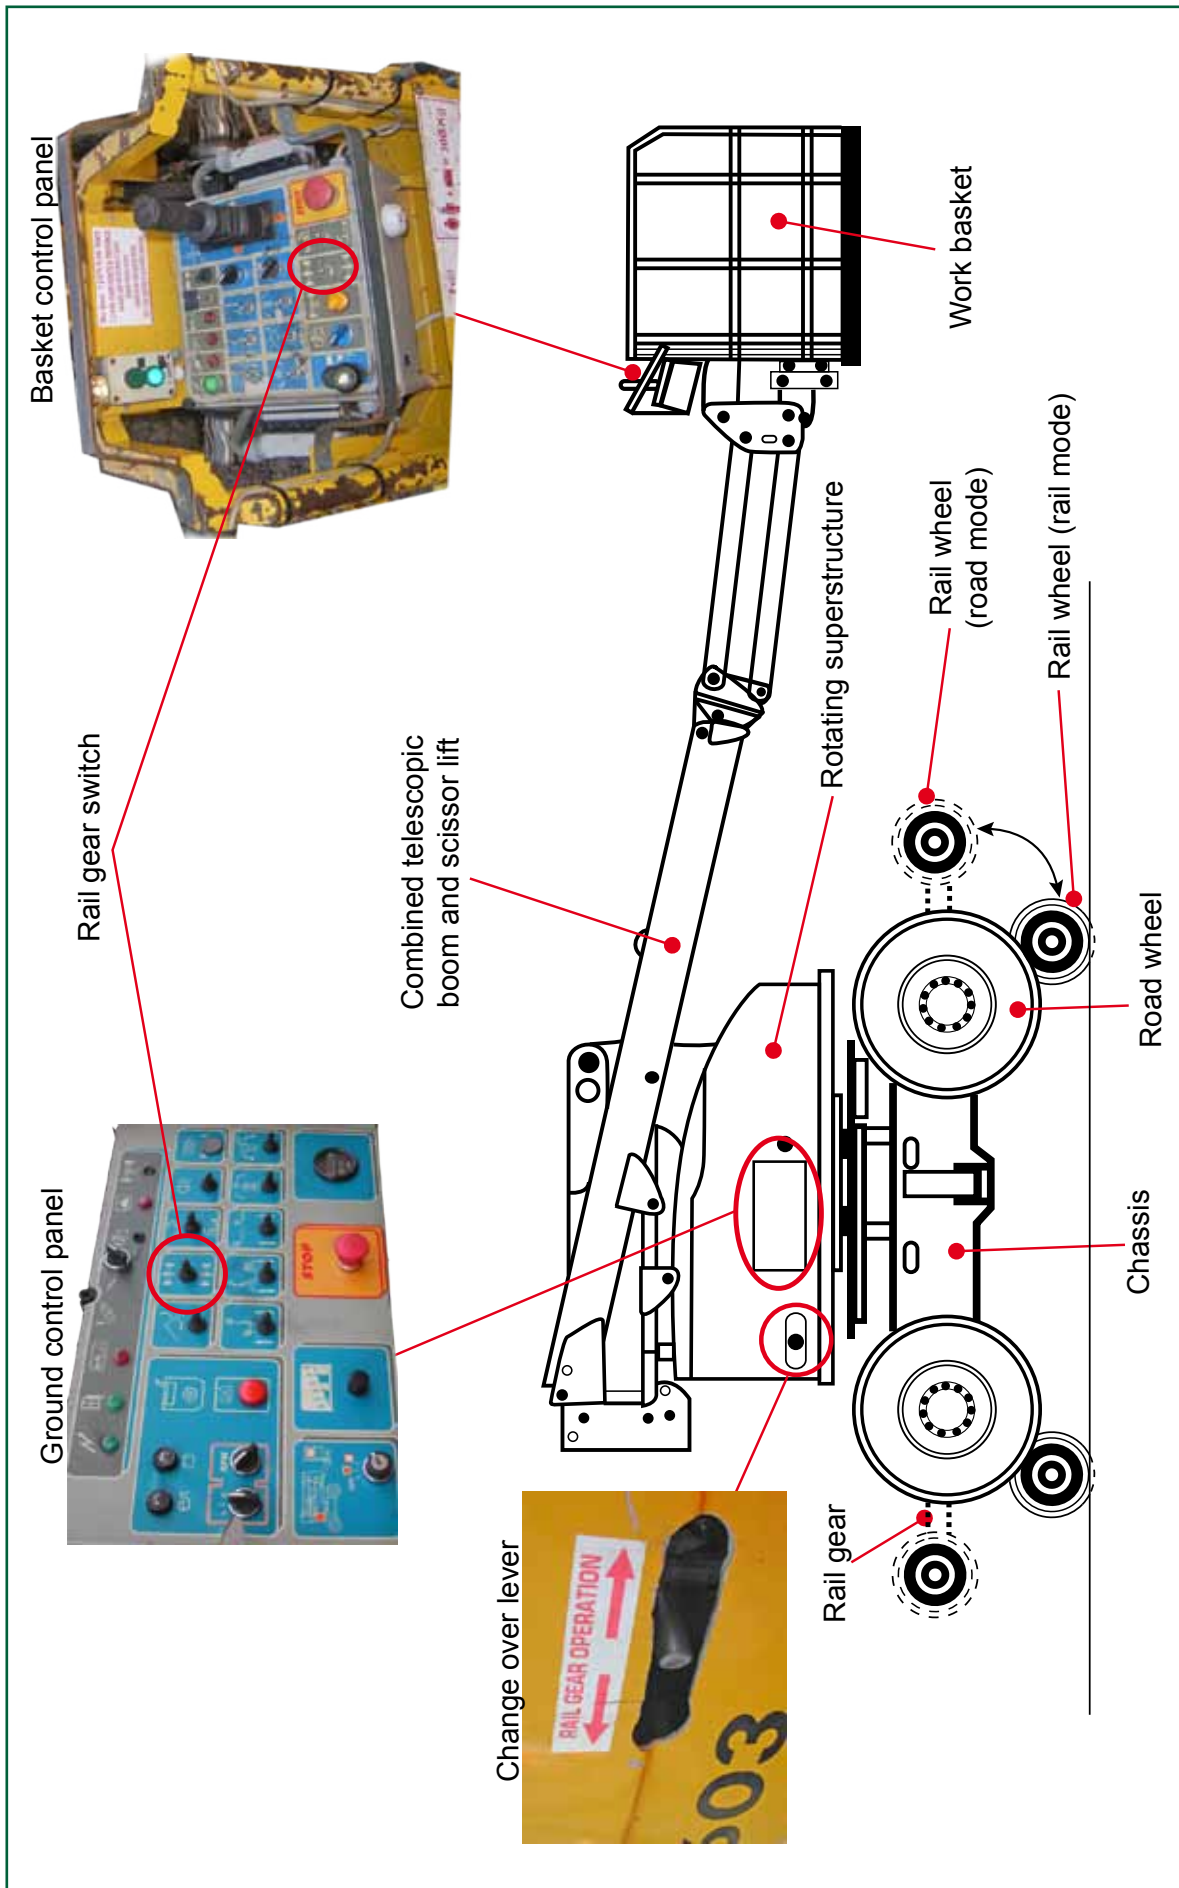
Figure 10: Basket 14 RRV – principal features

- 109 Figure 10 shows the principal features of the Basket 14 RRV. It shows the machine with the rail wheels in both road mode (dashed lines) and rail mode (solid lines) positions. In road mode, the road wheels are on the ground and the rail wheels are up. When going to rail mode, the rail wheels lower onto the rail and then rotate around until they press into contact with the road wheels – the latter operation raises the machine and lifts the road wheels off the ground.

- 112 The rail gear is lowered (and raised) using a toggle switch (the rail gear switch); there is one on each control panel. The switch only operates one set of rail gear at a time. When the rail gear switch is operated, the position of a changeover lever (Figure 10) determines whether the front or rear rail gear is lowered or raised. This lever, mounted separately on the superstructure, moves a valve that diverts oil to the hydraulic rams at the end selected.

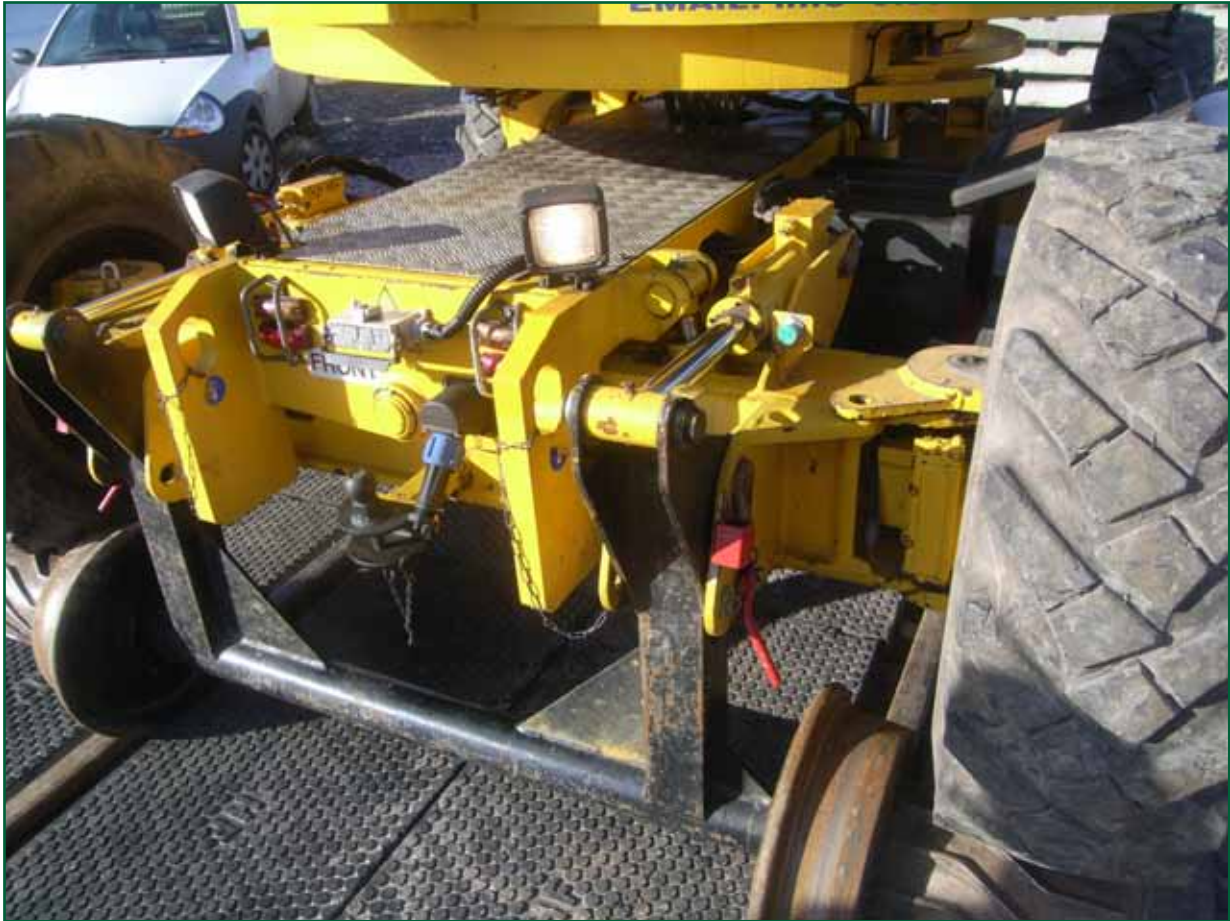
Figure 11: Basket 14 RRV - rail gear

- 110 One set of rail gear is fitted at each end of the machine. Each consists of rail wheels that are connected to arms, which in turn pivot on the chassis (the rail gear arms), Figure 11. Hydraulic rams lower and raise the rail gear by rotating these arms. When the rail wheels are fully down and in contact with the road wheels, a hole in each rail gear arm lines up with one in a bracket on the chassis (the chassis bracket). Locking pins can then be inserted to secure the rail gear in place. There are four locking pins, two for each set of rail gear.

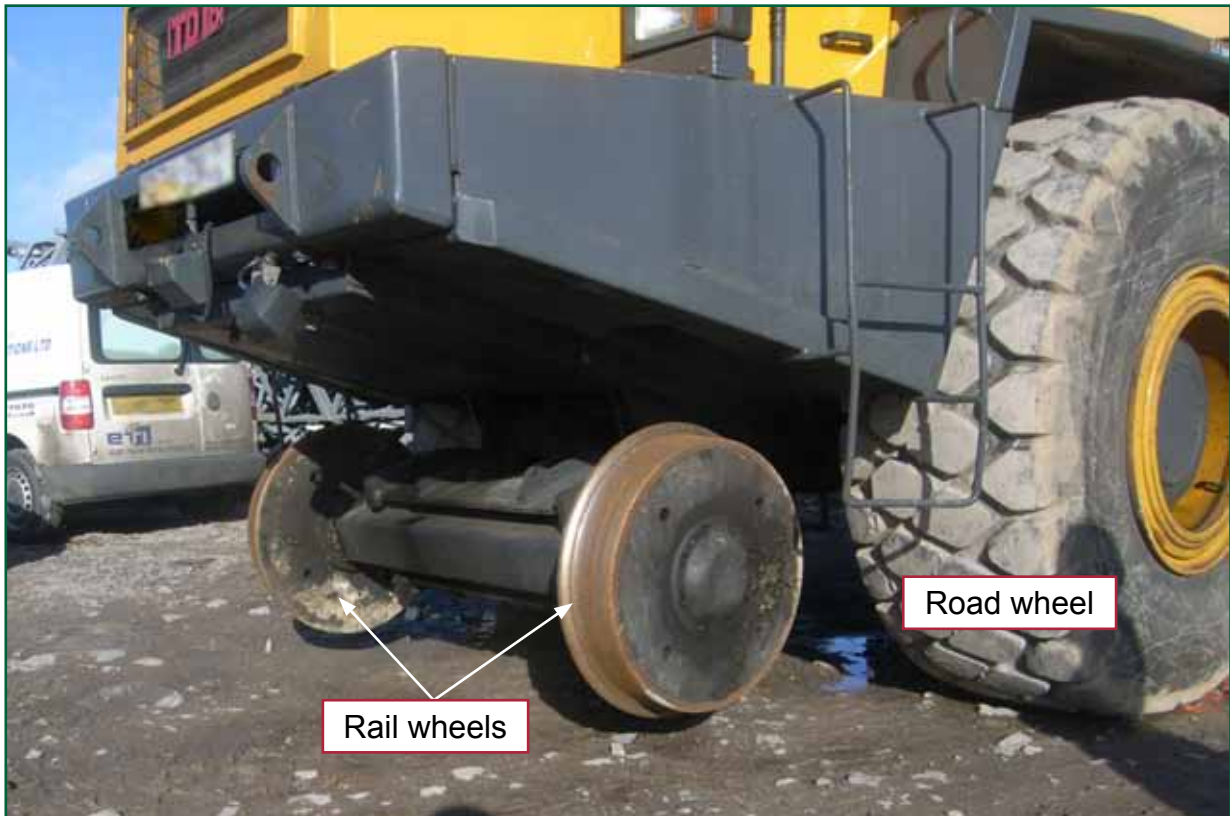
Figure 12: TD-18 RRV rail gear at the front of the machine

- 115 The rail gear on the TD-18 RRV has rail wheels that are connected to a pivoting steel assembly (Figure 12). As on a Basket 14 RRV, the rail gear is raised and lowered using hydraulic rams; however, no locking pins are required to secure it in place.
- 116 A lever on the cab floor (the *rail gear lever*), to the left of the driver's seat, is used to control lowering and raising. As with the rail gear switch on the Basket 14 RRV, the lever operates one set of rail gear at a time. The *rail gear selector switch* on the driver's console determines whether this is the set at the front or the rear.

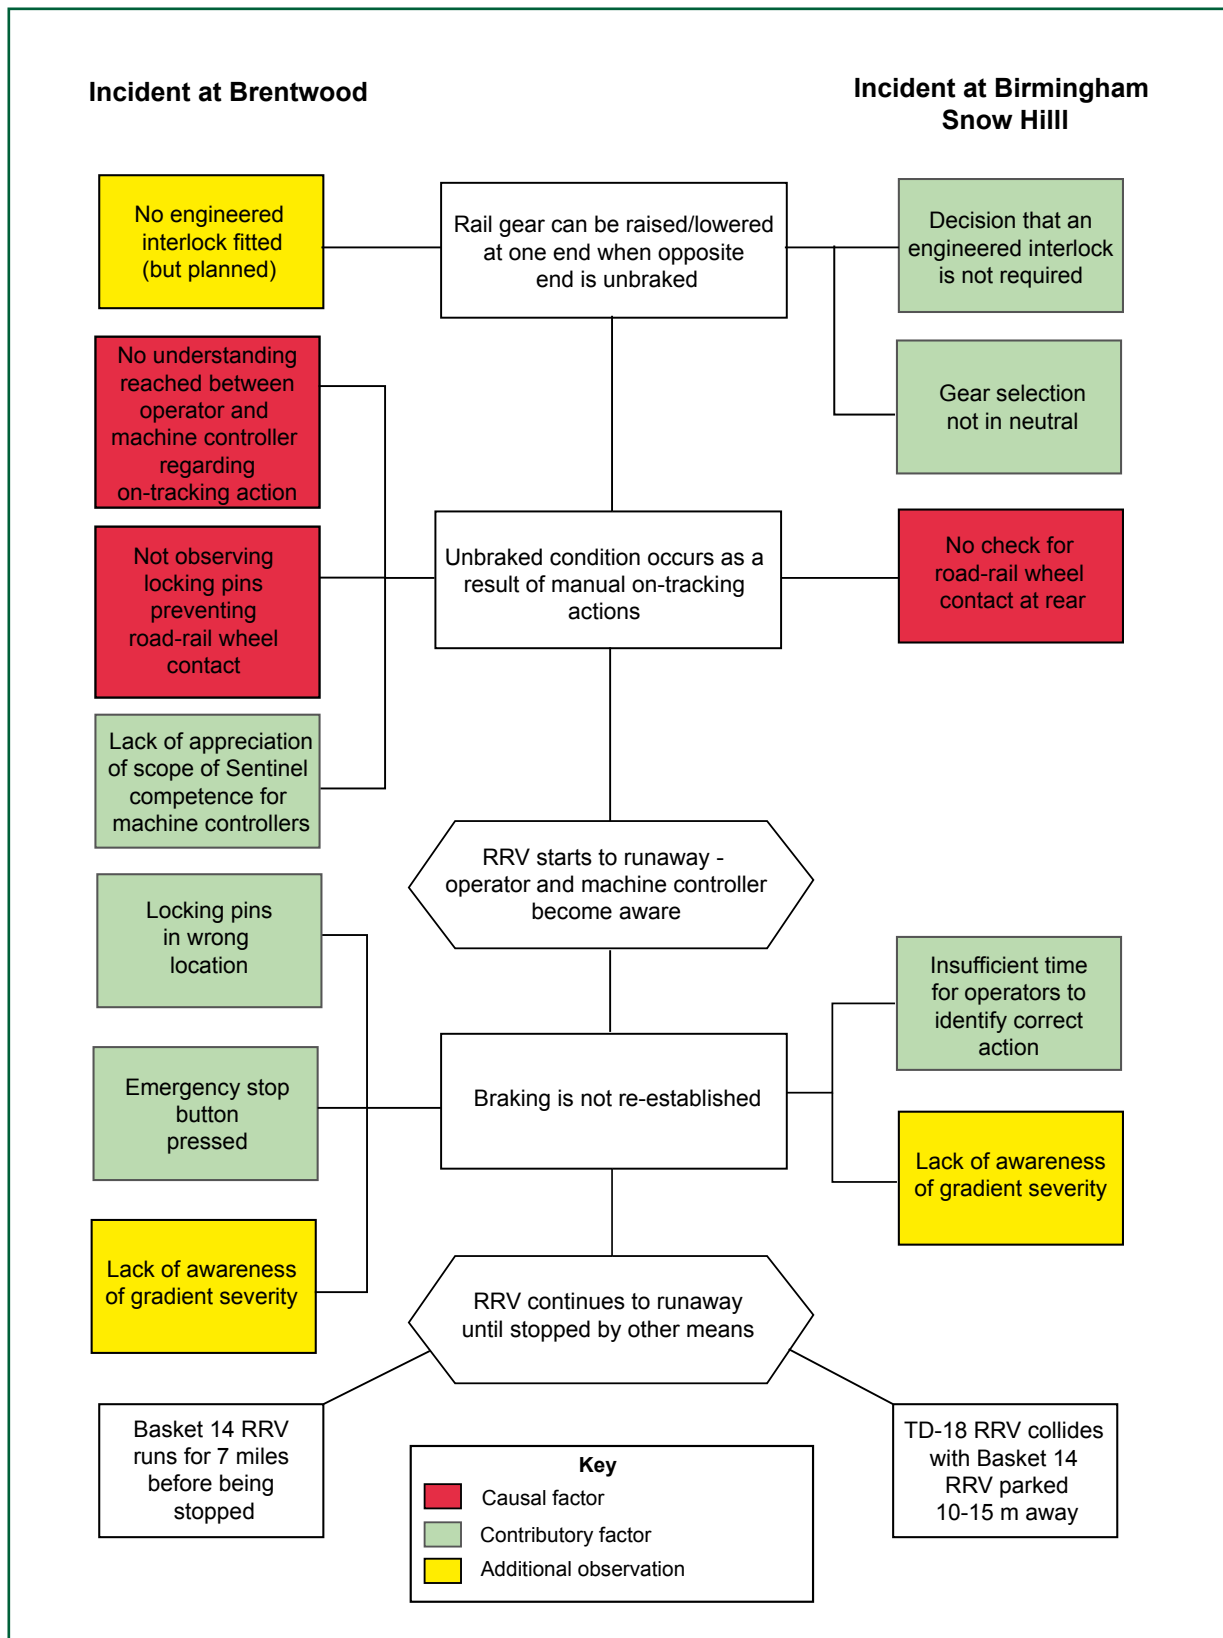
Figure 18: Diagram showing chain of events and causal factors for the incidents at Brentwood and Snow Hill

- 233 Figure 18 is an overview of the identified causal and contributory factors for both incidents, showing their relationship to the chain of events.
