Rail Accident Investigation Branch

Rail Accident Report

Derailment of a freight train at Carrbridge, Badenoch and Strathspey 4 January 2010

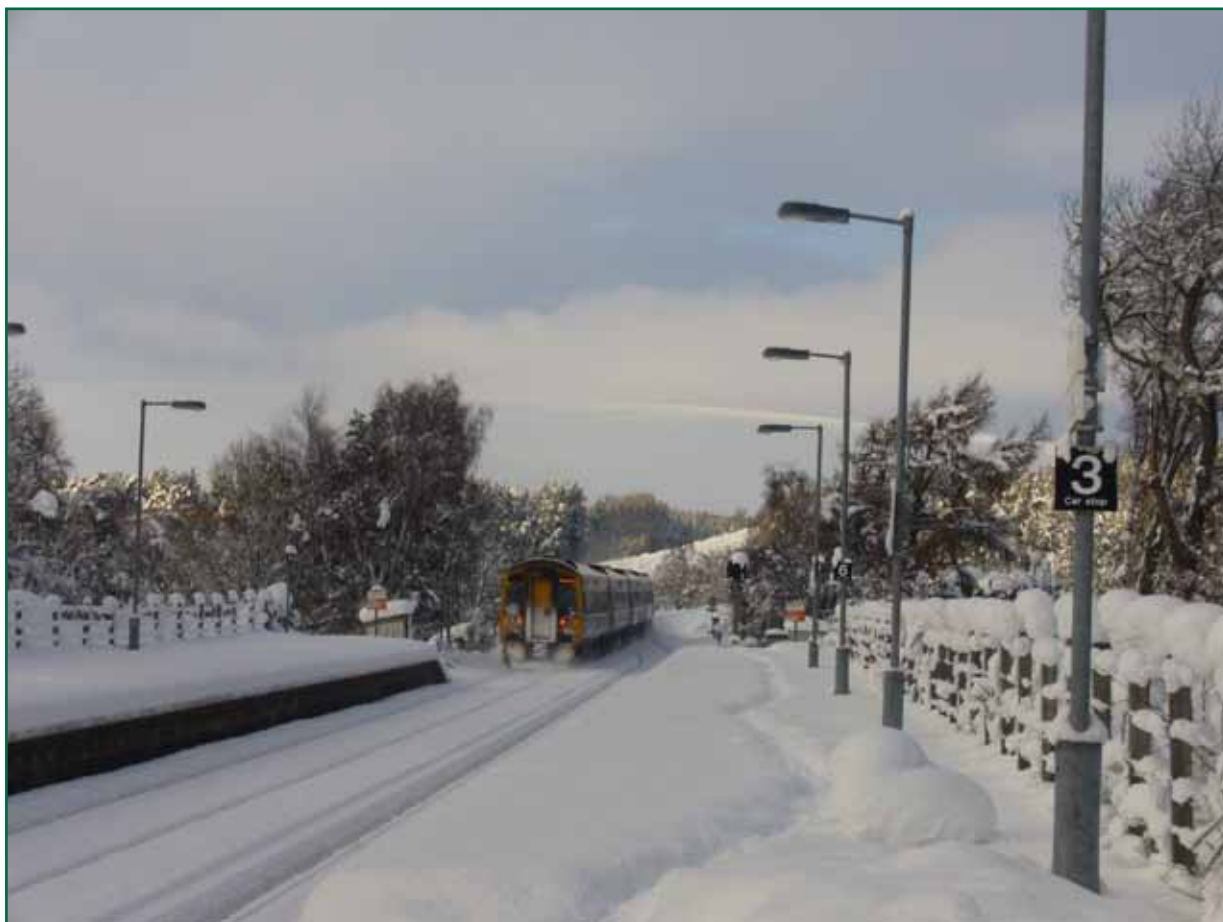
Figure 3: View towards the north end of Carrbridge station on 2 January 2010 (image courtesy of Roy Brown)

- 16 Lying snow had been present in the area of the journey since mid-December 2009 (see figure 3). By 4 January 2010 the depth of lying snow³ on the line from Inverness to Carrbridge was between 300-400 mm, around 150-250 mm above rail height⁴.

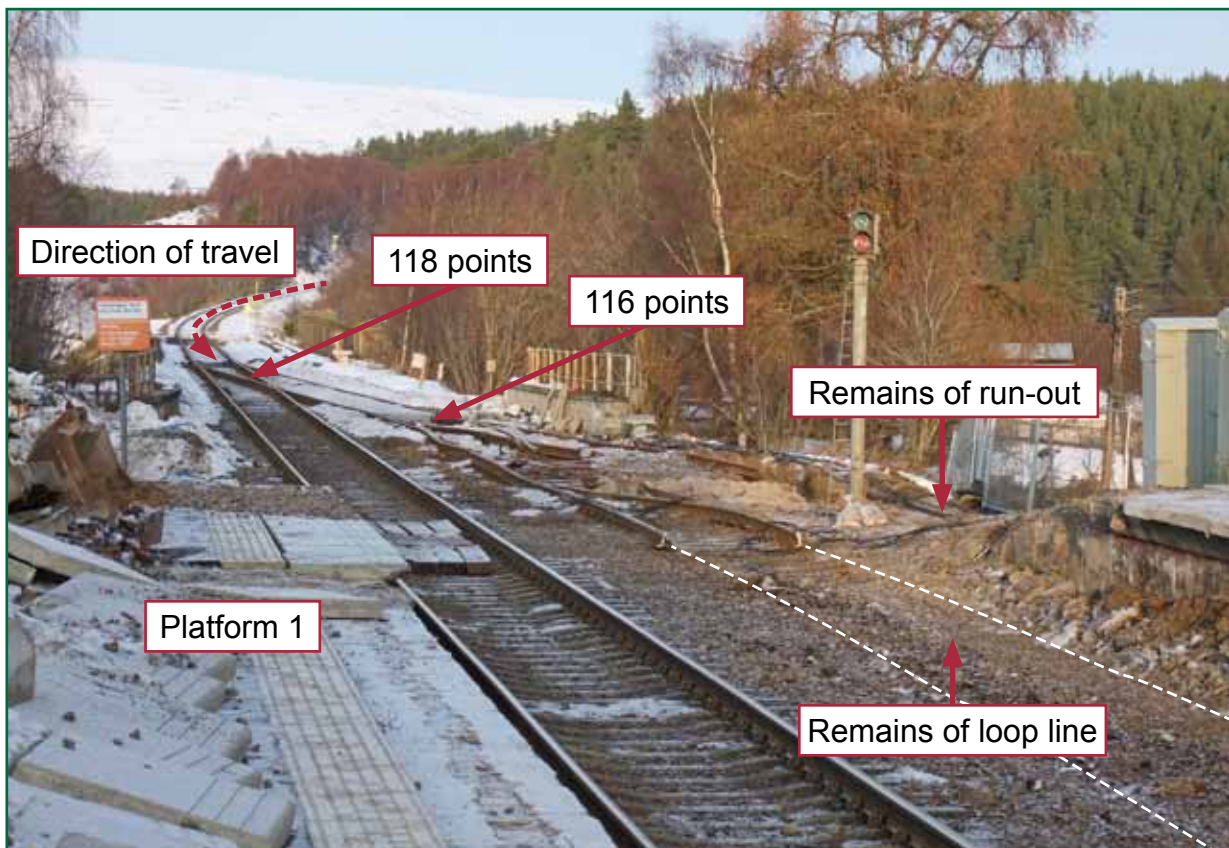
Figure 7: View of the north of Carrbridge station taken whilst post-accident repair work was ongoing (image courtesy of Trevor Roots).

- 33 The railway at Carrbridge consists of the single track main line with *points* located north (118 points) and south (115 points) of the station which allow access to and from the 560 metre long loop. Because of the risks posed by the steep descent which leads into the station from Slochd summit (see paragraph 188), the passing loop is fitted with trap points (116 points) which can be set either to allow trains to enter into the loop or on to a 27 metre long run-out (see figures 6 and 7).

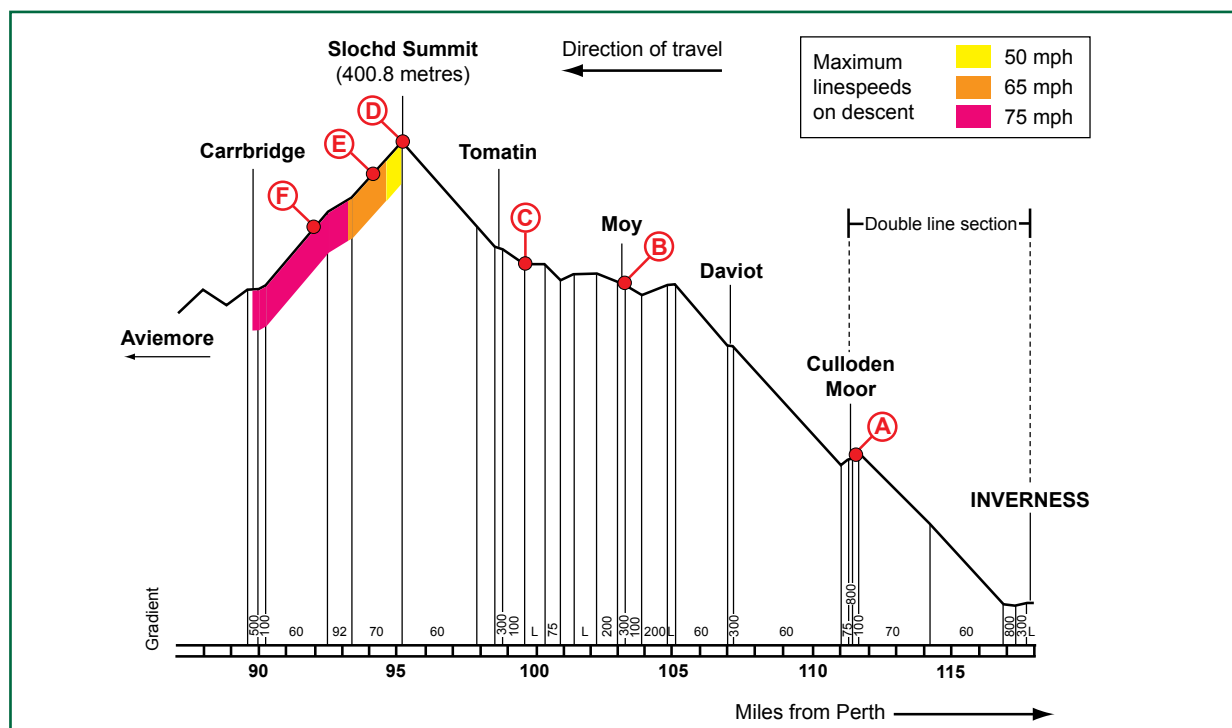
Figure 10: Key events during passage of 4N47 between Inverness and Carrbridge on 4 January 2010

- 49 At 15:45 hrs, train 4N47 passed through Moy at 50 mph (80 km/h) (Point B on figure 10). The driver made an *initial application* of the automatic brake lasting 10 seconds with the locomotive's throttle at its maximum setting of 8. There was no reduction in train speed during this brake application. It had been 28 minutes since the train's brakes had previously been operated.

- 50 At 15:49 hrs, train 4N47 was continuing to climb towards the summit at 51 mph (82 km/h). Prior to passing through Tomatin (Point C on figure 10), the driver made another initial application of the automatic brake of 10 seconds duration, again with the throttle set at 8. There was no reduction in train speed during this brake application, which came four minutes after the previous one and which was the last undertaken on the ascent. The driver's later recollection was that he had made a brake application on or near the summit in order to slow the train down for the approaching PSR and that the brakes had functioned correctly. The OTDR recorded no brake application being made at or near the approach to the summit.

- 53 At 15:59 hrs the train was descending towards Carrbridge at 44 mph (Point E on figure 10) when the driver shut-off the throttle and made an initial application of the automatic brake which lasted 21 seconds. Train speed increased slightly during this brake application, which came 10 minutes after the final one made during the ascent.

- 54 At 16:01 hrs, train 4N47 was approaching signal AC336R (Point F on figure 10) at 67 mph (107 km/h), with the locomotive's throttle just below its maximum setting. This was around 46 minutes after line proving locomotive 1Z99 had passed through Carrbridge and around 8 minutes after passenger service 1T99 had stopped at signal AC336.

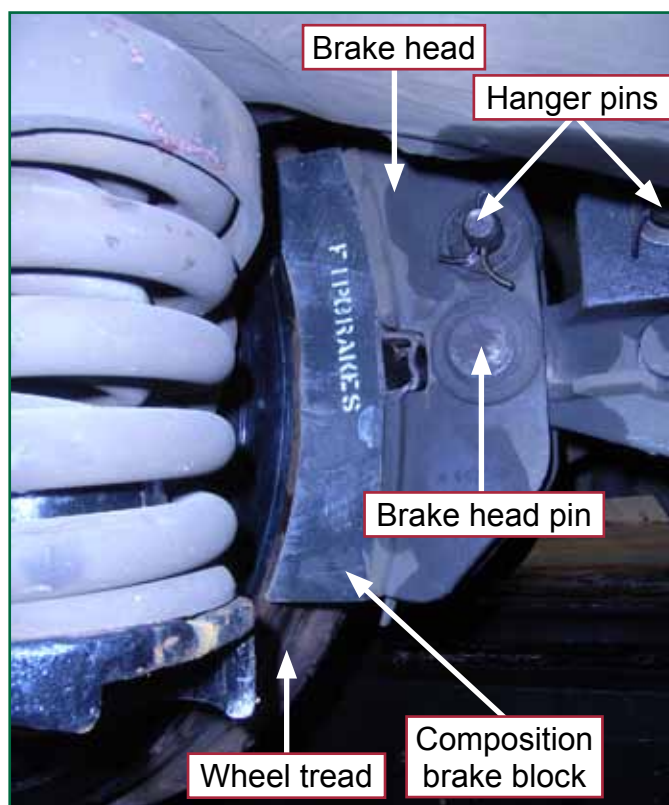
Figure 13: Photograph of the brake block, brake head, suspension springs and underframe of an FKA wagon without a coating of ice or snow

- 90 Snow and ice ingress between the brake block and the wheel tread can reduce the effective coefficient of friction for the portion of the block affected when it is applied to the wheel tread. This would in turn reduce the total braking force being generated to retard the wheel.
- 91 Photographs of the train taken in the hours following the derailment show that, on some of the wagons which did not derail, the brake blocks, brake heads, suspension springs and underframe were coated in a layer of snow, ice and slush. In some cases a thin layer of ice and snow could also be seen between the lower portion of the brake block and the wheel tread (see figures 13, 14 and 15).

- 93 The brake heads (which hold the brake blocks) on FKA wagons are connected to the brake beam via a mounting pin (see figure 13). This arrangement gives the brake block a limited ability to pivot so that it can apply a uniform contact to the face of the wheel tread during normal braking applications¹⁹. Analysis undertaken by the RAIB has showed that, if the lower portion of the brake block is prevented from moving towards the wheel tread by an obstruction (such as a significant build up of ice or snow), then the block will pivot to apply the upper edge of the brake block face to the wheel tread²⁰.

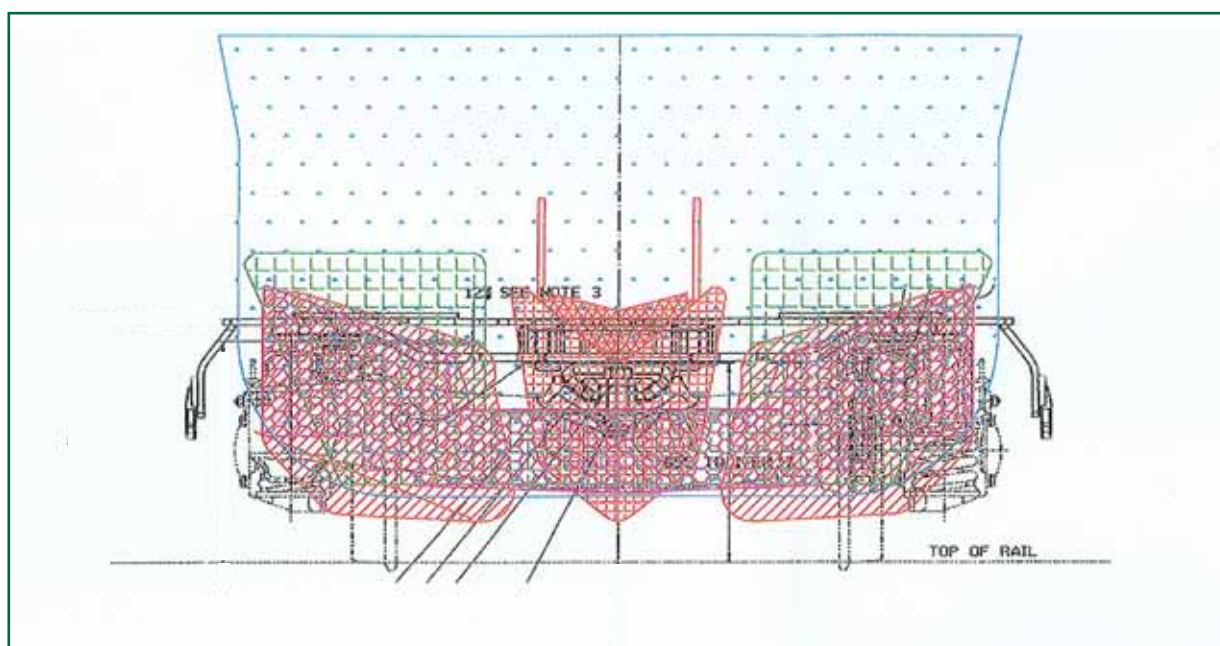
Figure 17: Profile of an FKA wagon element compared with the combined ploughing profiles of MSP-equipped stock and other trains running between Inverness and Carrbridge (coloured sections) (image courtesy of DB Schenker)

118 DB Schenker produced a diagram (see figure 17) which shows the combined 'ploughing' profile that the MSP equipped line proving locomotives and the other freight and passenger stock types running on the line would produce in lying snow. This shows that the combined 'ploughing' profile left snow lying close to the line. When compared to the profile of an FKA wagon, it could also be seen that the lower portion of the bogies' axleboxes and suspension springs were not covered by this combined 'ploughing' profile, meaning that they could potentially have run through lying snow.

119 As these wagons had travelled over the same route in reverse only around six hours prior to the passage of train 4N47 any lying snow which could have been directly contacted by these components would have probably been pushed aside at this point. However, as snow was continuing to fall periodically throughout the day it is possible that, by the mid-afternoon, the lying snow had again reached a level where it could be contacted by components on the FKA wagons.

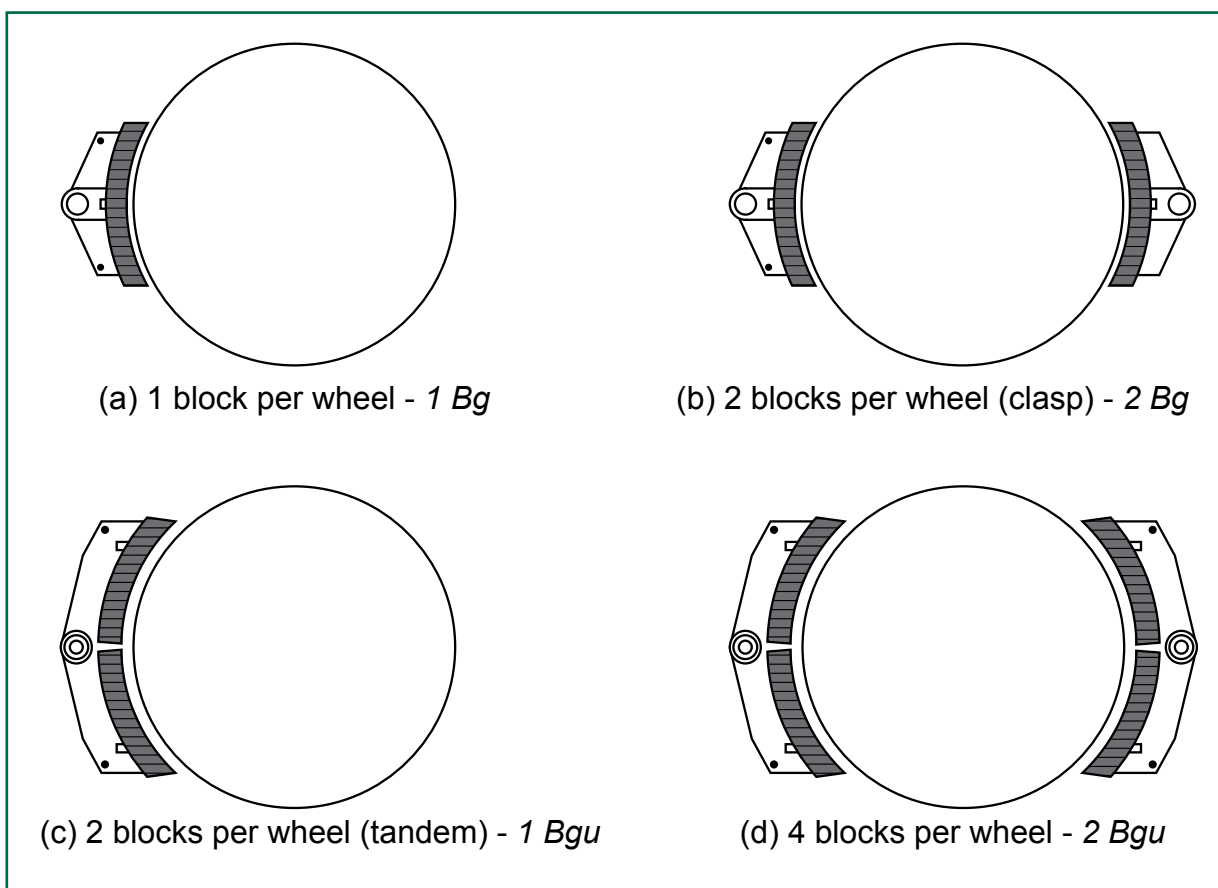
Figure 20: Four common arrangements of brake blocks. Blocks can be used in either a clasp or tandem arrangement

165 FKA wagons have a 1Bg braking arrangement (see paragraph 24). This applies a brake block to only one side of the wheel. In contrast, 'clasp' type arrangements, such as the 2Bg and 2Bgu (see figure 20), where brake blocks are applied to both sides of the wheel, may have more redundancy when dealing with the ingress of snow and ice. This is because if one side becomes affected by snow and ice ingress, then the other side may remain clear.

166 The 1Bgu, 2Bg and 2Bgu type block arrangements also have a larger brake block face surface area than the 1Bg arrangement and so may require a greater degree of snow ingress to reduce their effectiveness. The 2Bg and 2Bgu arrangements additionally also have twice the number of brake block edges available to pivot and apply to the wheel if the lower portions of the blocks are prevented from moving towards the wheel tread by an obstruction.

167 The 1Bg braking arrangement may however have certain advantages compared to other arrangements when used in ice and snow. Assuming that the overall force applied by the brake rigging in each arrangement is similar, the pressure exerted by a single brake block would be higher than in the other arrangements. Whilst increased pressure will not result in greater brake forces being generated in dry conditions, greater block pressure more effectively purges water (such as that resulting from the melting of ice and snow) from the tread surface and so may improve overall braking effectiveness.
