# Rail Accident Report

**Uncontrolled freight train run-back between  
Shap and Tebay, Cumbria  
17 August 2010**

# Uncontrolled run-back between Shap and Tebay, Cumbria, 17 August 2010

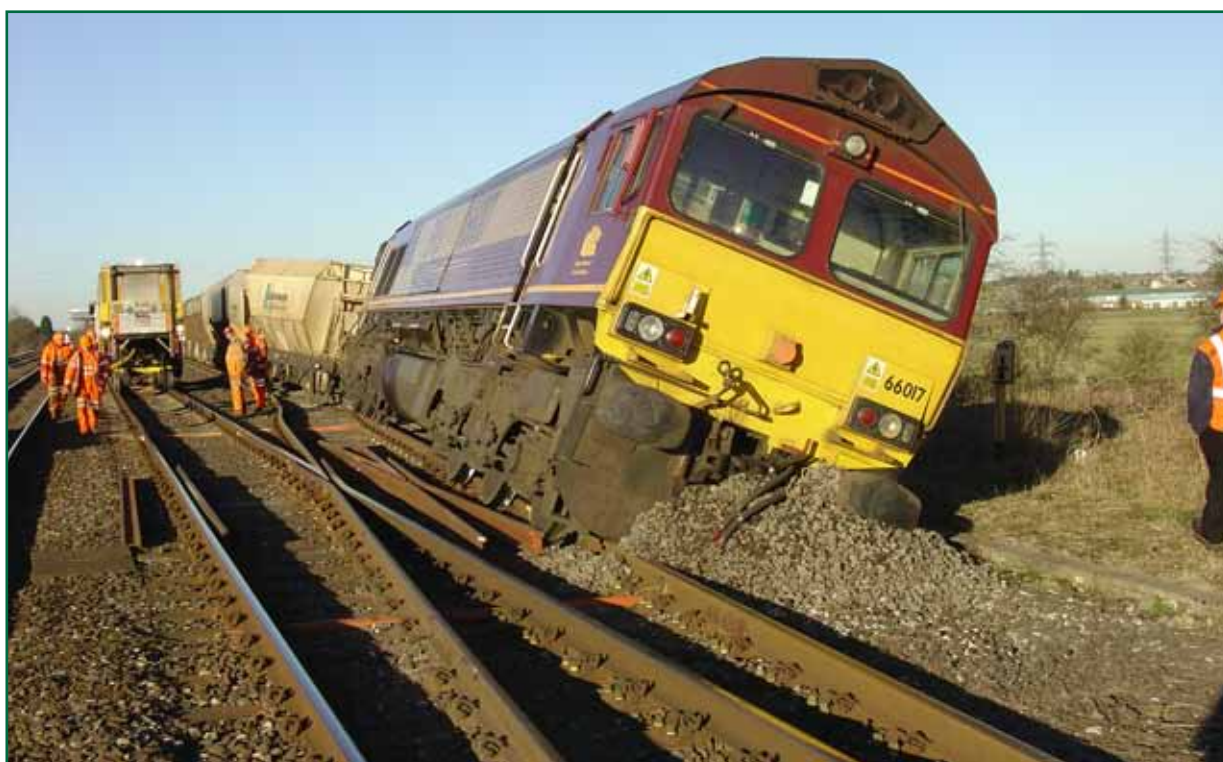
*Figure 14: Derailment at Brentingby Junction, 9 February 2006*

- 67 At 05:31 hrs on 9 February 2006, an EWS (now DB Schenker) freight train derailed at Brentingby, near Melton Mowbray, after its driver passed a red signal (figure 14). The driver was coming to the end of his first night shift and had been awake over 22 hours at the time of the accident. During the Shap investigation, the RAIB used the Fatigue and Risk Index and the Brentingby driver's shifts to calculate that he had a fatigue score of 14.8 and a risk score of 0.83 at the time of the accident. These scores are well below industry good practice night shift thresholds.
