Rail Accident Investigation Branch

Rail Accident Report

Incident at Llanbadarn Automatic Barrier Crossing (Locally Monitored), near Aberystwyth, 19 June 2011

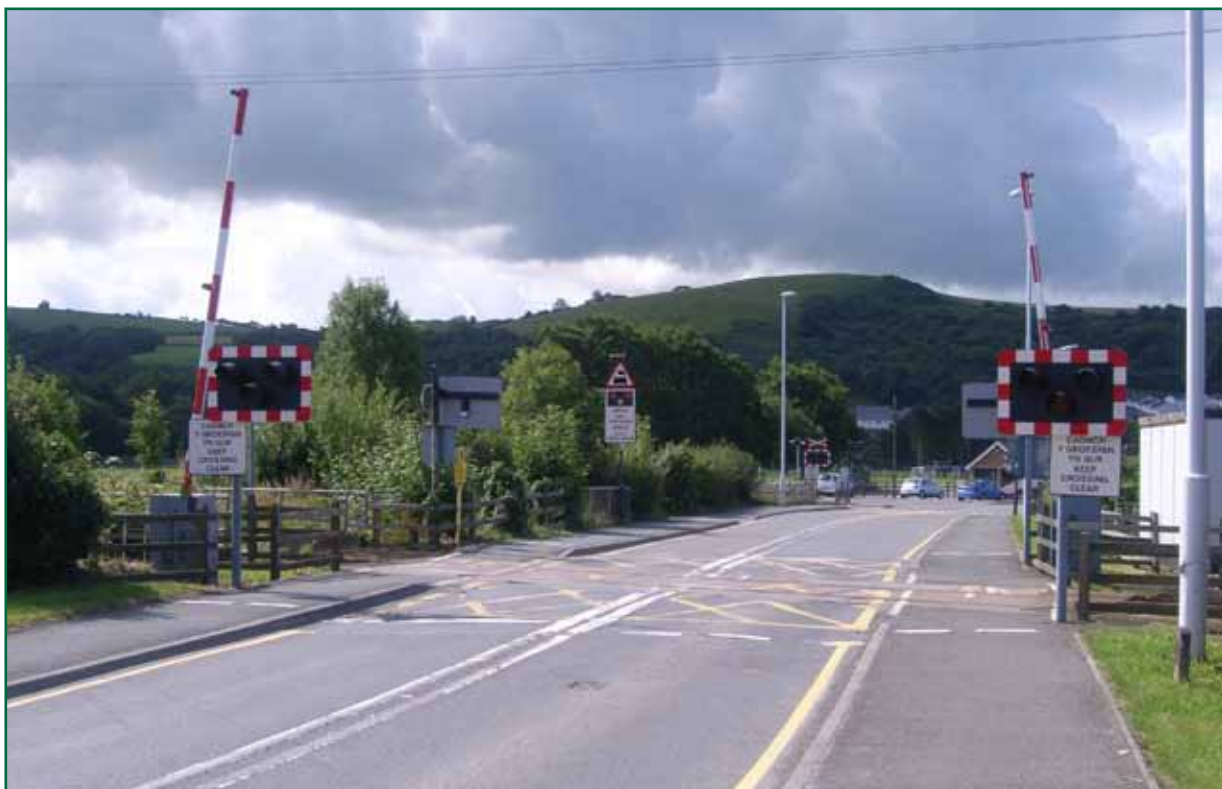
Figure 3: Llanbadarn ABCL crossing looking south along A4120 (with the Vale of Rheidol Railway AOCL crossing in the background)

- 13 The Llanbadarn level crossings are located where the two railways cross the A4120 road approximately one mile (1.6 km) east of their terminal stations at Aberystwyth. The two adjacent level crossings are about 60 metres apart. The more northerly crossing is on the Shrewsbury to Aberystwyth line of Network Rail, at 128,222 metres (94 miles and 56 chains) and the southern level crossing is on the Vale of Rheidol Railway, 1 mile and 15 chains (1.9 km) from Aberystwyth (figure 3).

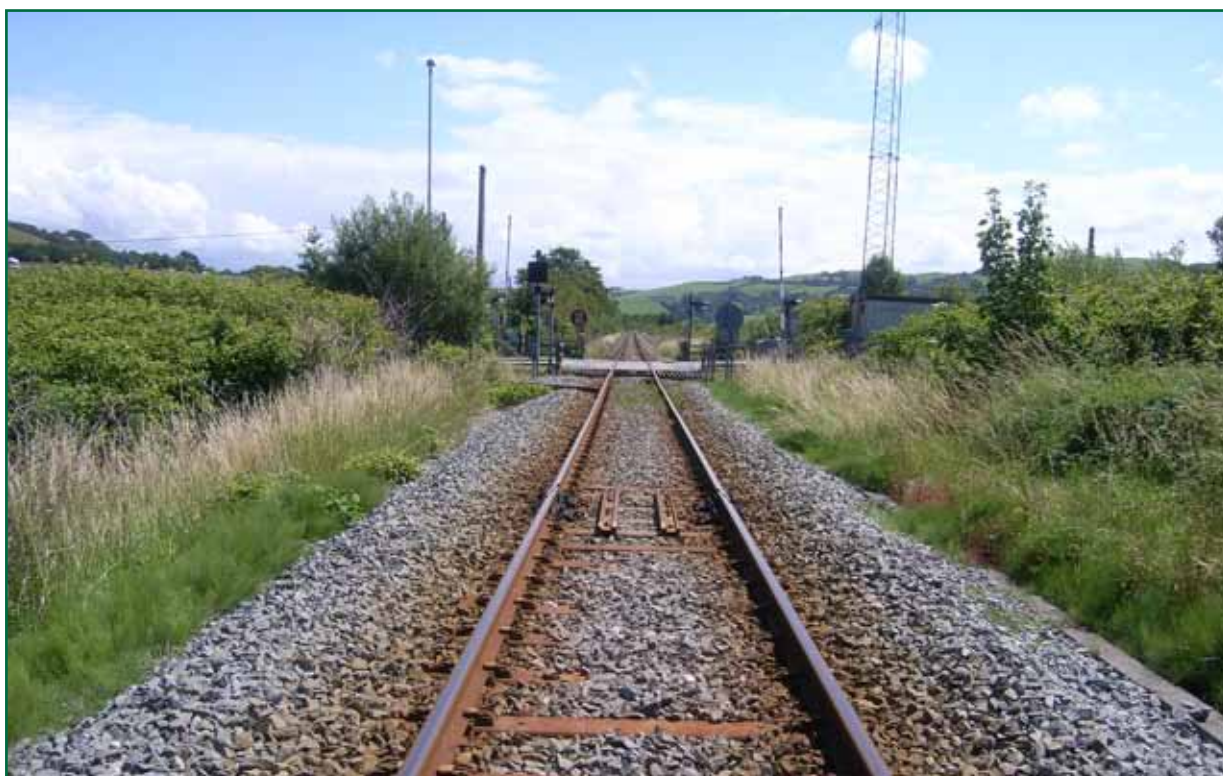
Figure 4: Llanbadarn ABCL crossing approach in the up direction

- 15 The Network Rail line rises as it approaches Llanbadarn *Automatic Barrier Crossing, Locally Monitored* (ABCL) from Aberystwyth, and continues to rise until approximately 325 metres east of the crossing (figure 4).

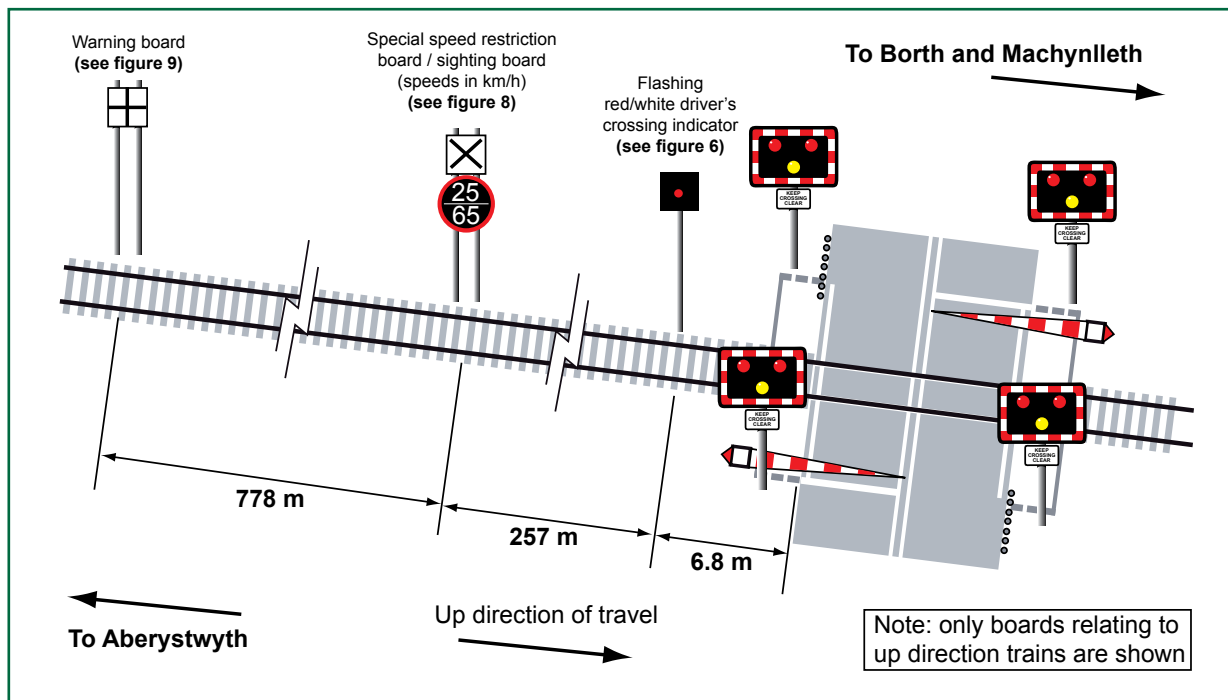
Figure 5: Schematic diagram of Llanbadarn ABCL

29 Until the arrival of a train initiates its operation, the crossing is in its 'normal state'. In this state an indicator, known as the *driver's crossing indicator* (DCI), shows a flashing red light to rail traffic (figures 5 and 6), and there are no lights shown to road traffic. If, when a train approaches, the crossing sequence has initiated correctly, and the highway flashing red lights have begun to show to road traffic, and the barriers have started to lower, then the flashing red light at the DCI will be replaced by a flashing white light. This flashing white light informs the driver that the crossing is functioning correctly. The maximum permitted speed of trains as they pass over the crossing (known as the crossing 'permitted' speed) is limited by the ETCS¹, and a 'sighting board' is placed a set distance before the crossing. This board should be positioned so that a train travelling at the permitted speed² can be stopped before reaching the crossing if the DCI has not displayed a flashing white light by the time the front of the train passes the board. This board is referred to in the Office of Rail Regulation Guidance³ as the special speed restriction board (SSRB). This board is known in the Rule Book as a 'sighting board'. Another board, known as the 'warning board' (paragraph 37) warns the driver that the train is approaching the sighting board.

- 36 The sighting board for up direction trains at Llanbadarn ABCL is located 257 metres before the DCI (figures 5 and 8), which, in turn, is located 6.8 metres before the crossing. Thus the board is approximately 264 metres before the crossing. The DCI can be seen by a driver approximately 950 metres before the train reaches it. The warning board is located 778 metres on the approach to the sighting board.

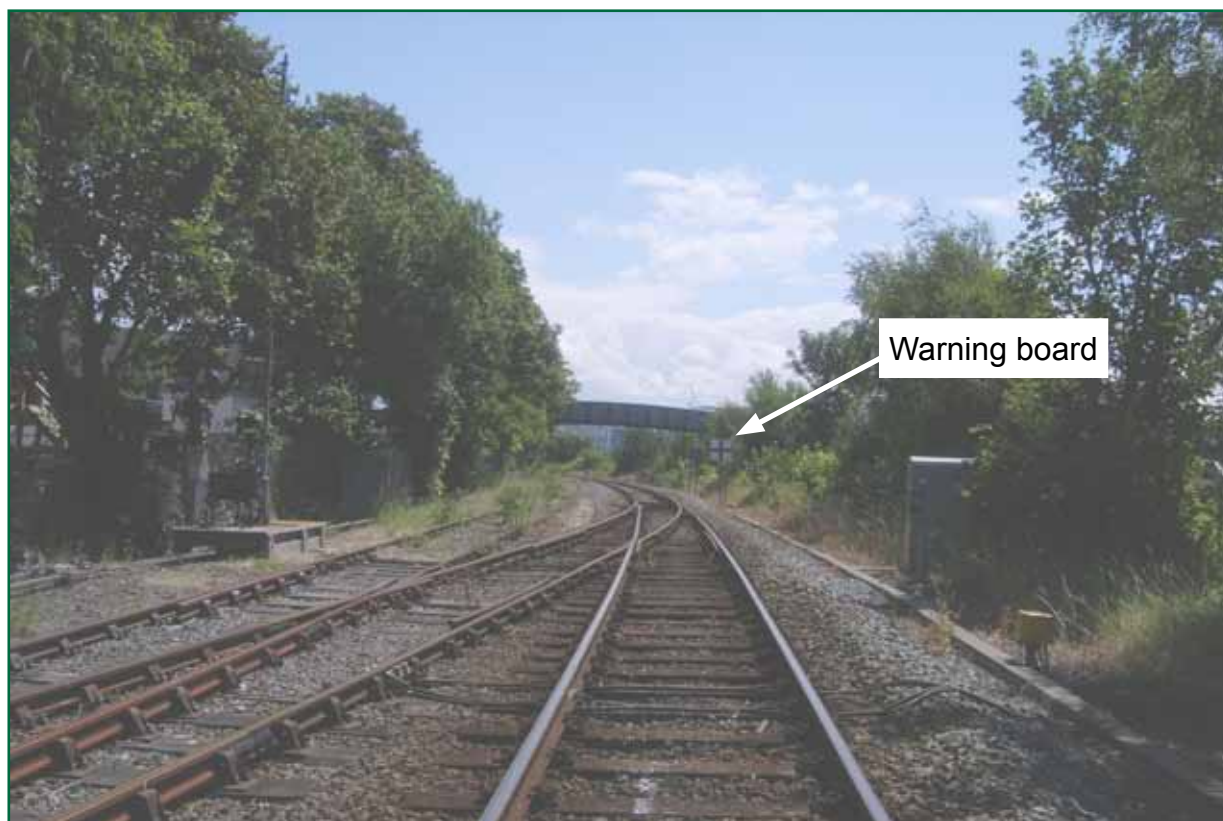
Figure 9: Warning board - as seen by an approaching train driver after leaving Aberystwyth station

- 37 A warning board (figure 9) warns the driver that the train is approaching the sighting board⁵. Under ERTMS operation, on the approach to the warning board, an audible alarm is sounded in the driver's cab and a text message, 'ABCL ahead' appears on the driver's DMI screen. This text message disappears from the DMI when it is acknowledged by the driver by pressing a button on the DMI. If the message is not acknowledged within 3 seconds, then the brakes on the train will automatically apply.
