Rail Accident Investigation Branch

Rail Accident Report

Derailment at Bordesley Junction, Birmingham 26 August 2011

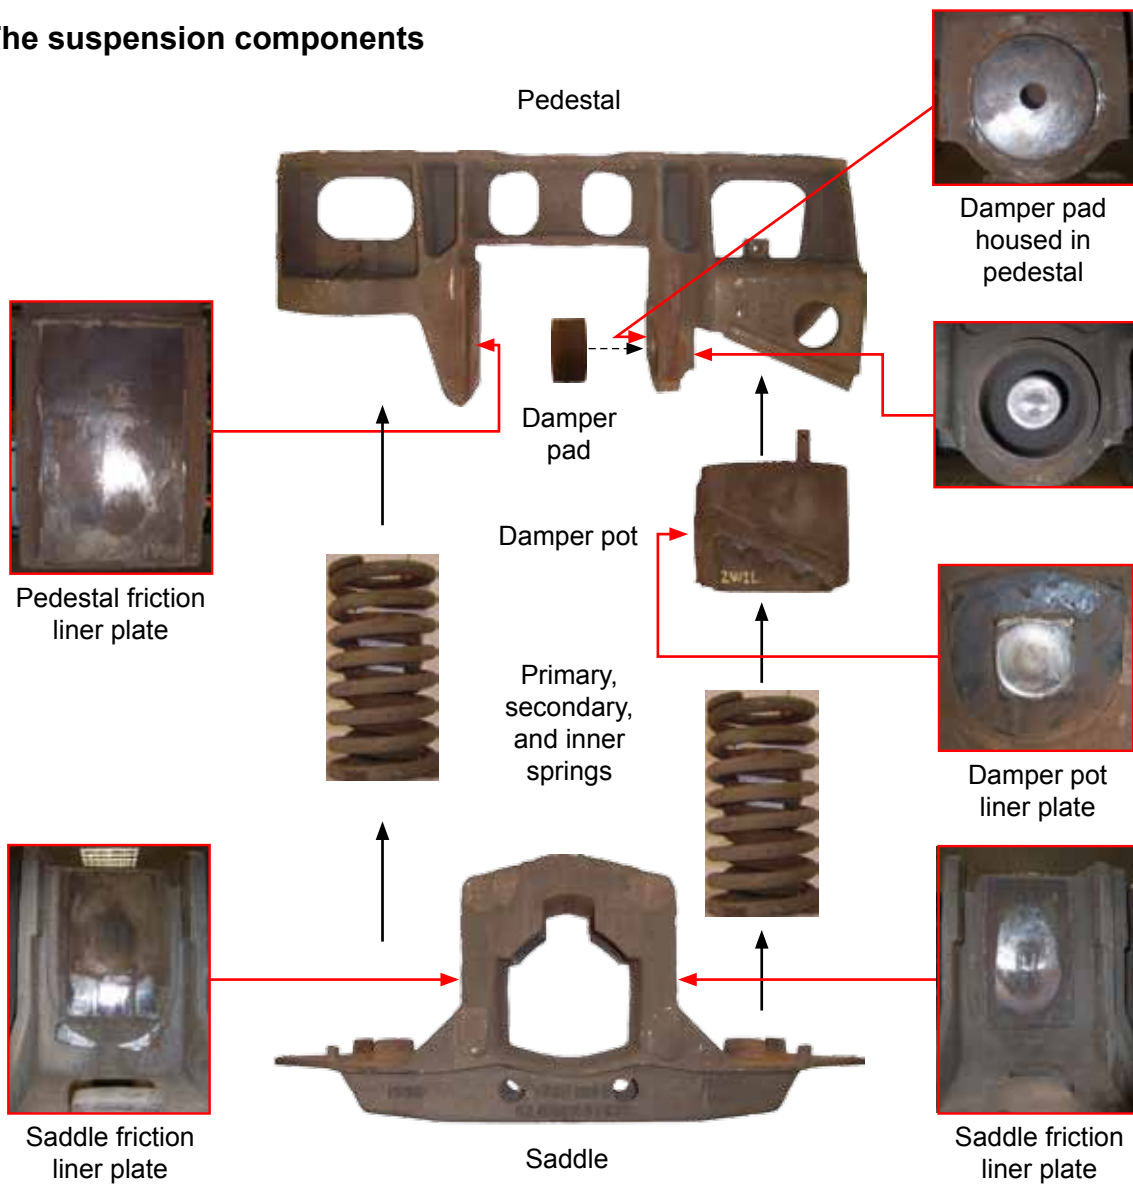
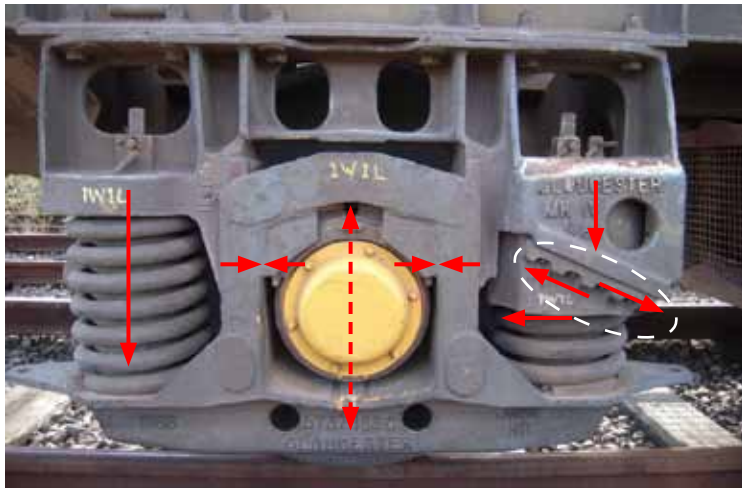
Figure 7: The Mark 4 Floating Axle Suspension

- 44 The suspension used by the PHA wagon was manufactured by the Gloucester Railway Carriage and Wagon Company in 1987 and is known as a Mark 4 Floating Axle Suspension (figure 7). This suspension unit has a *pedestal* (also known as an axle horn guide) bolted to the underside of the frame. A *saddle* sits on the axle bearing and slots into the pedestal.

Wedge between pedestal and damper pot to convert vertical force into a horizontal force which damps movement of the saddle

- 45 The saddle supports primary, secondary and inner top hat or 'cup' springs. The spring arrangement is fixed with a retaining pin known as an 'anti-separation pin' running through the centre. The springs are located between the pedestal and the saddle and are compressed by the weight of the wagon.
- 46 On the inner side of the saddle, a *damper pot* is located between the top of the springs and the pedestal. The weight of the wagon and its payload acts upon a pair of wedges between the pedestal and the damper pot. The damper pot converts the downwards force into a horizontal force which pushes a *damper pad*, housed inside a hole in the pedestal, against a friction liner plate on the saddle, to damp the vertical movement of the saddle. The damping force thus changes according to the load.

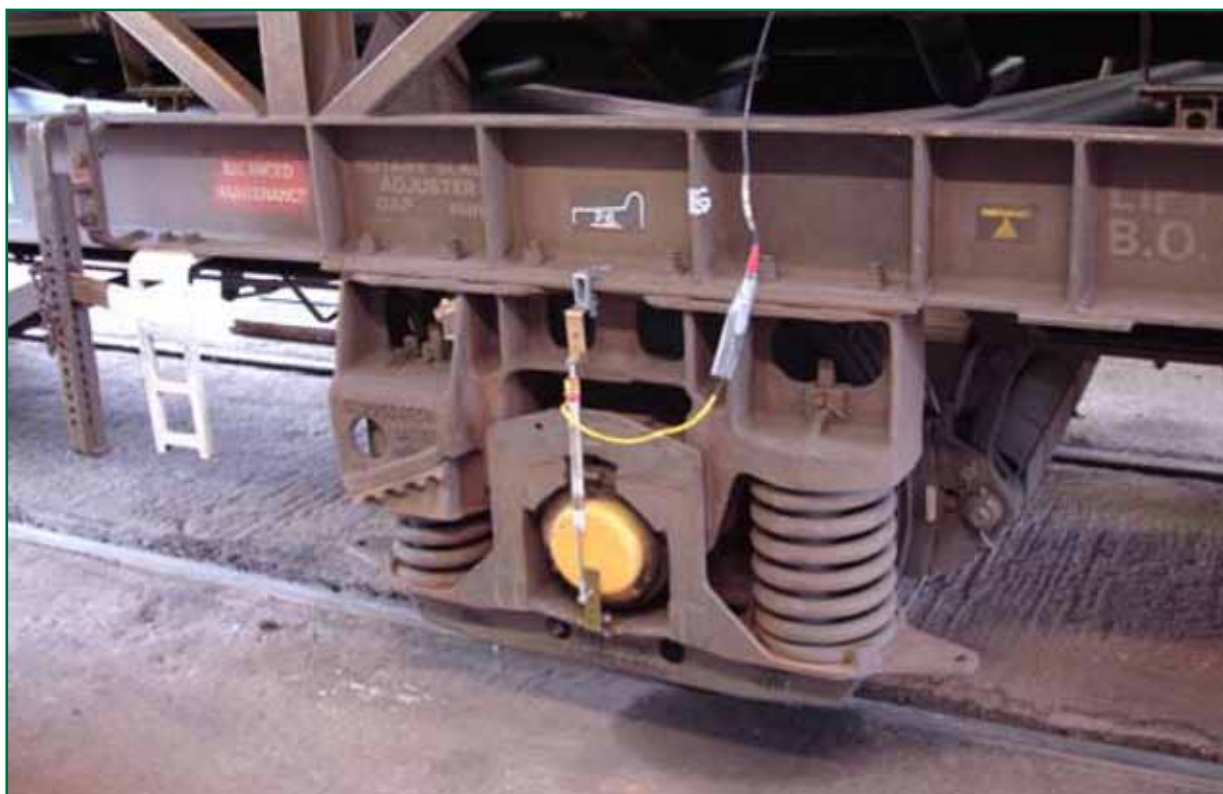
Figure 14: Instrumentation fitted to the PHA wagons that were tested (image courtesy of Serco)

- 77 During 2009, Network Rail's PWRAMG commissioned Serco to measure the movement of the PHA wagon's suspension when in running in service. Lafarge gave its permission for instrumentation to be fitted to five wagons within a set of ten. A transducer was fitted to each corner of the five wagons (figure 14) which measured the vertical movement of the saddle within the pedestal in steps of 0.1 mm. The data from each transducer was recorded by a data logger that was housed on one of the wagons. The logger also included a *global positioning system* (GPS) device so that date, time, location and speed information could be recorded at the same time.

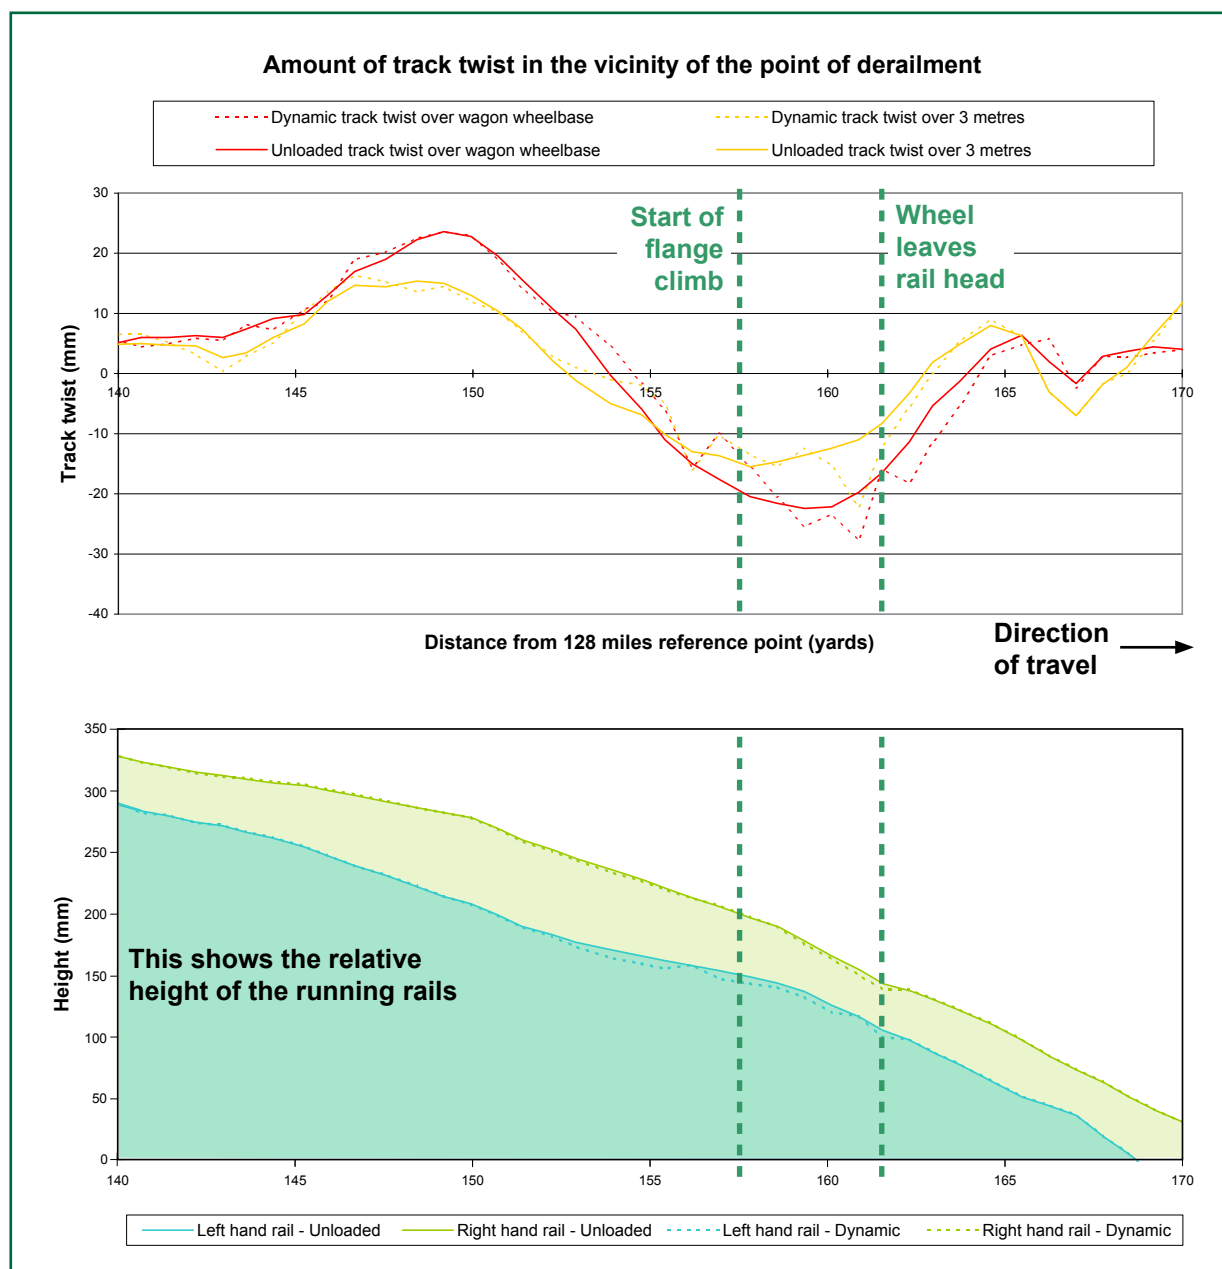
Figure 16: Graph showing the amount of track twist and relative change in height of the running rails

- 105 The marks found by the RAIB showing where the flange of the leading right-hand wheel of REDA 16066 had climbed onto the rail head coincided with the location of abnormal track twist (figure 16). At this location, the RAIB measured a 3 metre dynamic track twist of 1 in 200 (cant difference of 15 mm) which increased to 1 in 140 (cant difference of 21 mm) over the next four sleepers. The most severe dynamic twist over the wheelbase of the wagon (4.775 metres) measured by the RAIB was 1 in 172 (cant difference of 28 mm) at the sleeper before the point of derailment. The direction of this track twist caused a further reduction of the vertical load on the leading right-hand wheel; the load on this wheel was already reduced by a suspension lock-up on the trailing left-hand wheel (paragraphs 59 to 65).

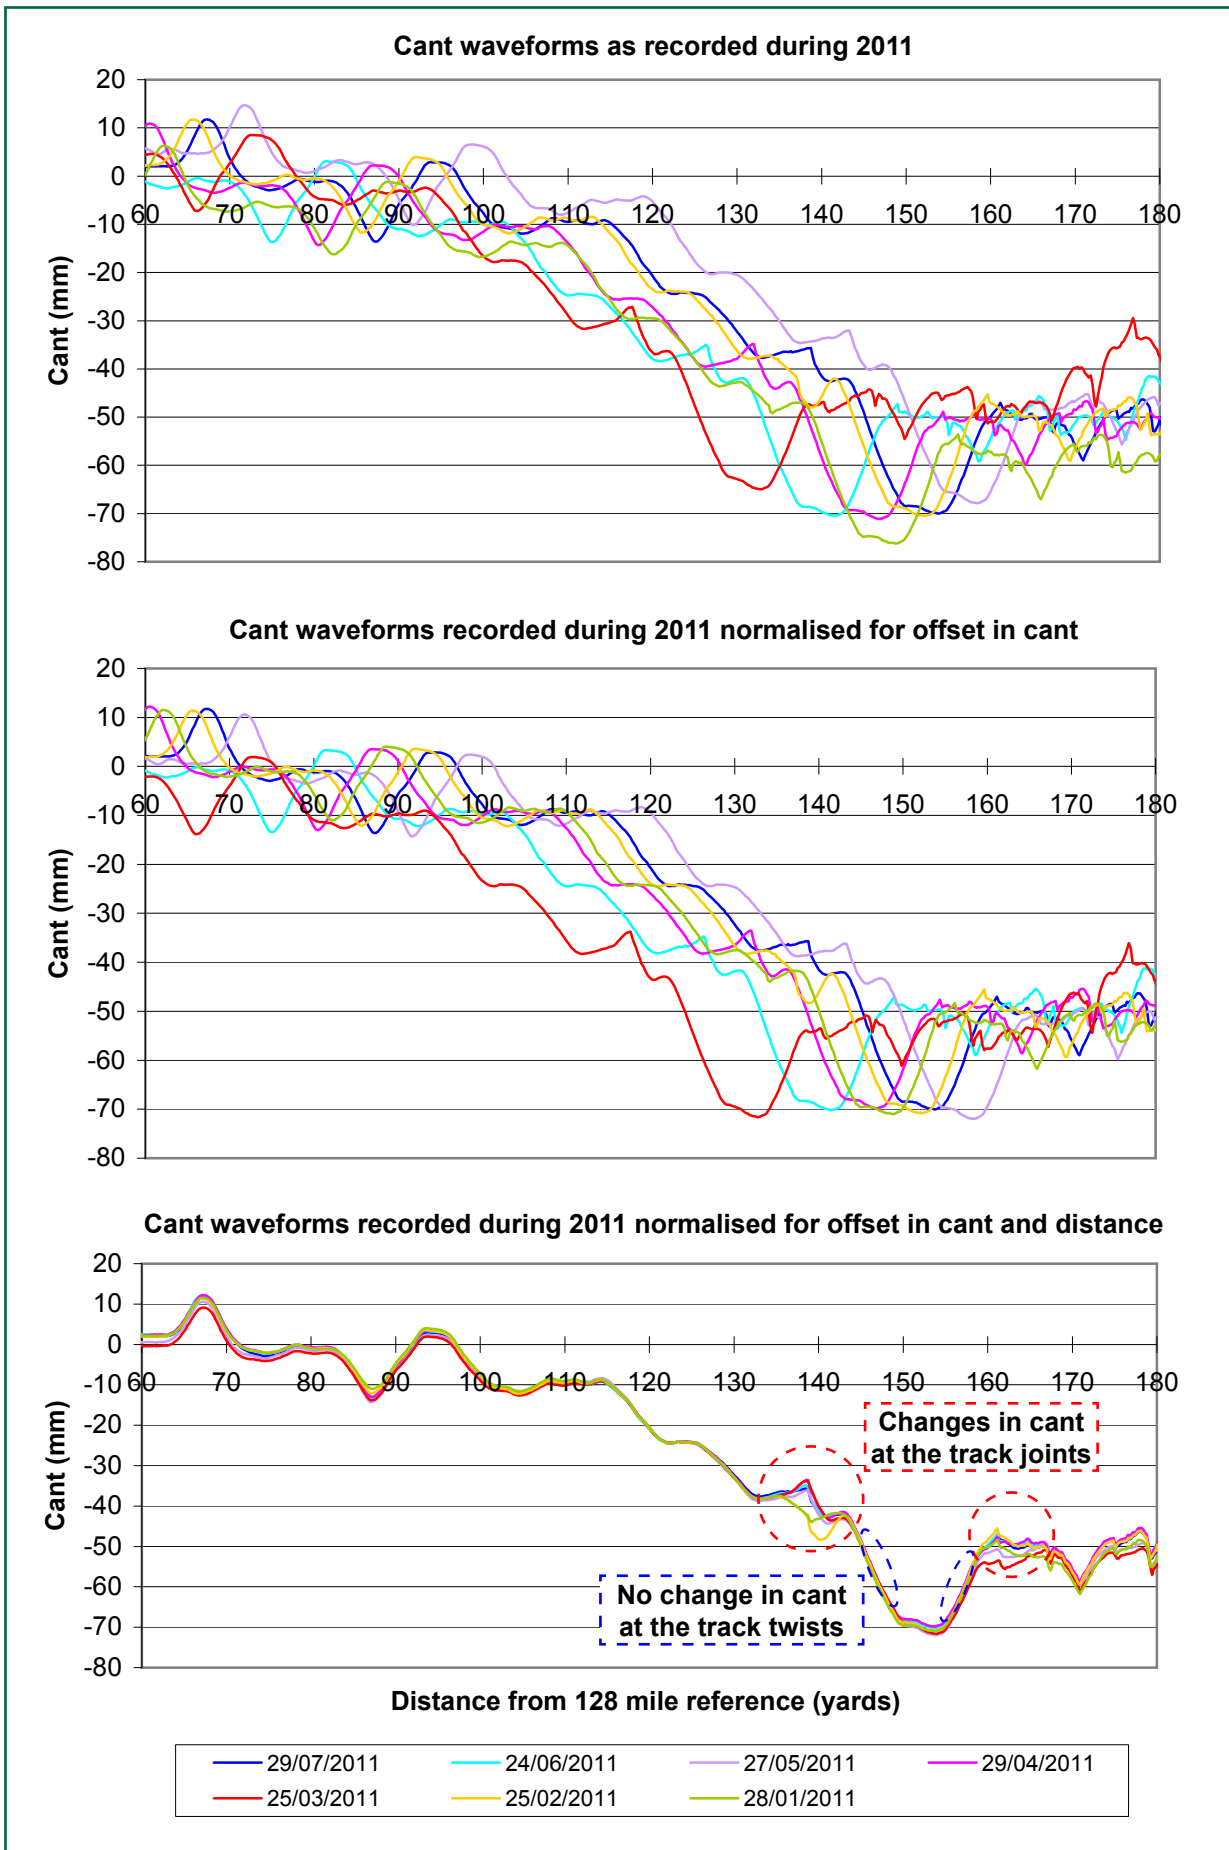
Figure 17: Graphs showing how cant changed during 2011

- 115 From witness evidence and analysis of the track geometry data, the RAIB concluded that the repair work was being carried out in the wrong place, either side of the track twists. The maintenance team were carrying out measured shovel packing repairs at a track joint before the first track twist and at the joints within the switches and crossing for the junction after the second track twist (figure 18). Figure 17 shows the cant waveforms measured by the track geometry recording trains in 2011. The cant reaches a peak of about 70 mm, with it changing at a rate of about 1 in 200 either side of this peak, which is just on the threshold for a reportable track twist (paragraph 112). The aligned cant waveforms for the section of track with the track twists did not change throughout 2011, but it did change over time in the vicinity of the joints which was as a result of the work done by the maintenance team.

- 116 The maintenance team had carried out similar repairs at these joints several times in the past. When the team had gone out to do the repairs, they had measured and found changes in the cant at these joints, so that was where they did the work to lift and pack the track. They did not measure the cant in the section of plain line between the joints, so they did not find the reported track twists. Therefore the track twists went unrepaired.
