Rail Accident Investigation Branch

Rail Accident Report

**Fatal accident at Bayles and Wylies footpath crossing, Bestwood, Nottingham
28 November 2012**

Report 19/2013
September 2013

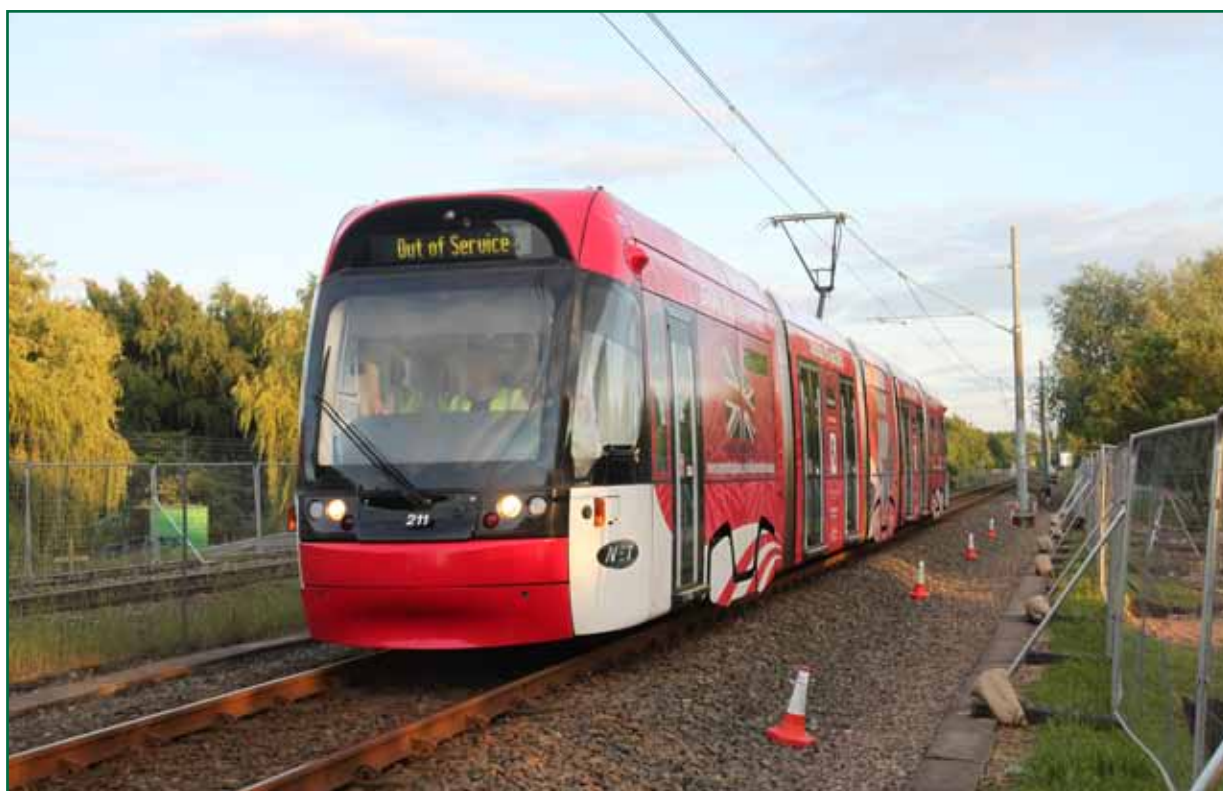
- 15 The tram involved, number 211 (figure 3), is one of 15 trams manufactured by Bombardier Transportation for the opening of the Nottingham tram system in 2004. All 15 are of the type known as the Incentro model. On the day of the accident, tram 211 had just been released into service following a major maintenance examination. Alstom recorded that the tram had no defects following maintenance. At the time of the accident, the tram was working the 18:30 hrs service from Nottingham Station Street to Hucknall.

Figure 3: The tram involved in the accident, tram 211, approaching Bayles and Wylies crossing

- 21 Alstom Transport staff carried out post-accident testing of the tram following the accident in the presence of Nottinghamshire Police and reported that they found no defects with the brakes, speedometer, horn or bell. The RAIB's analysis of the OTDR also indicated that these systems operated as designed.

- 22 Following the accident, the dipped beam filament of the right-hand (in the direction of travel) headlight bulb was found to be broken and was changed. Nottinghamshire Police investigated this failure and concluded that it had broken as a result of the impact. They reported that the bulb was not lit at the time of the accident because the headlights were set to main beam.
