Rail Accident Investigation Branch

Rail Accident Report

Locomotive derailment at Ordsall Lane Junction, Salford, 23 January 2013

Report 07/2014
March 2014

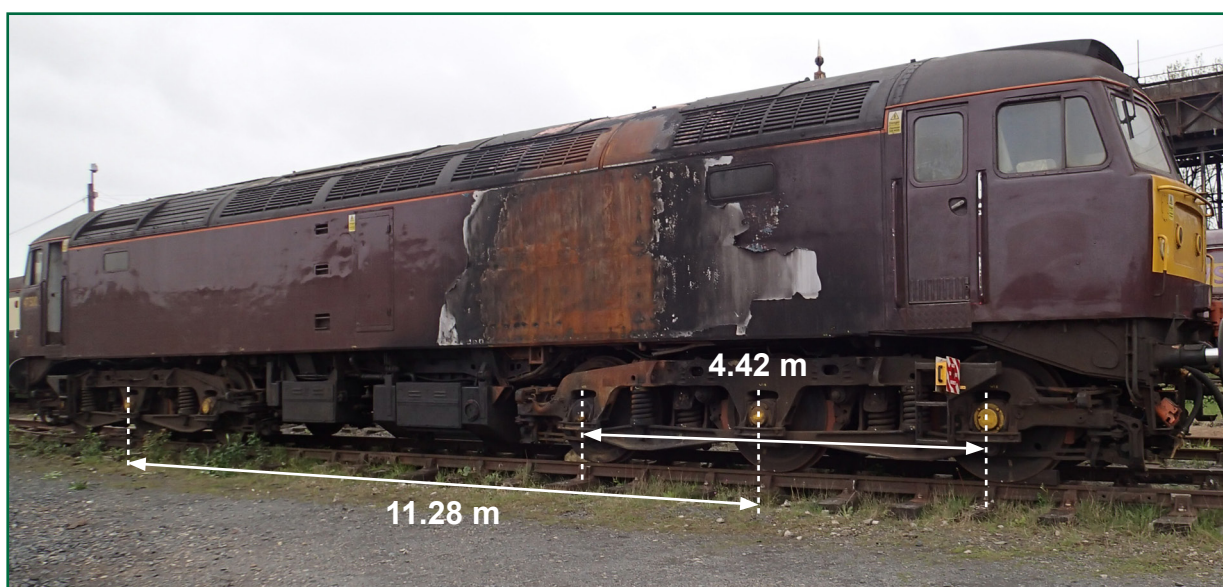
Figure 3: Locomotive 47500 showing wheelbase and bogie spacing dimensions

- 18 West Coast Railways had identified the need for wheel reprofiling on locomotive 47500 because a *wheel impact load detector* (WILD) had detected wheel flats when it passed over the WILD site at Salfords in Surrey, on 8 December 2012. The wheel profiles were restored to the *P1 wheel profile*. Selected coach wheel profiles were also restored at Ardwick depot.
- 19 Class 47 locomotives were built for British Rail in the mid-1960s. Their running gear comprises two three-axle bogies, each with an overall wheelbase of 4.42 metres. The bogies are spaced 11.28 metres apart (figure 3).

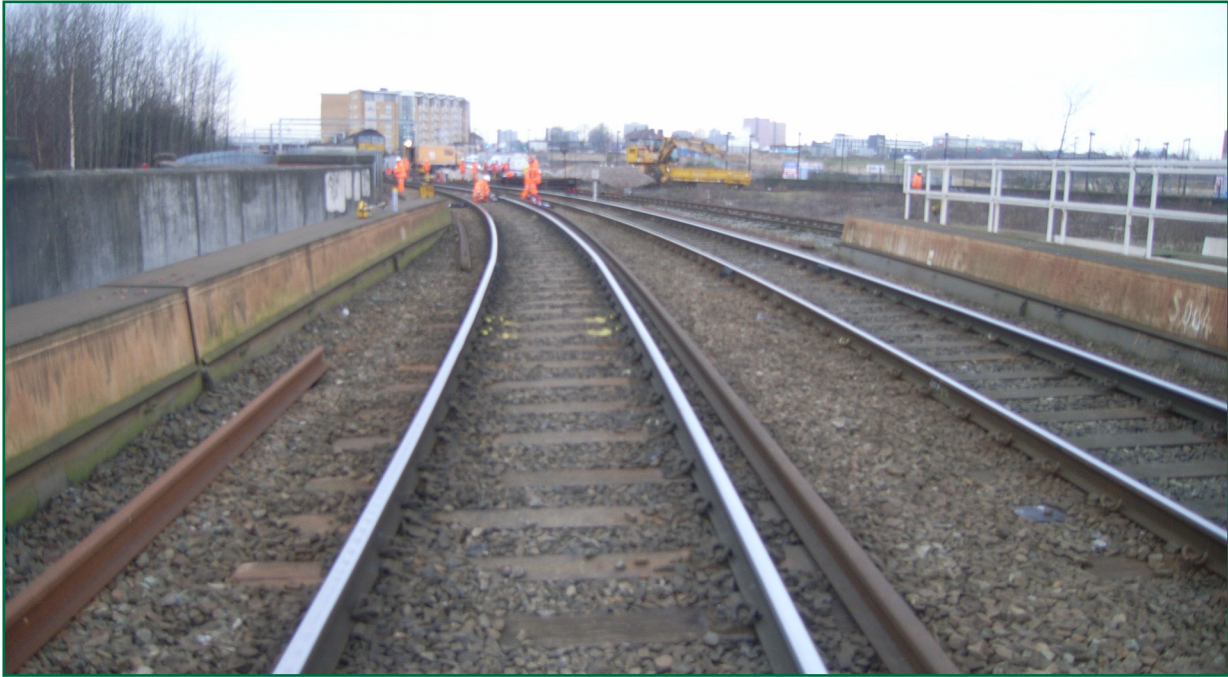
Figure 4: The track on the Down Bolton line, looking from bridge 130B towards the derailment site

- 21 The track on the curve, from bridge 130A through to the derailment site, comprises jointed *flat-bottom BS113A rail*, fastened with *pandrol clips*, to *pan 11 baseplates*. The baseplates are screwed into hardwood sleepers supported on stone ballast. Figure 4 shows a typical view of the track and its construction.

- 23 Witness evidence indicated that the last track renewal work on the down Bolton line was in 2008. The date of manufacture marked on the rails supports this; however, Network Rail was unable to supply the RAIB with any records of the work that was carried out (paragraph 78).

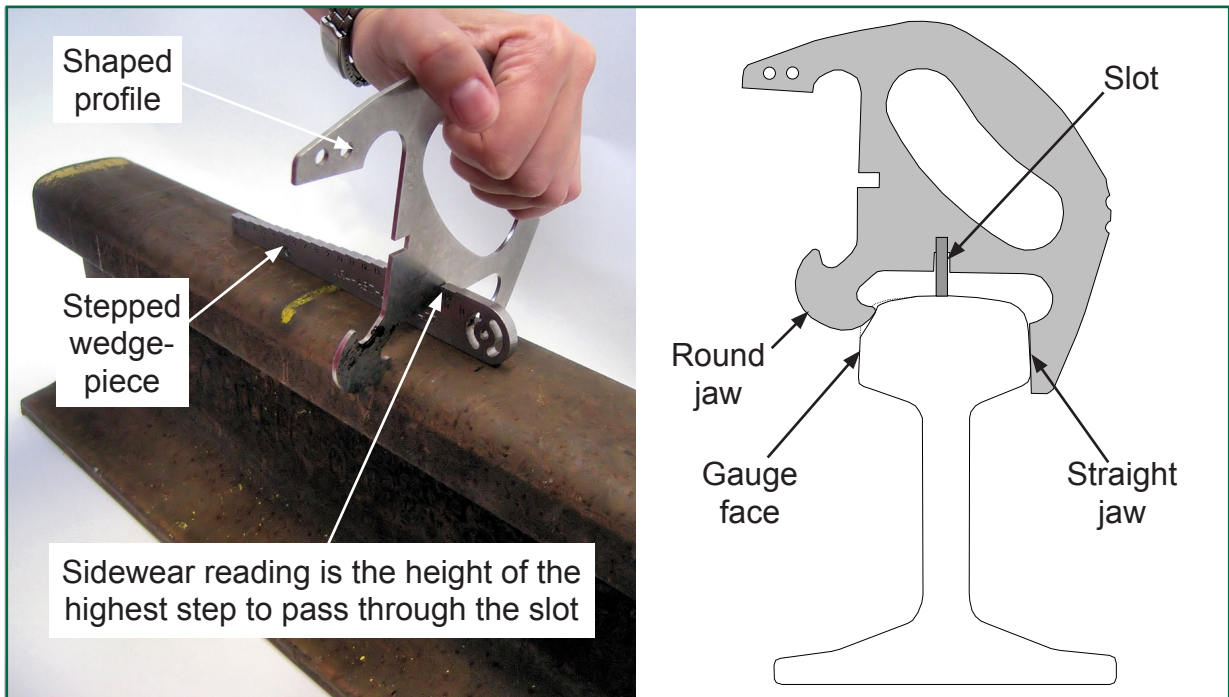
Figure 8: NR4 stepped sidewear gauge

⁶ The NR4 stepped sidewear gauge comprises a shaped profile, with jaws, and a stepped wedge-piece. The jaws are placed across the rail, with the straight jaw aligned to the outer face and the round jaw resting on the corner of the inner (gauge) face. The measurement is made by sliding the wedge-piece along the top of the rail in the slot between the jaws; the reading is the height (as marked on the wedge-piece) of the highest step that will just pass under (as shown on figure 8).

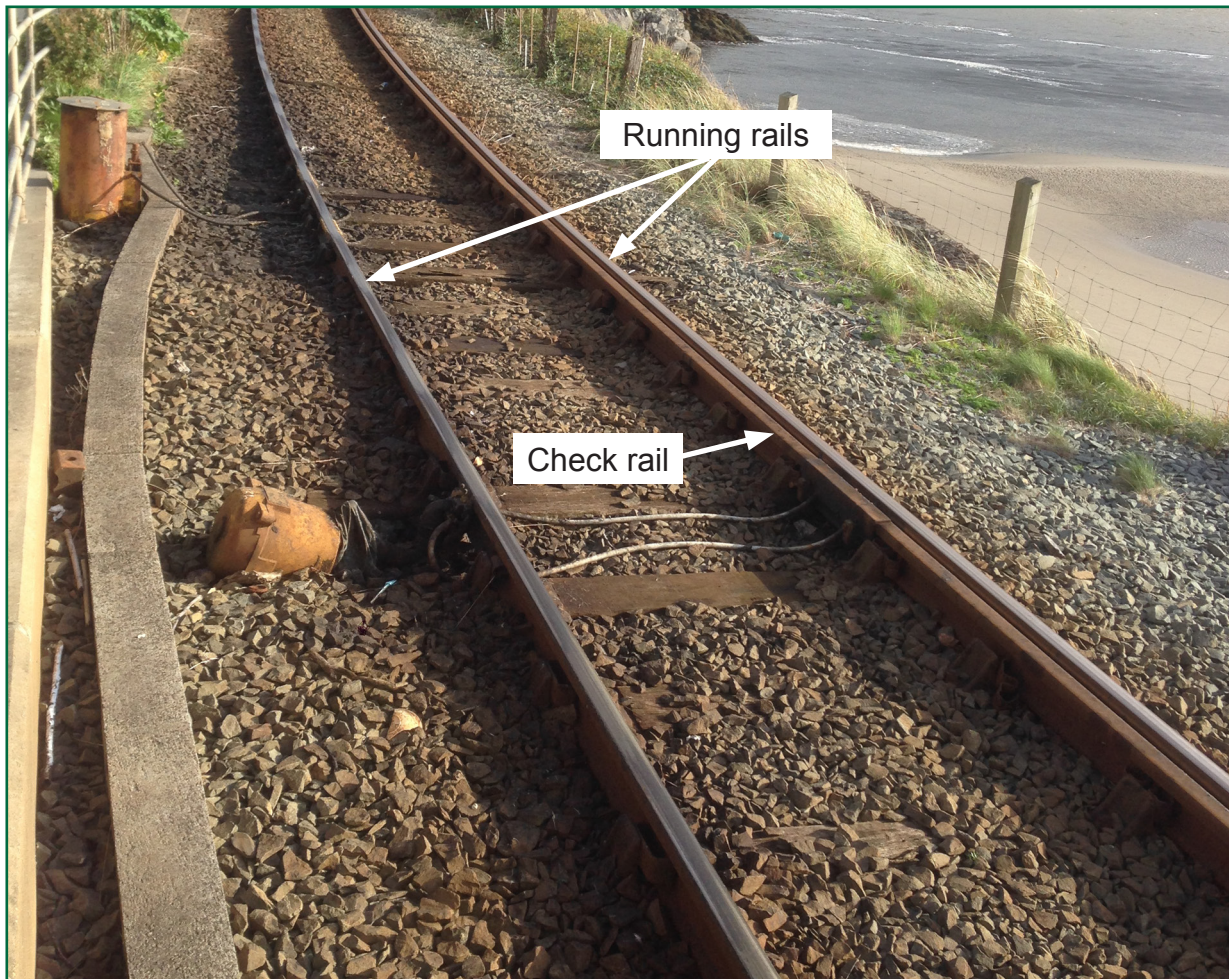
Figure 9: Check rail fitted to a typical small radius curve

- 41 A check rail is a rail that is fitted alongside a running rail at a specified dimension from the gauge face. When a railway vehicle with conventional bogies, such as a class 47 locomotive, negotiates a curve the flanges of the leading outer wheels on each bogie tend to be displaced towards the outer rail. On smaller radius curves the flanges can be forced into contact with the gauge face – the resulting lateral force increasing the risk of the wheel flange climbing onto the rail and into derailment (paragraph 66). A check rail fitted alongside the inner running rail of a curve restricts this lateral displacement, by bearing on the *flange backs* of the inner wheels, helping to prevent the flanges of the outer wheels climbing onto the outer rail. Figure 9 shows a check rail fitted to a typical small radius curve.

- 42 Both Railway Group standard GC/RT5021 'Track system requirements', and Network Rail standard NR/L2/TRK/2102 'Design and construction of track', require that check rails are fitted on all passenger lines⁹ (and running lines close to passenger lines) where the track radius is less than 200 metres, and that they should extend at least 9 metres into adjoining sections of straighter track. The RAIB found evidence of equivalent requirements going back over 100 years¹⁰ (it noted however that there is no equivalent requirement in the applicable *Technical Specification for Interoperability* issued by the European Commission).

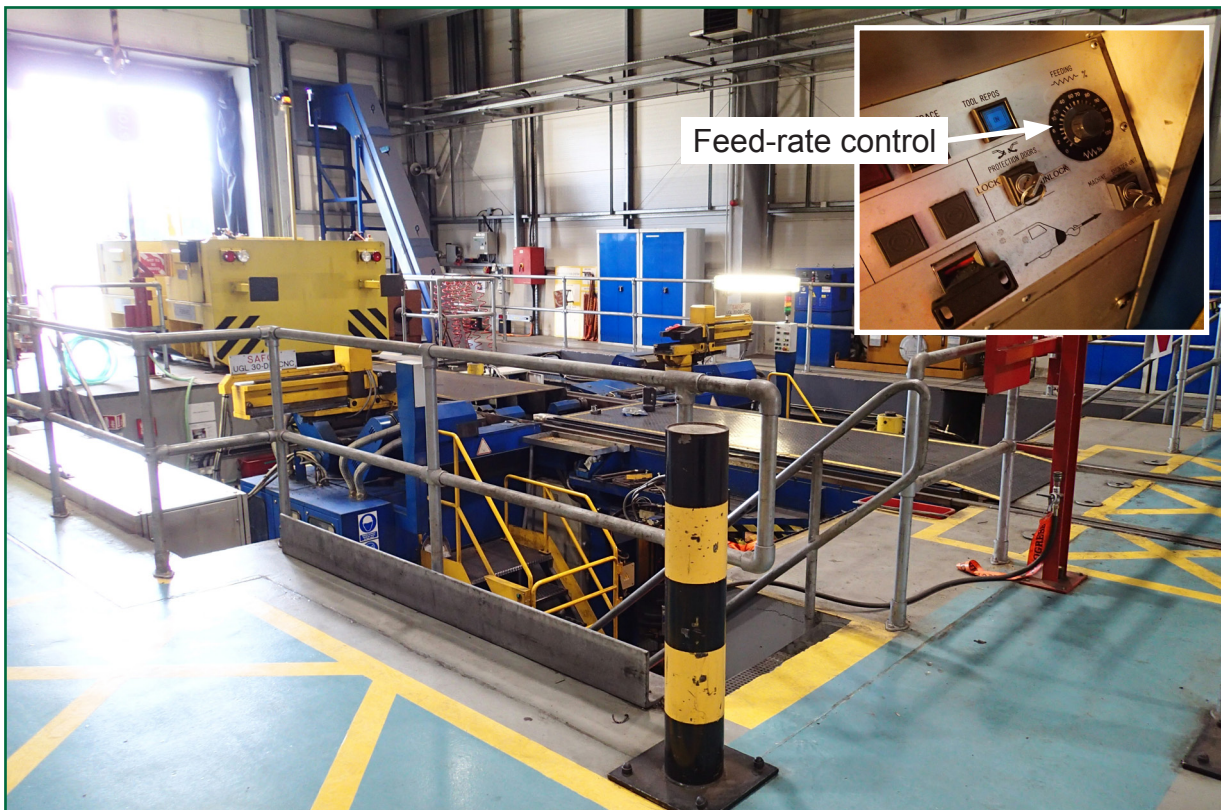
Figure 12: Wheel lathe at Ardwick depot (inset shows the control used to manually set the feed rate on the finishing cut)

- 58 Staff at Ardwick depot undertake wheel reprofiling work for West Coast Railways in accordance with an in-house procedure and an agreed customer specification (the 'Contract control form' (CCF)) - the latter detailing the specific requirements for the particular vehicle type. The work is carried out on a computer-controlled underfloor *wheel lathe* (figure 12). Coarse cuts are carried out first to remove the bulk of the unwanted material. The lathe operator then manually sets the feed rate necessary to achieve the specified *surface finish* on the final finishing cut, taking into account the condition of the cutting tool and other factors. In common with other maintenance depots, the machining process that Siemens uses does not require a lubricant or cutting agent.

- 60 The maximum wheel diameter difference recorded on a wheelset on locomotive 47500, after wheel reprofiling, was 0.108 mm. The wheel lathe procedure requires operatives to regularly monitor the surface finish during wheel reprofiling by visual comparison with a roughness specimen machined to a range of finishes from N5 to N12 (figure 13). There was no requirement to record the results of the comparison. However, from an inspection of the post-derailment condition of the wheel surface the RAIB estimates that a surface finish of between N10 and N11 was achieved, which was marginally rougher than the value of N10 that was specified (paragraph 93).
