Rail Accident Investigation Branch

Rail Accident Report

Dangerous occurrence at Denmark Hill station 1 August 2013

Report 23/2014
October 2014

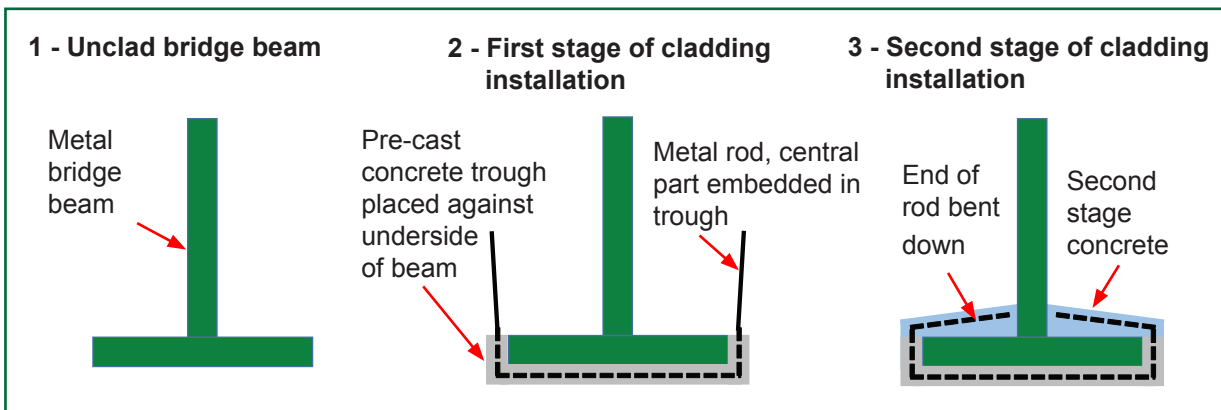
Figure 6: Likely construction sequence

- 14 A simplified illustration of the likely construction sequence for cladding the underside of the metal beams is shown in figure 6, based on typical bridge construction details provided by Network Rail. Short lengths of concrete trough were pre-cast⁵ with metal rods protruding from the upper side of the troughs. The troughs were then placed against the underside of the girder and the metal rods bent over the underside (the lower flange) of the beam. Concrete was then placed above the web to encase the metal rods. This form of construction is illustrated in figure 7.

- 16 The presence of open joints meant that the metal rods were more susceptible to corrosion. It is the view of the RAIB that corrosion of the rods over many years caused a gradual weakening of the cladding until it reached the point when the trough was no longer adequately supported.
