Rail Accident Investigation Branch

Rail Accident Report

Buffer stop collision at Chester station 20 November 2013

Report 26/2014
November 2014

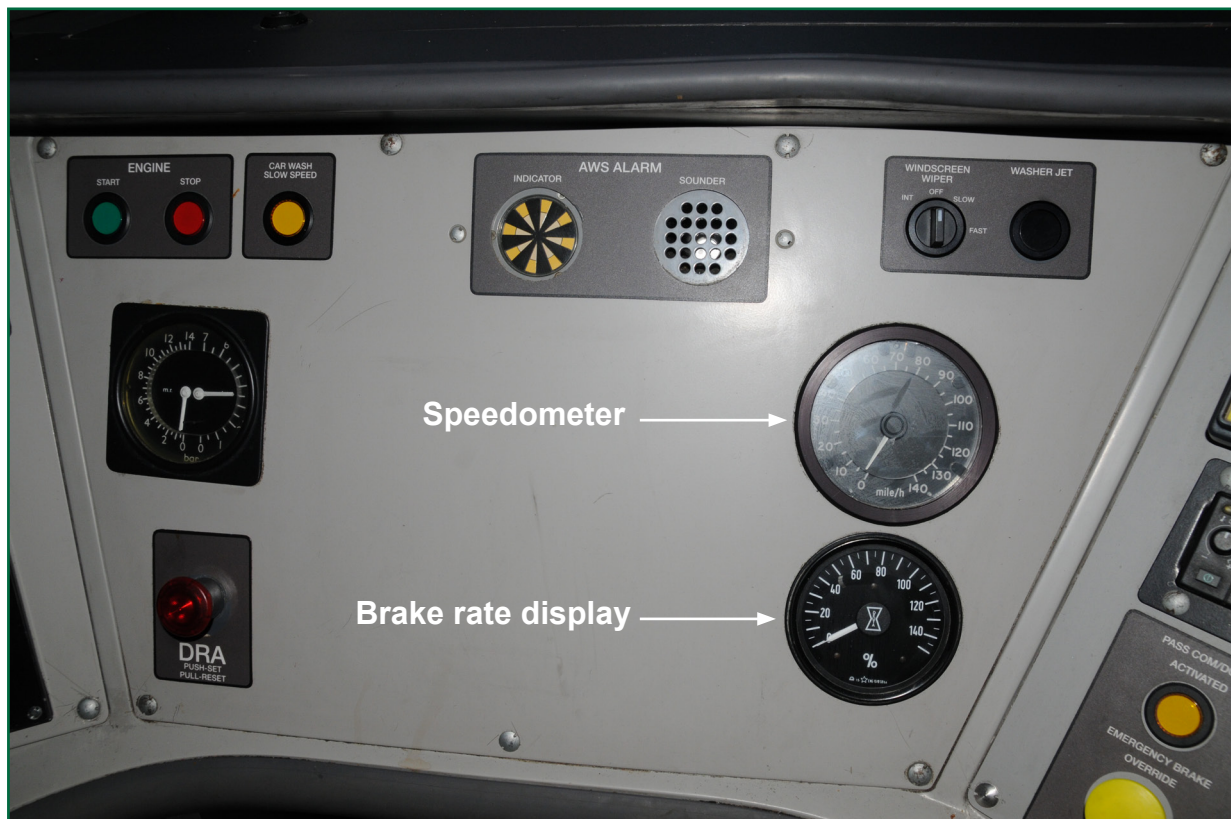
Figure 8: Driver's desk showing speedometer and brake rate display (photo courtesy of BTP)

- 67 The BCU on the leading vehicle also provides the speed output signal to the speedometer and provides an indication of the retardation rate being achieved, which is displayed to the driver on a gauge below the speedometer on the driver’s control desk (figure 8).

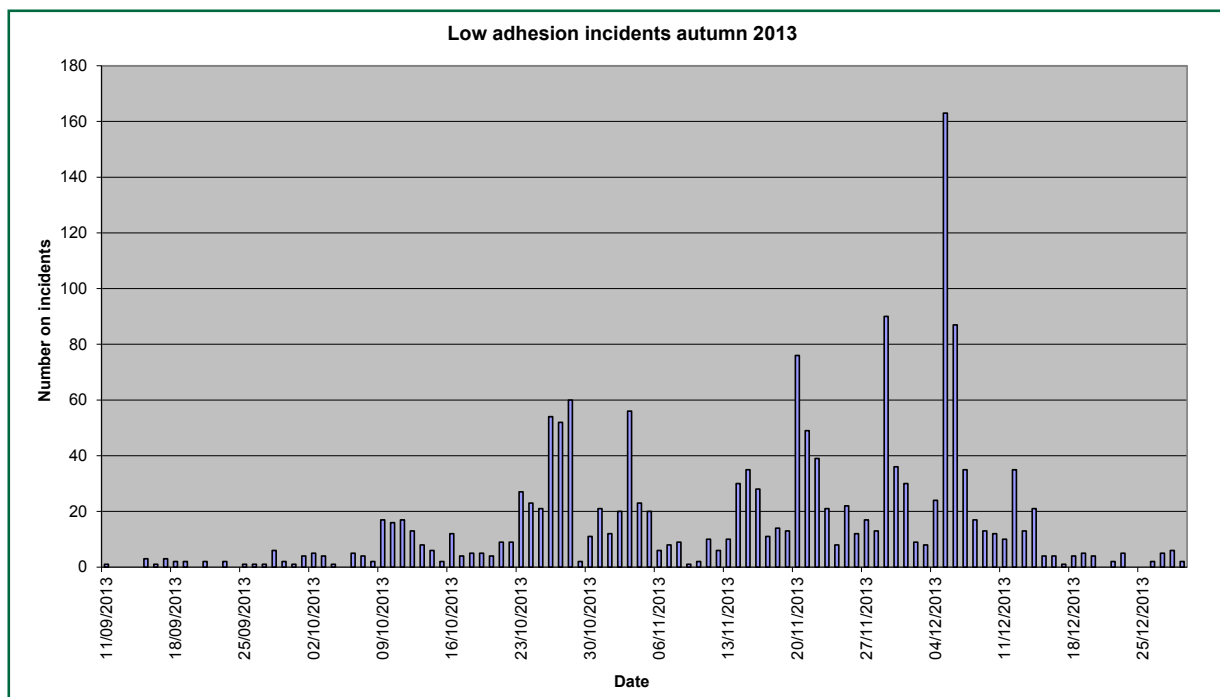
Figure 11: Number of low adhesion incidents recorded in CCIL each day during autumn 2013

- Leaf fall;
 - Freight Adhesion Issues (Leaf Fall); and
 - Collision.
- 120 The data was reviewed to ensure that only incidents involving low adhesion were included in the analysis (some station overruns, for example, were due to the driver forgetting that the train was booked to stop there). The number of incidents occurring each day is plotted in figure 11 and shows that there are several peaks which are likely to correspond to poor weather events. There were 76 low adhesion events on 20 November. This was the fourth highest number on a single day during autumn 2013.

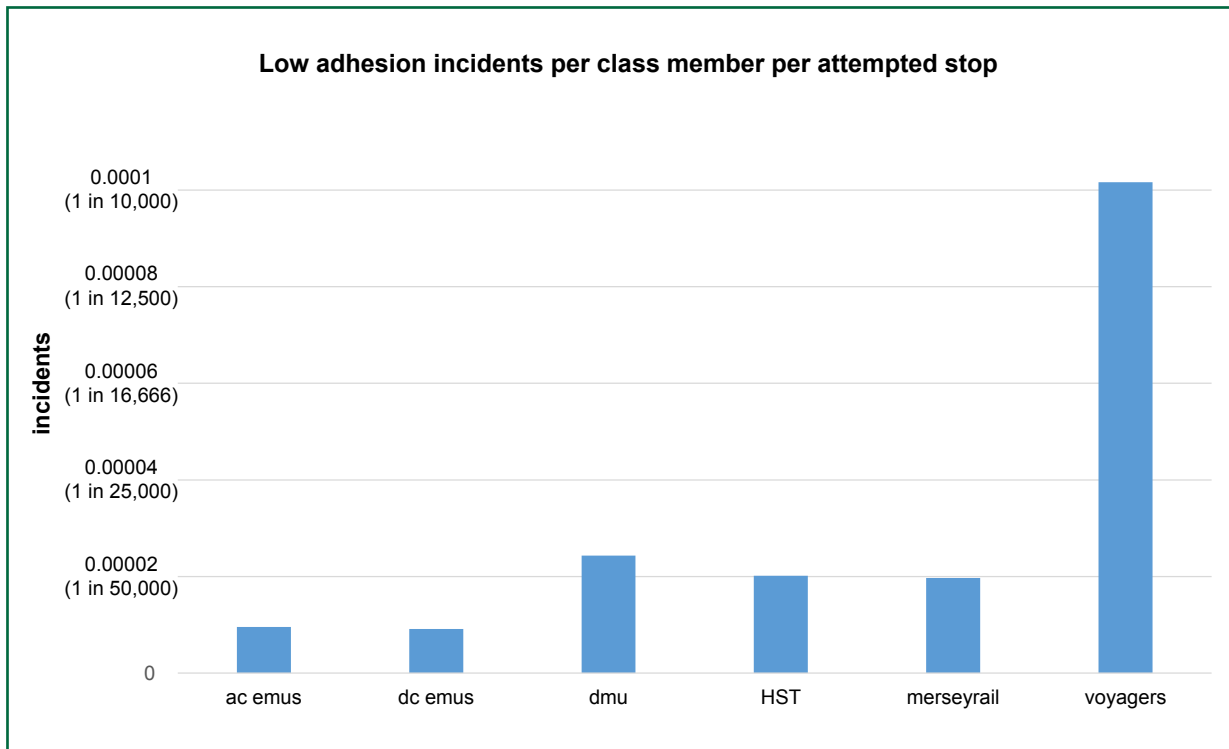
Figure 12: Number of low adhesion incidents by type of train

122 The number of low adhesion braking events for each generic group was normalised by the total number of units of that type on the network to give the number of low adhesion braking events per unit. The results were further normalised by the typical number of stops per hour that each type of train is scheduled to make (as an indicator of how often a train is exposed to the potential for a low adhesion event during braking). This normalisation was only approximate as the *diagrams* worked by the trains vary within each class. The figures used for this normalisation are given in appendix C. The results of the normalisation of the low adhesion incident data for autumn 2013 are given in figure 12. This indicates that the Voyagers (classes 220 and 221) are significantly more likely to be involved in a low adhesion incident each time they attempt to stop than any other classes of train.
