Rail Accident Investigation Branch

# Rail Accident Report

## **Collision at New Addington on Croydon Tramlink, 23 November 2005.**

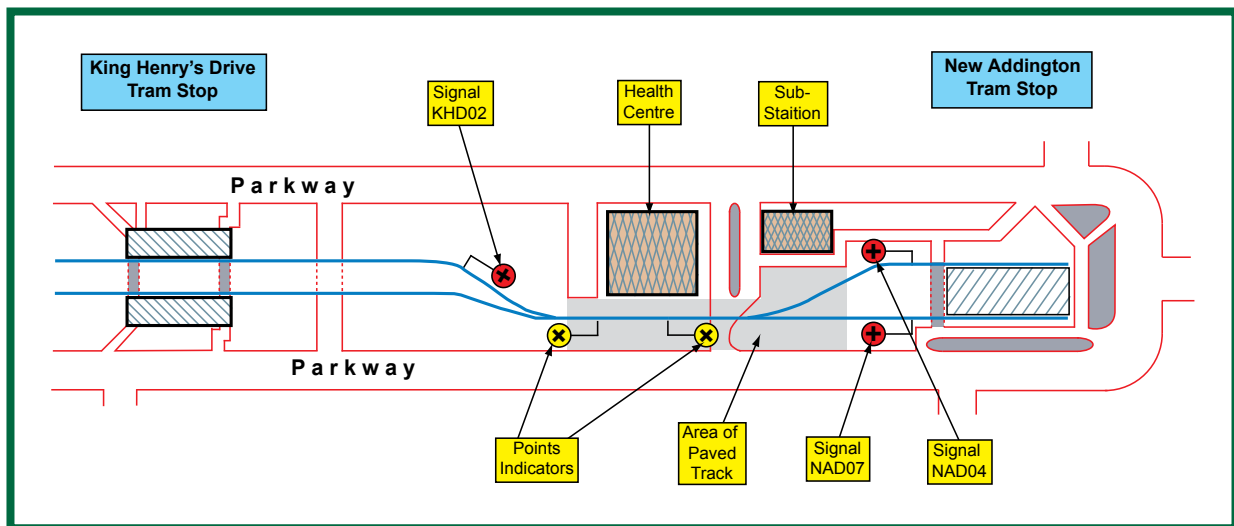
Figure 4: Diagrammatic representation of the line between King Henry's Drive and New Addington

- 21 The single track section is located immediately north-west of the New Addington terminus; the reason for this is its proximity to a building (used as a Health Centre) where there is inadequate room for double track. It is located on the apex of 0.68% and 0.63% rising gradients from New Addington and King Henry's Drive respectively. A shallow right hand curve is apparent on departure from New Addington. The entry to the single line is controlled by a motorised point and NAD04 and NAD07 signals at New Addington and a *spring point* and KHD02 signal from King Henry's Drive. *Points Indicators* are provided at both ends of the single line. Good sighting of the collision point is possible from at least 50 m distance under conditions of moderate visibility.

- 22 The entry to the single line at New Addington is controlled by signals at each end. The controls are triggered by track-located sensors, one at King Henry's Drive tramstop and one adjacent to KHD02 signal. Similar sensors are provided at New Addington. Apart from the sensor at King Henry's Drive tramstop which operates automatically, a proceed request is activated by the driver initiating a 'Ready-to-Start' signal from the cab. The system normally operates on an automatic first come – first served basis, although manual over-ride from the control centre at Therapia Lane Depot is possible.
