Rail Accident Investigation Branch

Rail Accident Report

**Derailment at Trooperslane near Carrickfergus,
Northern Ireland
23 April 2006**

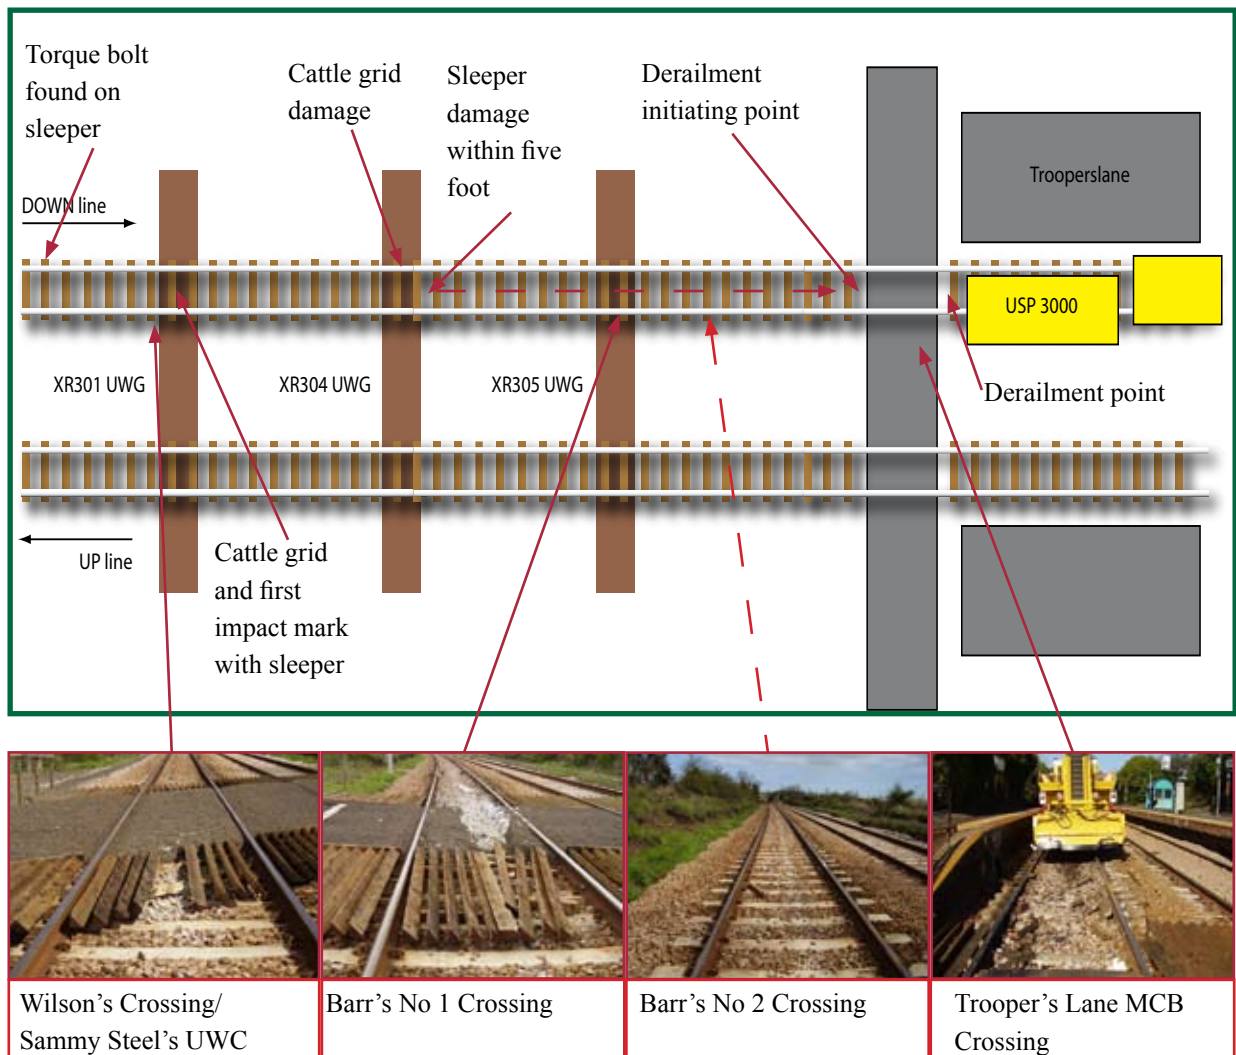
Figure 7 Detailed diagram showing immediate incident route prior to derailment

- 62 As the train passed over crossing X301 (7 miles 163 metres) (Figure 7) the guard became aware of bad riding of the regulator. Ballast and chippings from the crossing sprayed out and upwards from around the front axle towards the ballast regulator cab. He initially thought this had been caused by person(s) unknown throwing stones at the cab.

- 123 The cattle grids either side of the UWC X301, 304 and 305 had fractured and splintered, which corroborated witness testimony about the chippings and ballast hitting the underside of the regulator at UWC crossing X301 and the bad ride encountered from there to Trooperslane (See Figures 7 and 11).
- 124 The securing pin was found at 7 miles 45 metres (see paragraph 105) in the *cess* side of the running rail of the down line on a concrete sleeper.
- 125 There was no damage to the track between the immediate area of UWC X301 and 6 miles 1700, nor between that point and York Road depot
- 126 A track walk and visual search for the missing castellated nut and split pin was undertaken between York Road depot and 7 miles 46 metres but they were not located.

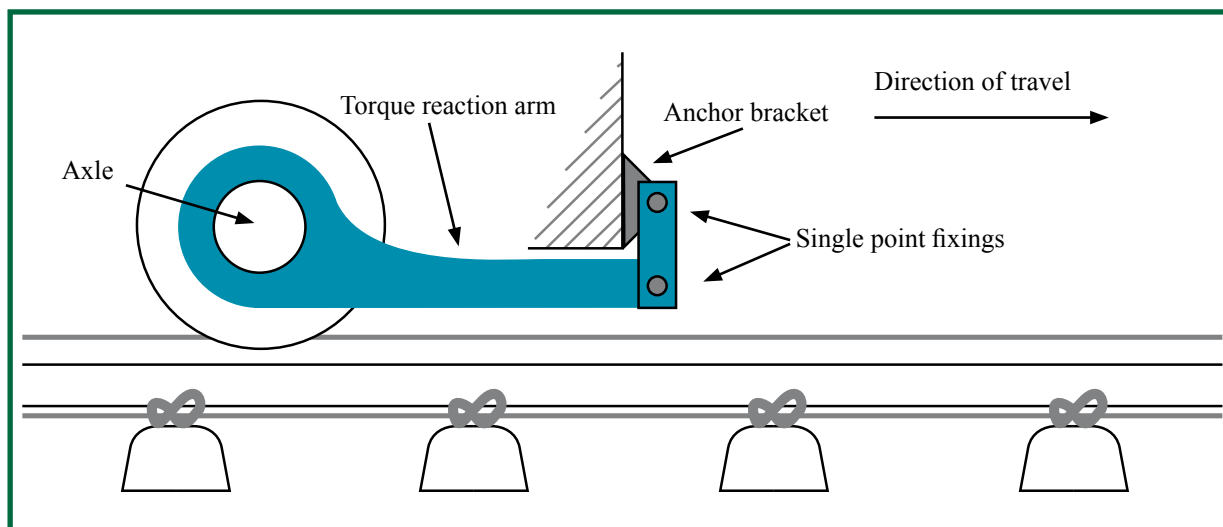
- 97 The gearbox drives the rotation of the regulator’s wheels. This creates an opposing torque, and this is resisted by a torque arm that prevents the gearbox from rotating (Figure 8).
- 98 The torque arm is attached to the axle of the ballast regulator which was leading in the direction of travel on 23 April 2006. The torque arm extends forward from the axle to the front of the machine where it is held by the headstock (Figure 9).

Figure 8: Schematic cross-section through regulator viewed from right in direction of travel. The torque reaction arm is shown in position linking powered axle to anchor bracket mounted on headstock
