Rail Accident Investigation Branch

# Rail Accident Report

**Near miss involving a track worker at Tinsley  
Green Junction  
17 March 2007**

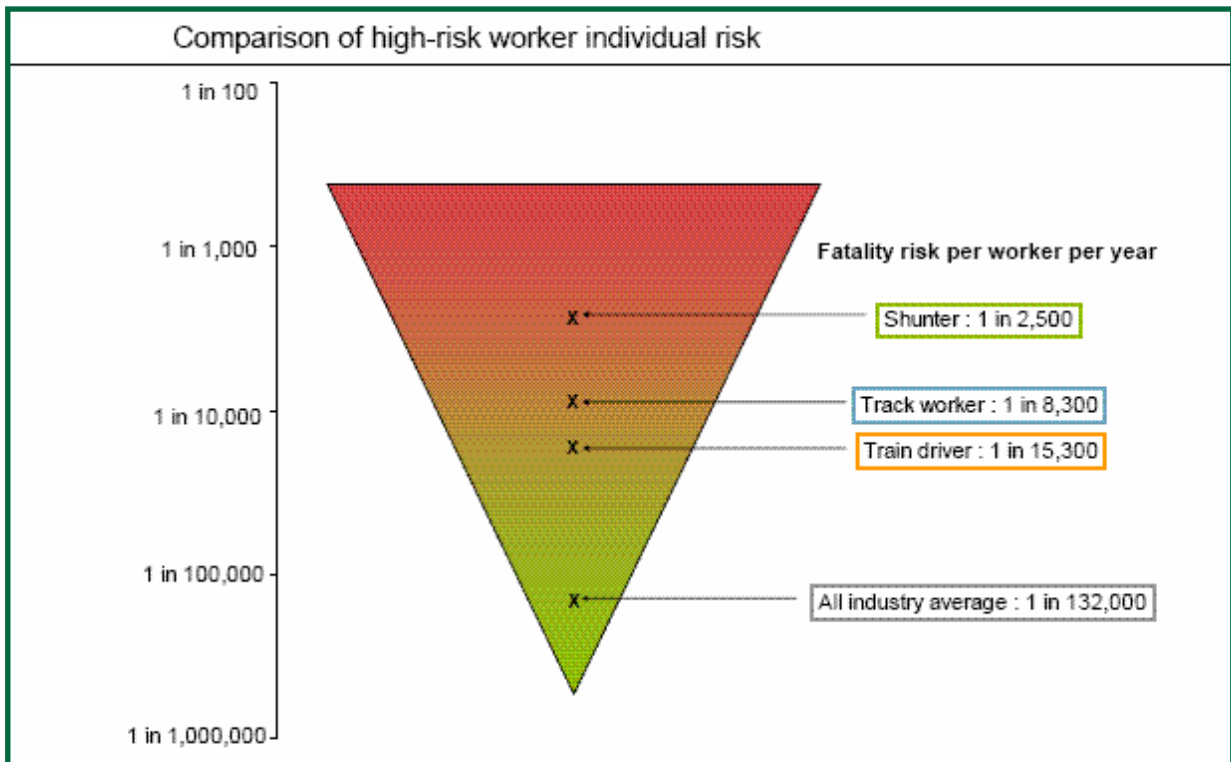
Figure 4: Levels of individual risk (extract from RSSB Annual Safety Performance report)

- 53 Track workers are subject to levels of risk well in excess of the average for all workers in the railway industry. The RSSB Annual Safety Performance Report (provisional) for 2006 concludes that the risk of fatality per track worker per year is 1 in 8,300 (see Figure 4). This compares to 1 in 15,300 for train drivers and 1 in 132,000 average for all workers in the industry.

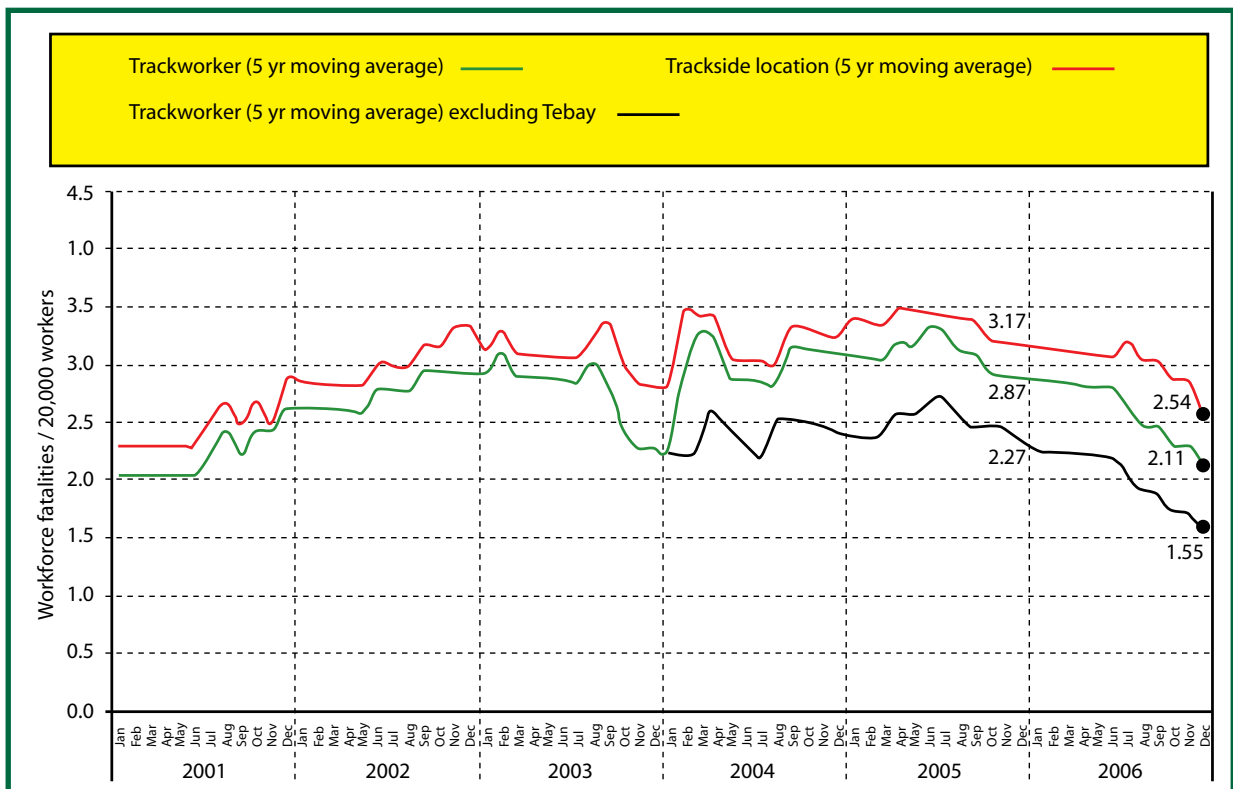
Figure 5: Track worker fatality rates normalised by staff numbers (data provided by RSSB)

- 54 Statistics provided by the RSSB show that the 5-year moving average track worker fatality rate (normalised by staff numbers) for 2006 was roughly similar to that in 2001 (see Figure 5). However, this average was influenced by the four fatalities that occurred in 2004 as a direct consequence of a criminal act at Tebay. If the impact of this single event is excluded from the data, the track worker fatality rate is calculated to have fallen by 25 percent between 2001 and 2006.
