Rail Accident Investigation Branch

# Rail Accident Report

**Derailment in Hooley Cutting, near Merstham,  
Surrey  
13 January 2007**

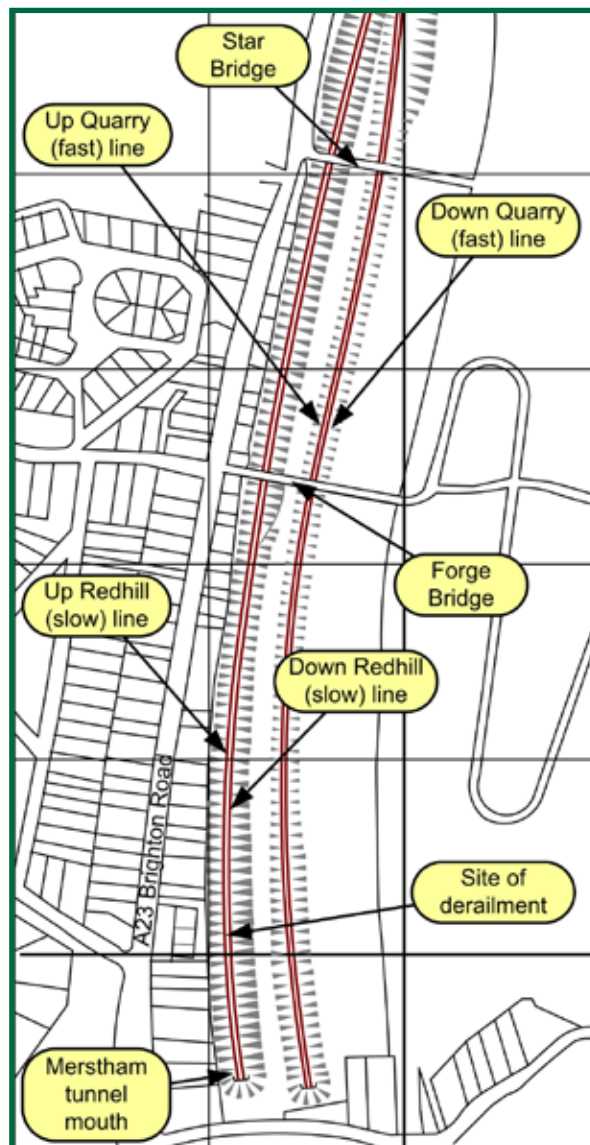
Figure 2: Drawing of railway lines in and around Hooley cutting

- 73 The area identified at highest risk lay between two road overbridges: Forge Bridge and Starr Bridge (Figure 2). Here a 500 mm reinforced concrete beam was installed at the top of the cutting. It was supported by a grid of concrete columns and beams supported by piles from the bottom and face of the cutting. A chain link catchment fence was installed at cess level along part of the route.

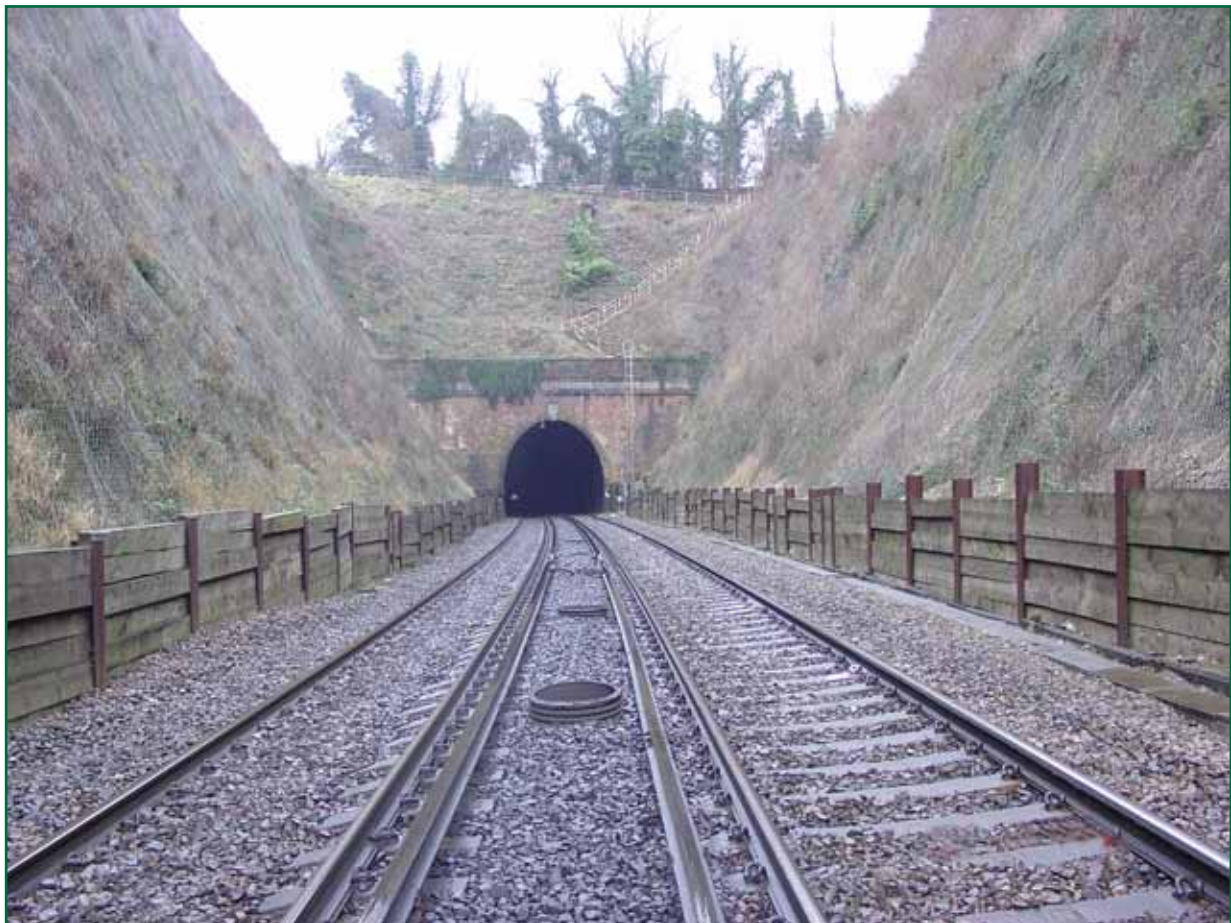
- 27 The track comprises *flat bottom rail* held by *Pandrol clips* to depressed centre concrete *sleepers*. The *ballast* is granite. Drainage inspection manholes are situated between the up and down lines, in the *6 foot*.
- 28 The cess to the left of the up line is bounded by a king post wall which is formed of timber horizontals slotted into vertical steel I beams (Figure 7). The timber horizontals are not linked together. They are removable to permit clearance of rock and soil debris, and vegetation from behind them (see also paragraph 75).

Figure 7: Hooley cutting viewed from the site of the derailment looking towards the tunnel mouth.

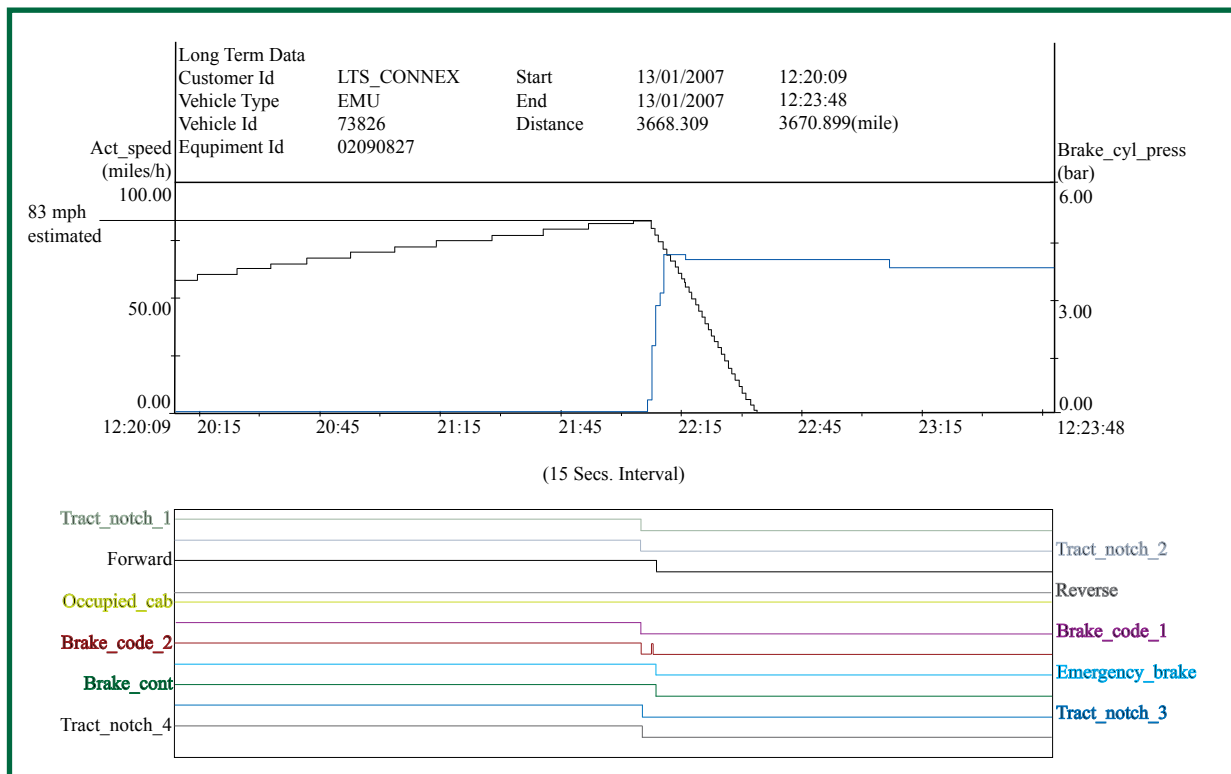
Figure 10: Output from the OTDR

- 32 The train was fitted with a Secheron *On-Train Data Recorder* (OTDR). This was downloaded at Selhurst depot and provided details of the train speed and the status of power and braking functions immediately before the collision (Figure 10).

- 36 At 11:50 hrs the driver joined train 1C23 at Horsham, relieving another driver who had driven the train from Bognor Regis.
- 37 Train 1C23 had an uneventful journey from Bognor to Horsham. Following a stop at Redhill the train commenced its diagrammed fast run to East Croydon via the Redhill lines with 413 passengers on board. The train speed increased to a maximum of 83 mph (132 km/h) inside Merstham tunnel, below the permitted line speed of 90 mph (144 km/h).
