Rail Accident Investigation Branch

Rail Accident Report

Runaway and collision at Armathwaite 28 January 2007

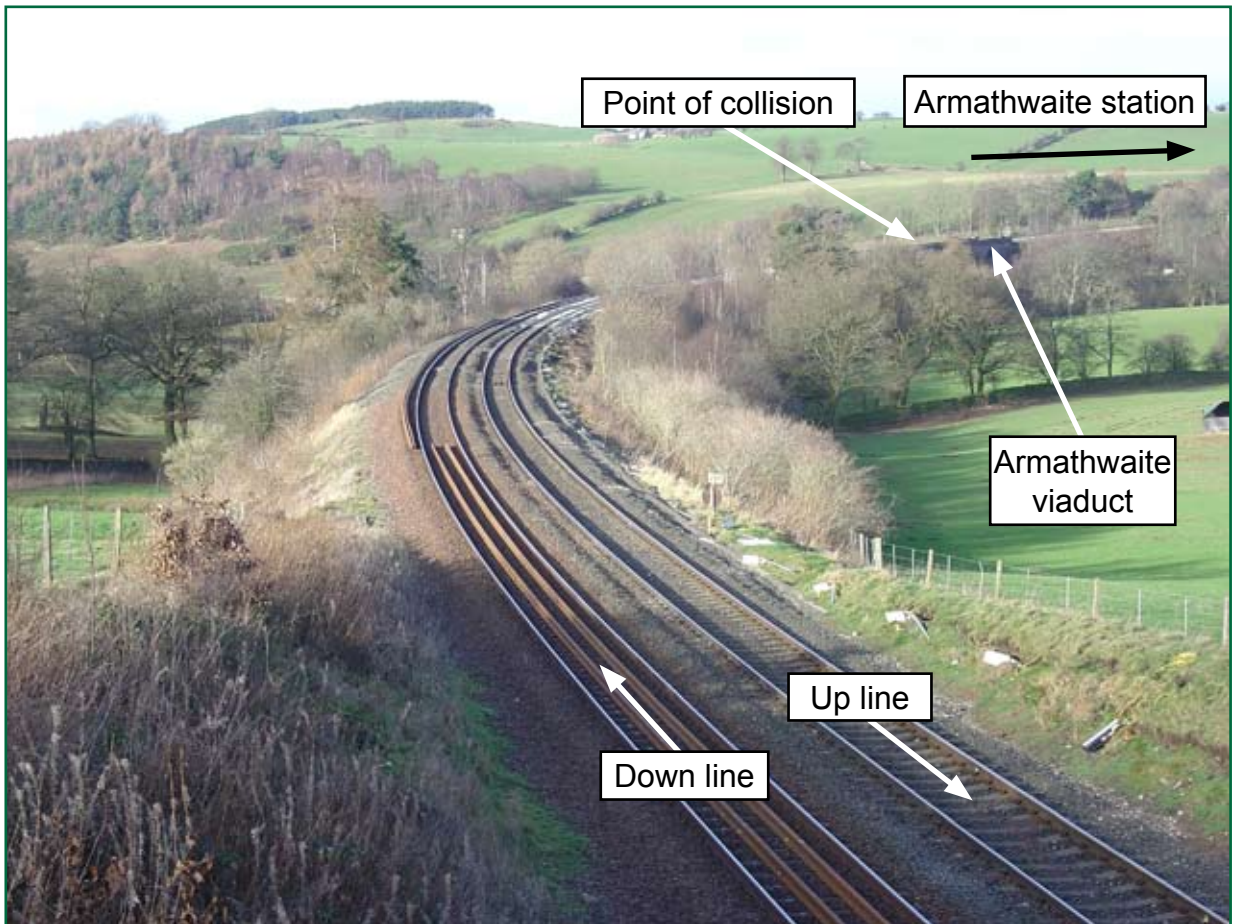
Figure 3: View north towards Armathwaite viaduct

- 21 The collision occurred on the down line at the south end of Armathwaite viaduct at 297 miles 23 *chains*. This was just south of Armathwaite station (298 miles 9 chains) on the line which runs from Settle Junction at 234 miles 44 chains, to Petheril Bridge Junction, Carlisle, at 307 miles 12 chains. Figure 2 shows the location and Figure 3 is a view north from overbridge 319 towards Armathwaite viaduct.
- 22 Going south, the gradient of the line through Armathwaite station is a maximum of 1 in 217 falling, followed by a short section of level track at Armathwaite viaduct, followed by a rising gradient at a maximum of 1 in 155.

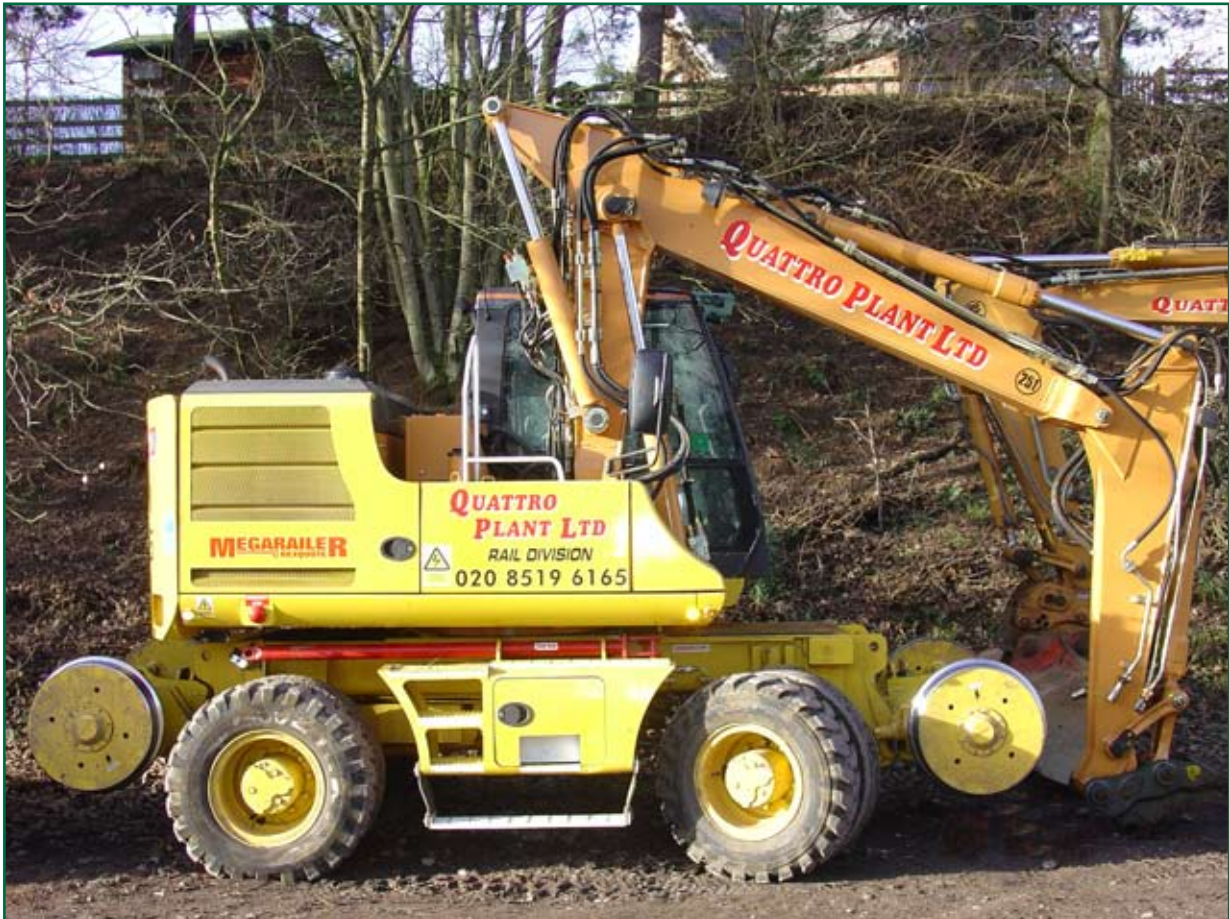
Figure 6: Case 170 RRV number 251

- 31 The RRV involved in the collision was a Case Poclairn WX170 excavator/crane, converted for operation on rail by Rexquote Ltd. It was numbered 251 in the fleet numbering system operated by Quattro Plant Ltd. Figure 6 shows the RRV.

- 49 From both witness evidence and subsequent calculations carried out by the RAIB, the speed at impact is likely to have been around 27 km/h (17 mph).
- 50 The impact caused the leading bogie of the salmon wagon to derail and pushed the RRV back along the railway by about 3 metres (3.28 yds).
- 51 The RRV was only superficially damaged, but the thimble being used to position the new rail was broken. Minor damage was caused to the salmon wagon including a snapped off brake pipe *air cock* and lamp bracket, and bogie springs in the leading derailed bogie that had come out of position. Figure 10 shows the consequences of the collision.
- 52 The RRV operator who had remained in his cab, although not injured, was shaken up as a result of the collision.
