Rail Accident Investigation Branch

# Rail Accident Report

## Collision with the gates at Lydney Town level crossing 15 August 2007

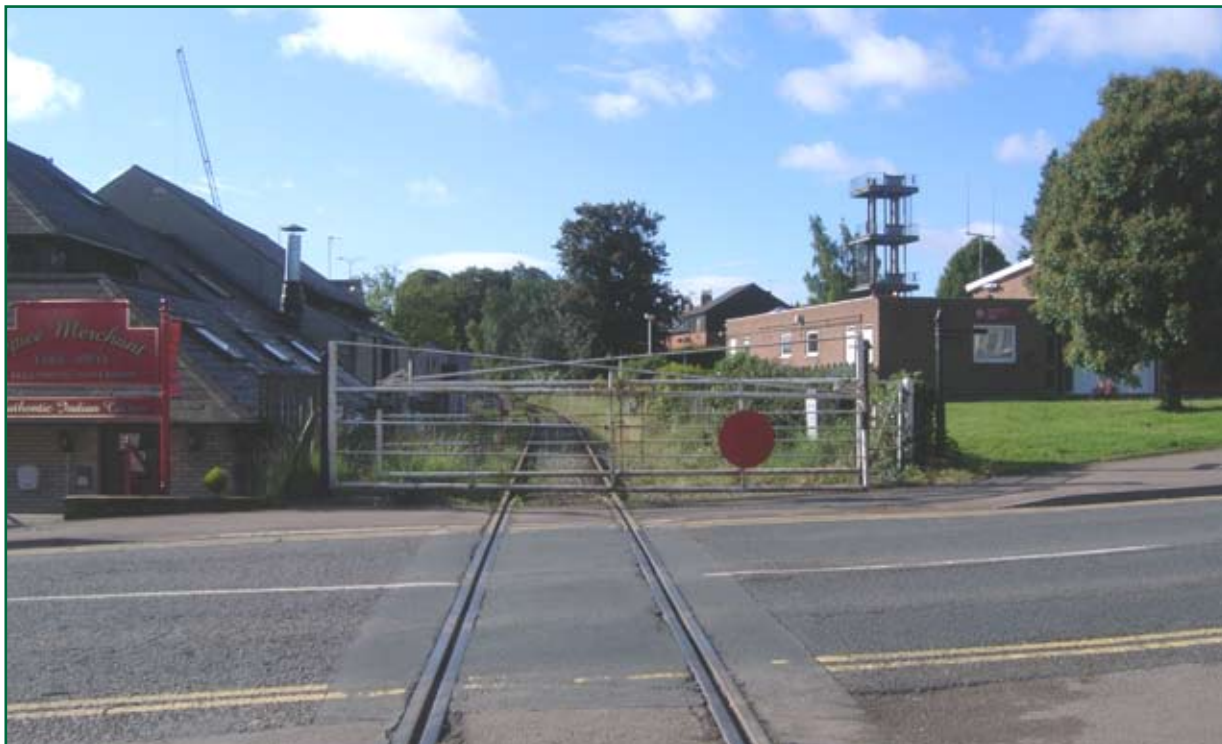
Figure 3: Lydney town crossing looking south

- 25 Lydney Town level crossing is a gated crossing on Hill Street, which is the main road through the centre of the town of Lydney (Figures 3 & 4). Before the Lydney by-pass was built in the 1980s, Hill Street was part of the A48, and although it is no longer a classified road it still carries substantial road traffic. When the crossing is closed to the road to allow a train to cross, road traffic quickly backs up on both sides.

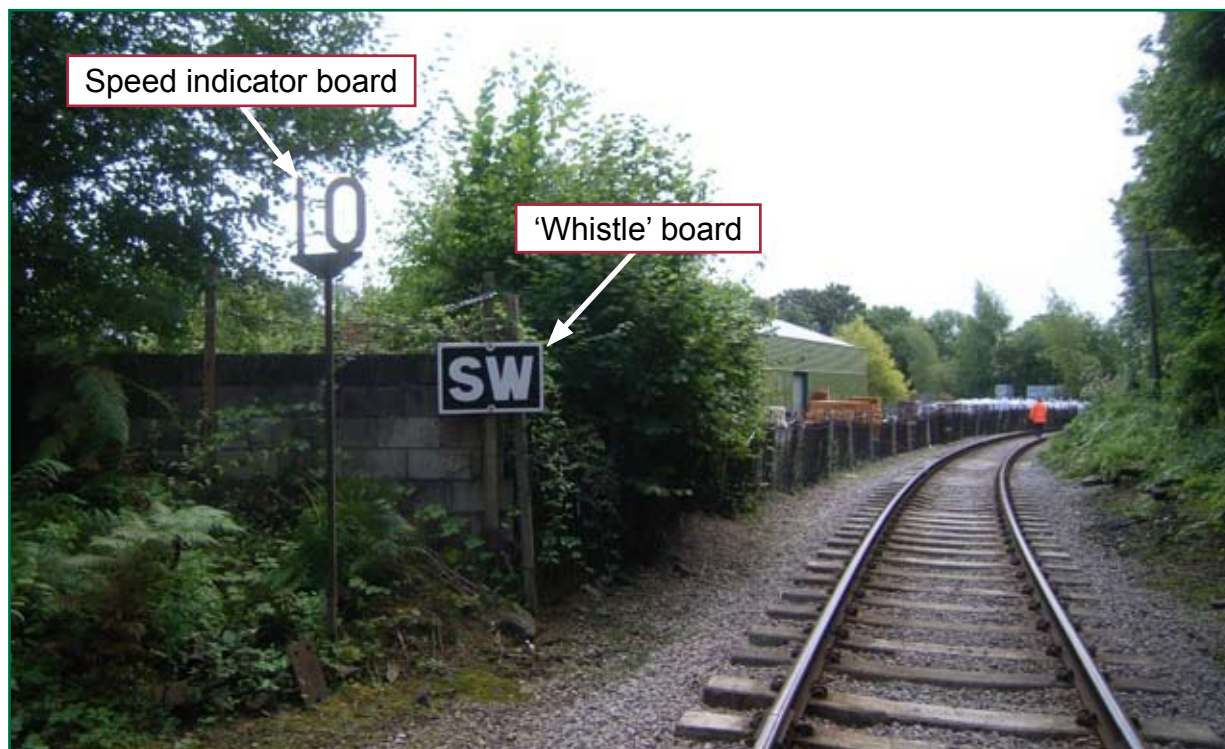
Figure 7: Speed indicator board and 'Whistle' board

- Reduce speed to 10 mph (16 km/h) at a speed indicator board. This is located to the left of the line, as seen by a train driver, 183 metres (200 yards) from the crossing (Figure 7).

- Sound a warning at a 'Whistle' board (denoted by the letters 'SW') located close to the speed indicator board (Figure 7).
  - Look out for the crossing gates and any hand signal from the crossing keepers. The gates come into the driver's view when the train is 119 metres from the crossing.

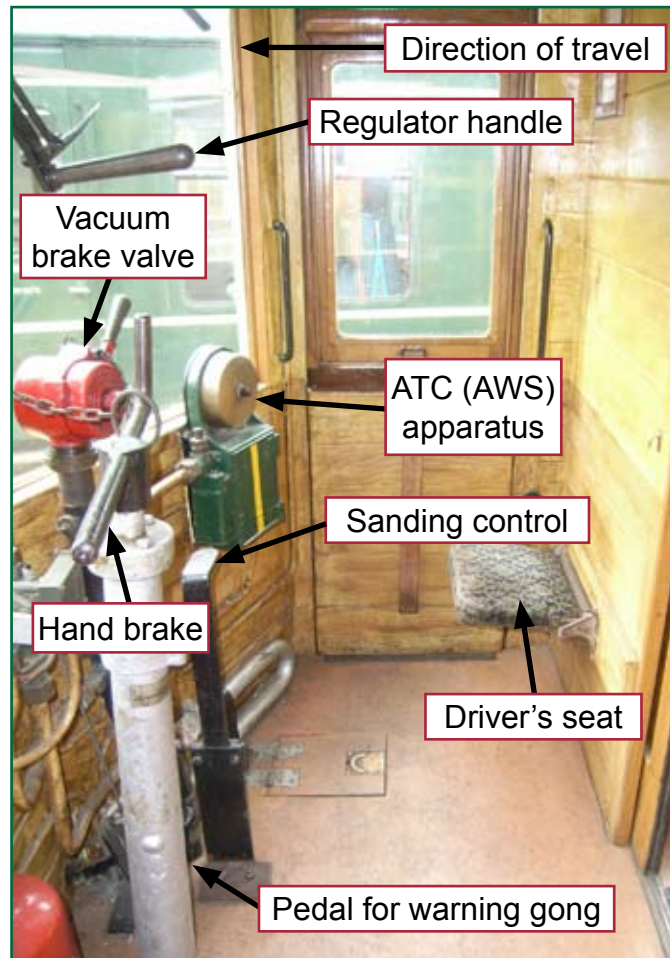
- 45 When the driver wishes the fireman to release the brakes by creating vacuum, he should give two rings on the electric bell between the autococh and locomotive to tell the fireman to release the brakes. The bell was not in working order on the day of the accident, so the engine whistle (operated by a wire from the cab of the autococh) was being used for communication instead.

Figure 13: Driver's position in Autococh. Bell and whistle controls are above front window, to left of picture

101 The autococh driving cab arrangement is shown in Figure 13. The driver is normally standing or seated towards the right hand side of the cab, looking forward. The views from the cab on the day of the accident were reported as being good with no observable windscreen contamination.
