Rail Accident Investigation Branch

Rail Accident Report

Derailed at Grayrigg 23 February 2007

Derailment at Grayrigg, 23 February 2007

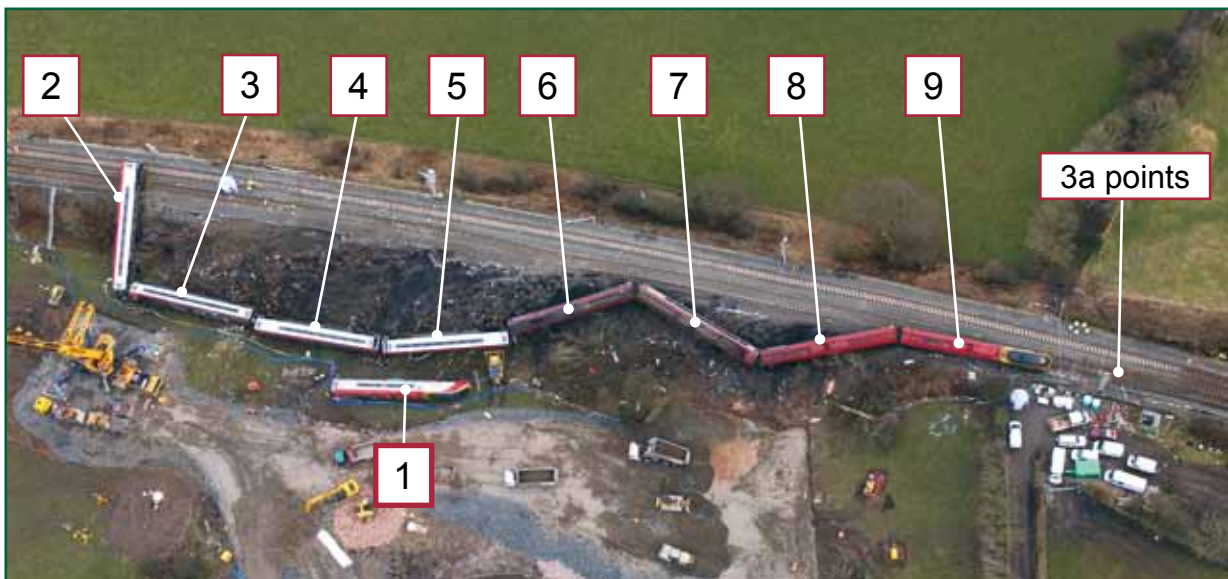
Figure 2: Aerial view of derailed train

- 13 The train derailed as it passed over 2B points which were in an unsafe state. A combination of failures of *stretcher bars* and their joint to the *switch rails* allowed the left-hand switch rail to move, under its natural flexure, towards the left-hand *stock rail*. The left-hand wheels of either the first or second *bogie* on the leading vehicle (it is not clear which) passed the wrong side of the left-hand switch rail and were forced into the reducing width between the switch rails. The wheels then derailed by climbing over the rails. All the other vehicles of the train derailed as a consequence. Figures 3 and 4 show the key details of the points.

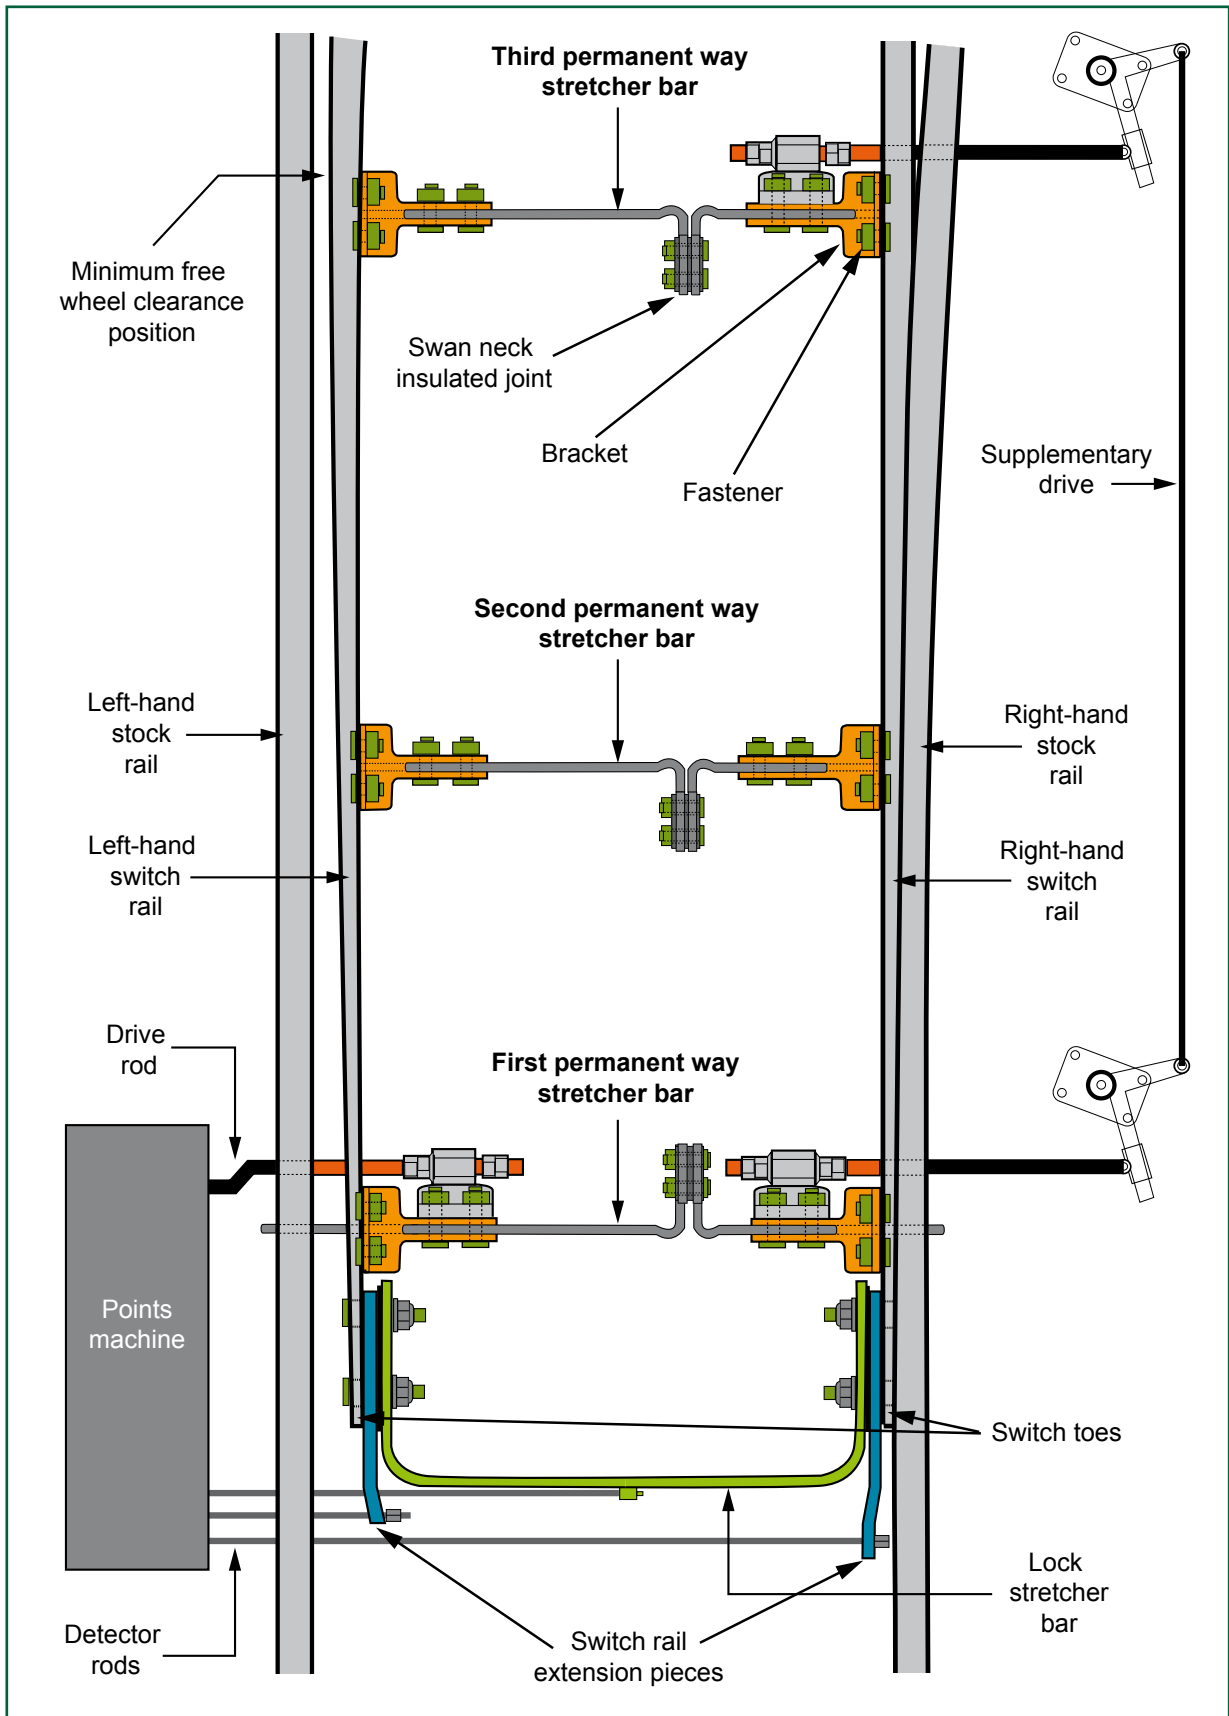
Figure 3: Layout of points showing switch and stock rails and stretcher bars

- 15 The bolts holding the third permanent way stretcher bar to the right-hand switch rail became loose, and subsequently completely undone. As a result of this, and the excessive residual *switch opening*, the left-hand switch rail was struck by the inner faces of passing train wheels, giving rise to large cyclic forces. As a consequence, rapid deterioration of the condition of the remaining stretcher bars and their *fasteners* occurred. This led to the left-hand switch rail becoming totally unrestrained.

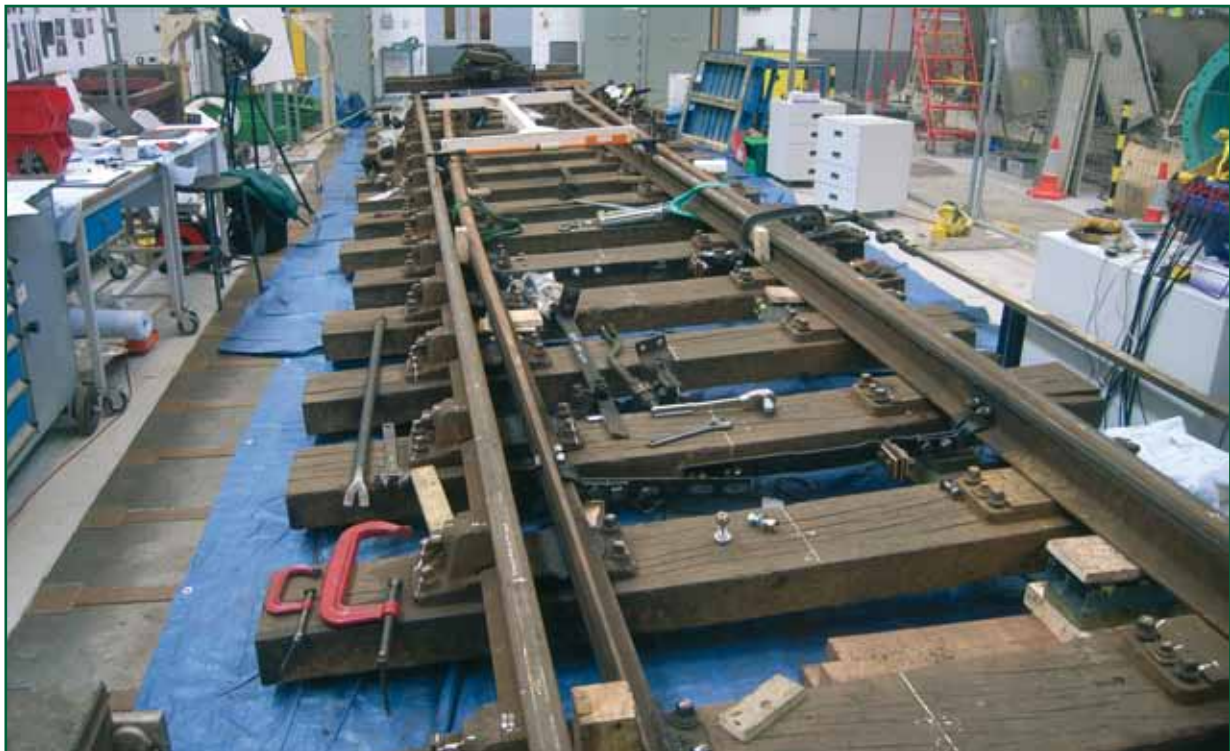
Figure 6: Points 2B switch section in laboratory

- The RAIB carried out all other aspects of evidence collection.
- 101 Following detailed on-site surveying, photography, measurement of the track under unloaded and loaded conditions, examination of the signalling system, taking of forensic samples and recovery of detached items of evidence in the vicinity, the whole switch section of 2B points (Figure 6) was secured for transport and removed as a complete panel to a secure laboratory for testing and analysis.

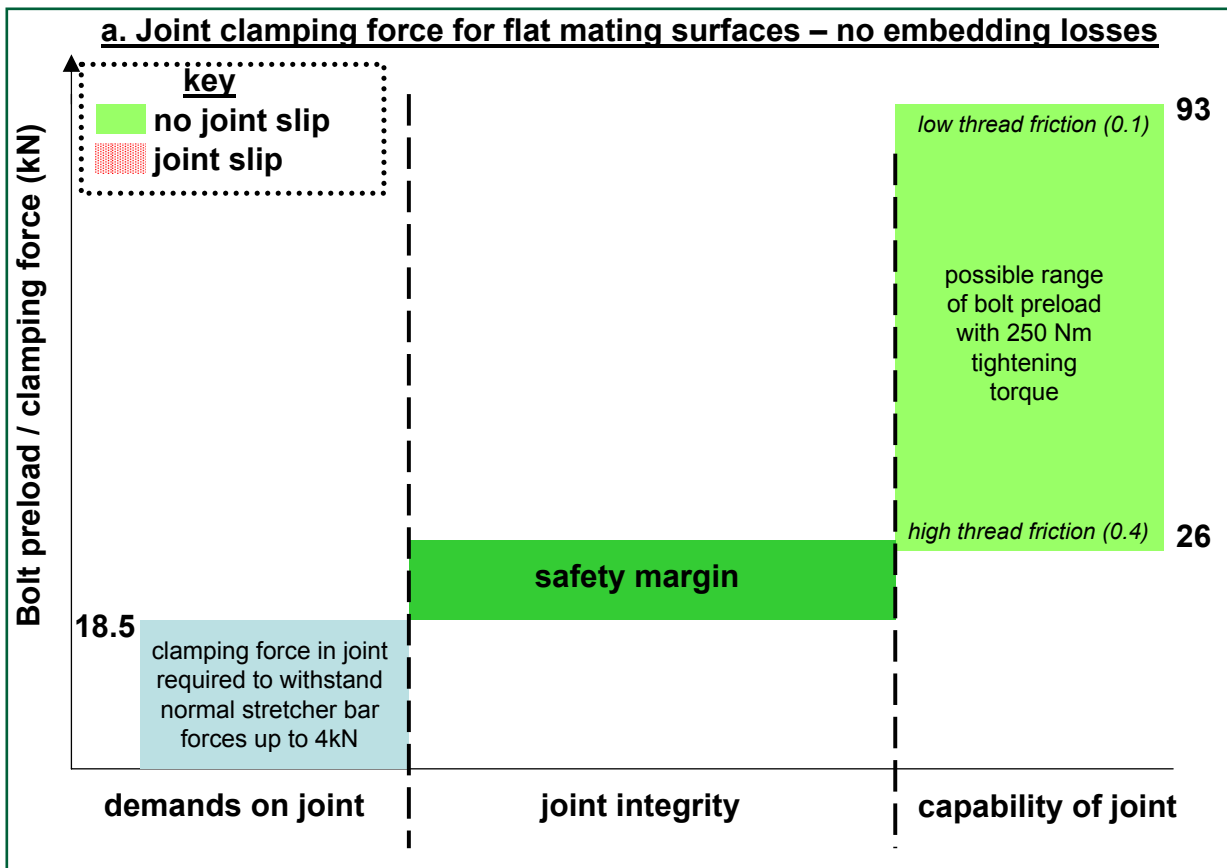
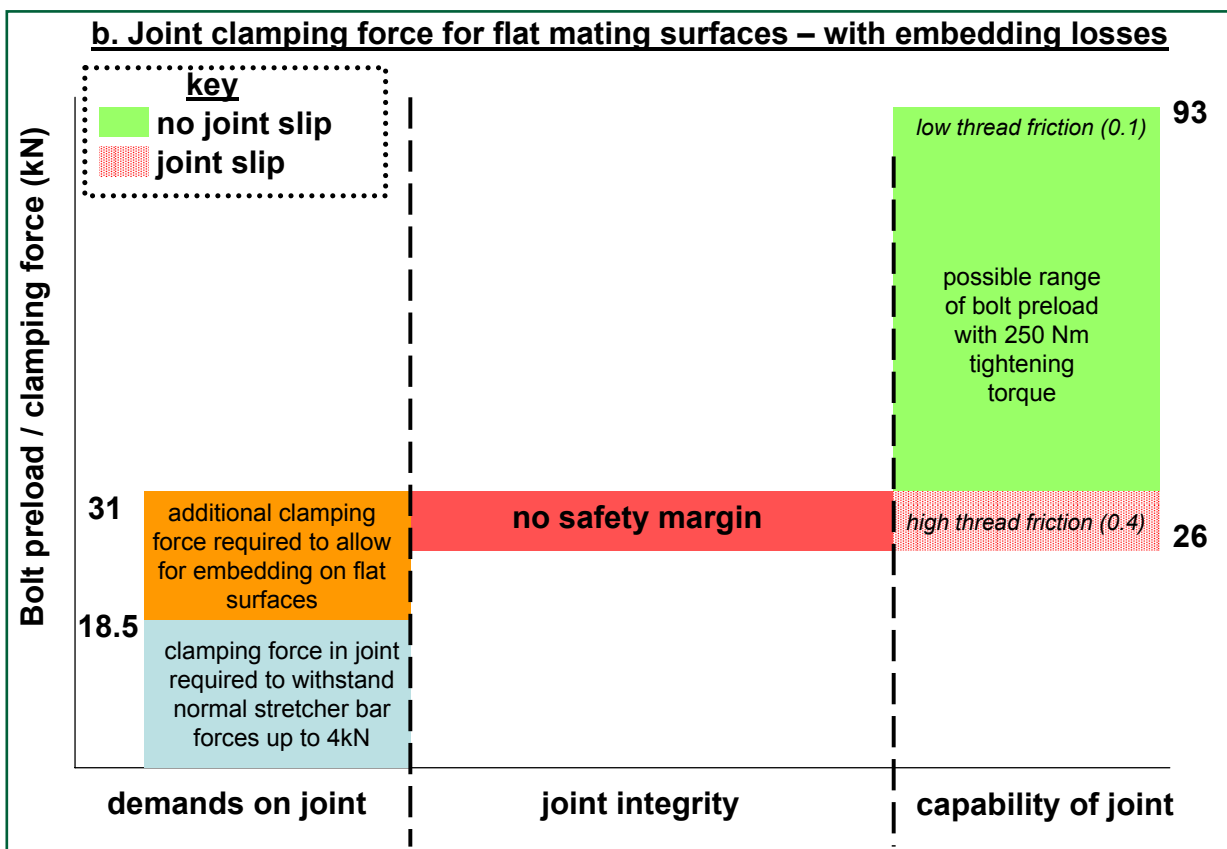
Figures 28a and 28b: The relationship between clamping force required to withstand realistic service loads and the clamping force achieved

- 74 Class 390 Pendolinos were designed for a maximum operating speed of 140 mph (225 km/h) and run on, among other routes, the WCML between London Euston and Glasgow Central. They began operating on this route in January 2004. The design features a tilt system to maintain a comfortable passenger environment while the train is negotiating curves at higher speeds than conventional rolling stock.

- 149 The range of preloads achievable by the fastener was calculated to be between 26 kN and 93 kN. This was based on the 250 Nm tightening torque and a realistic range of friction (Appendix E). The relationship between the 31 kN minimum clamping force required to resist slip and the range of achievable clamping forces is shown in Figure 28b. This shows that for points of a similar configuration and traffic loading as 2B points, even if fully tightened, a safety margin cannot be guaranteed between the as-designed joint's clamping force and the forces it can experience in normal service, ie without any flange-back contact.

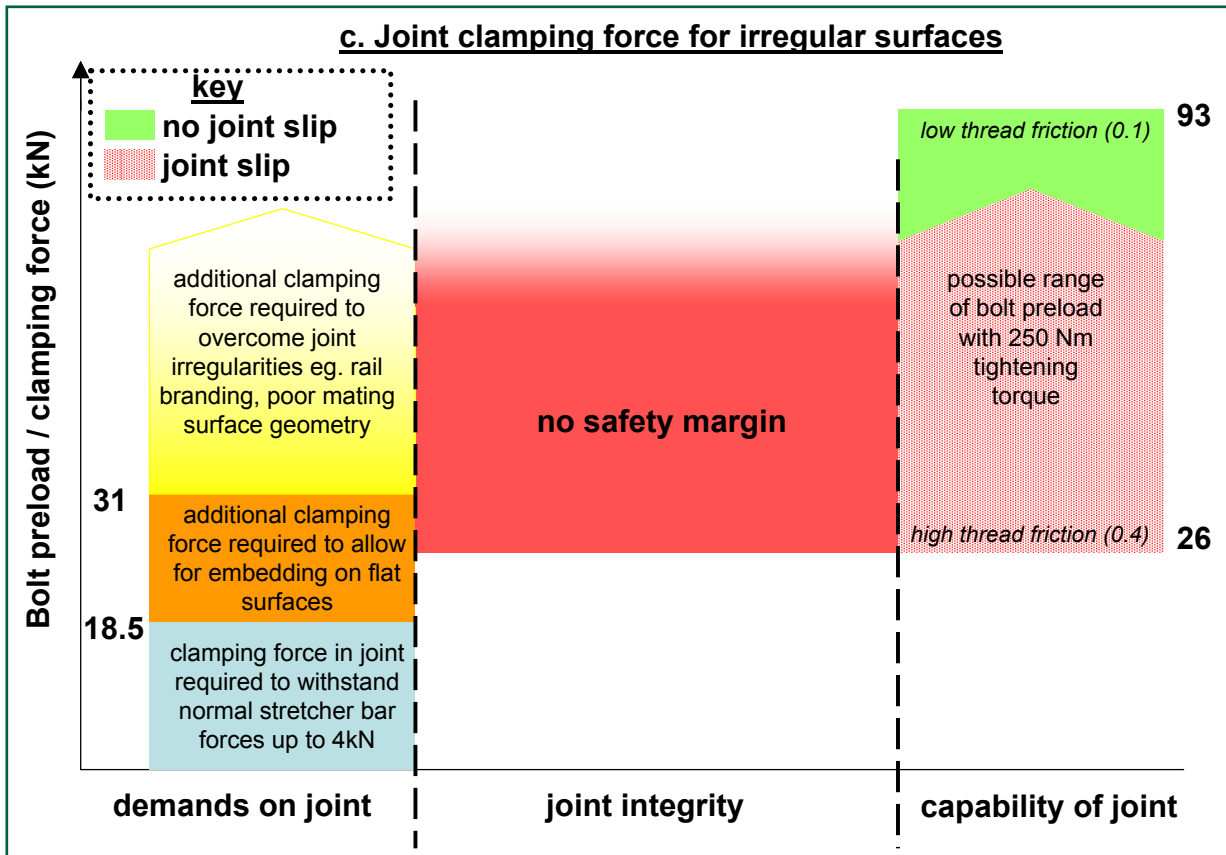
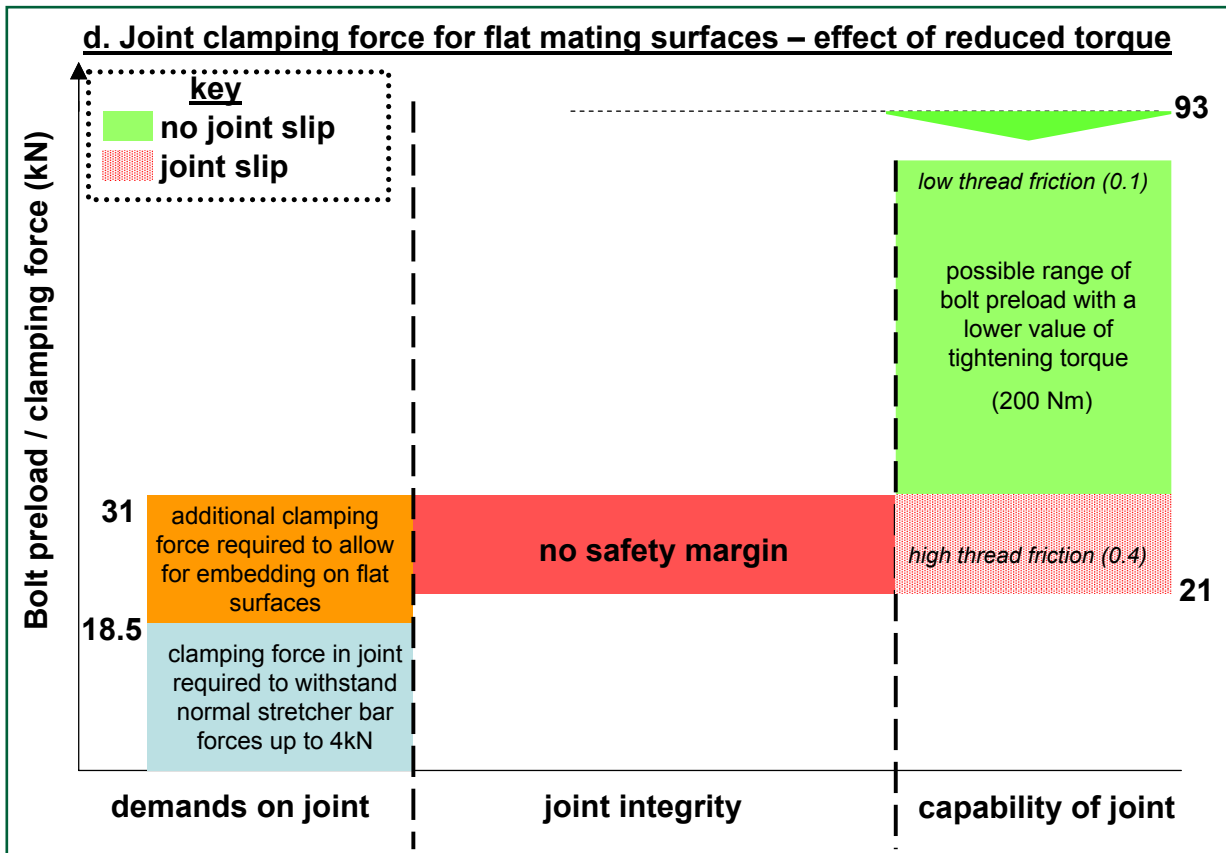
Figures 28c and 28d: The relationship between clamping force required to withstand realistic service loads and the clamping force achieved

- 150 This analysis is based on the nominal design, ie, flat mating surfaces, and the specified torque of 250 Nm. Other factors that may lead to plastic deformation of the surfaces and reduce the clamping force still further over time are described below (Figure 28c):

- 153 Tests undertaken by the RAIB on similar fasteners on other points found fastener torques as low as 20 Nm. The low torque indicated that there were significant reductions in the clamping forces in these joints, and an associated reduction in their resistance to slip failure (Figure 28d).

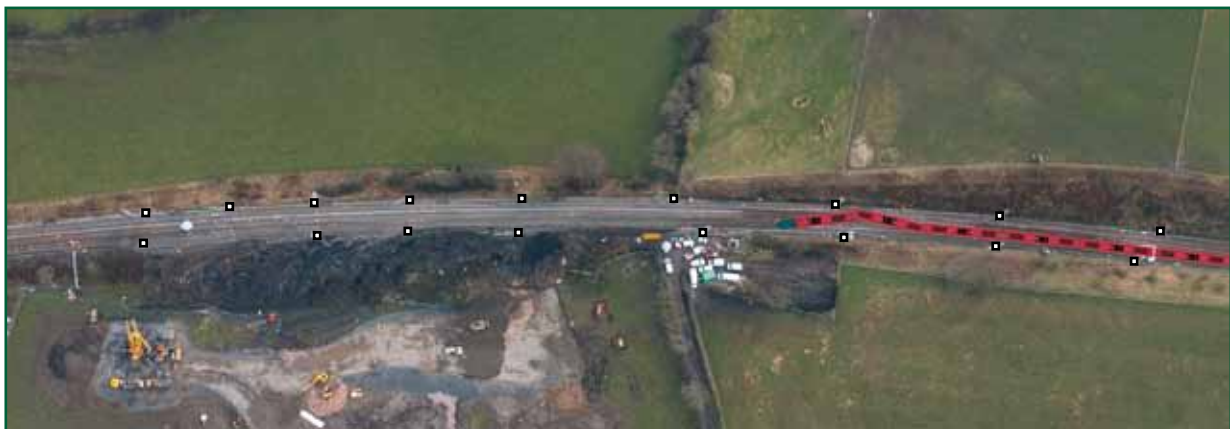
Figure 33: Diagram of the misalignment which developed between vehicles one, two and three after passing 2B points

540 Track damage showed that a number of wheelsets had crossed over and run close to, or in, the up line. These included wheels from bogie 2 and bogie 3. Whether or not bogie 1 derailed first, it stayed close to the down line and with bogies 2 and 3 running close to the up line, a misalignment formed between vehicles one, two and three, as shown in Figure 33.

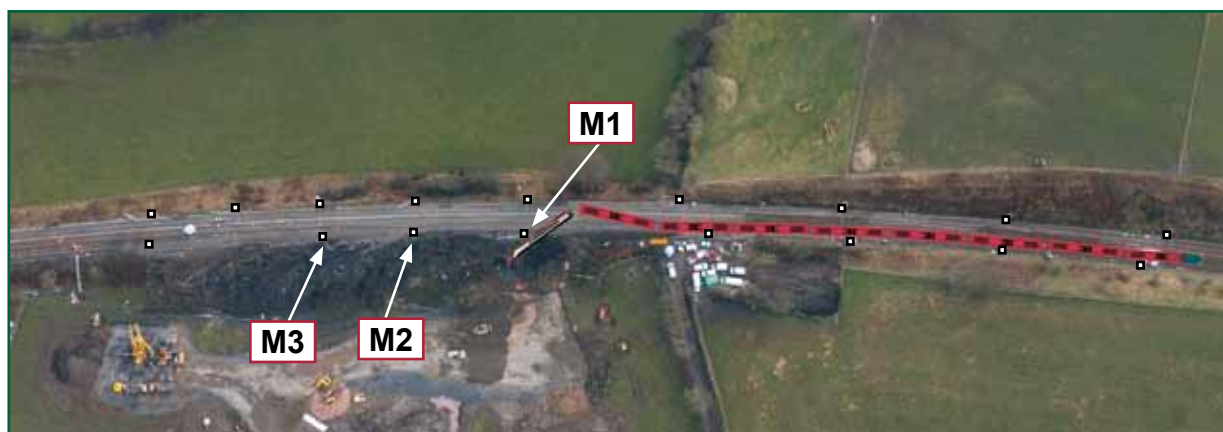
Figure 34: Diagram of vehicle one, partially rolled over and striking overhead line equipment mast M1

- 544 Vehicle one continued to yaw in an anticlockwise sense as it was pushed by the remainder of the train. When it was approximately perpendicular to the track and rolled over about 70 degrees onto its right-hand side, its trailing end struck mast M2 (Figure 34). More pushing from the vehicles behind it caused vehicle one to yaw even further until it lost contact with vehicle two and began to slide down the embankment slope. As it descended the embankment, it rolled over onto its side and continued to yaw. It came to rest at the foot of the slope, approximately 9 – 10 seconds after it first derailed, and having rotated through approximately 190 degrees to face backwards.

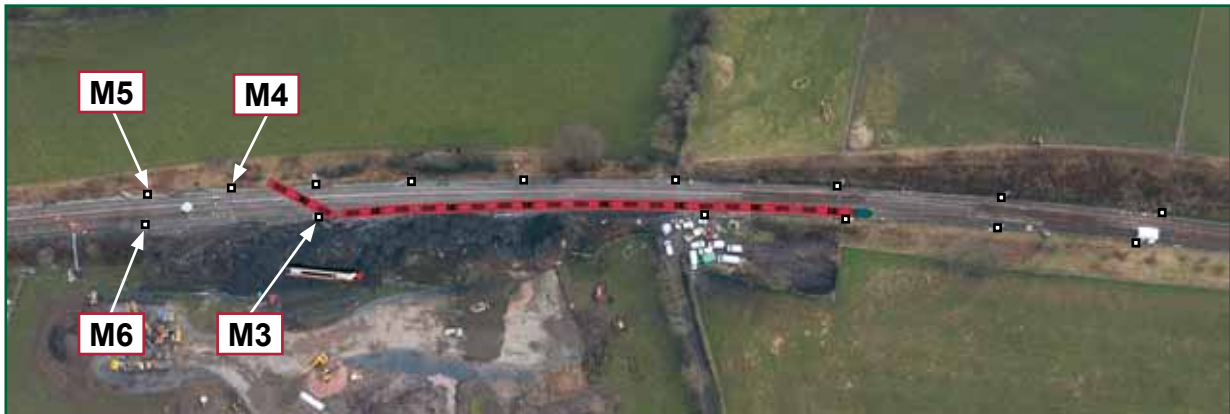
Figure 35: Reconstruction of vehicle two first striking overhead line equipment mast M3

545 Vehicle two, after becoming detached from the leading vehicle, continued to run misaligned and was pushed into yawing in a clockwise sense by the following vehicles. The trailing end of vehicle two struck overhead line equipment mast M3 as shown in Figure 35. Thereafter, it began to roll on to its left-hand side as the overturning forces resulting from the drag on its bogies increased. Its leading end then struck two overhead line equipment masts on the up line (M4 and M5 in Figure 35) and its centre section struck mast M6 on the down line. As it approached an orientation approximately perpendicular to the track, it was skidding on its left-hand side, perched on the crest of the embankment by the down line. Vehicle two came to rest shortly after with its trailing end at the foot of the embankment and its leading end overhanging the up line.

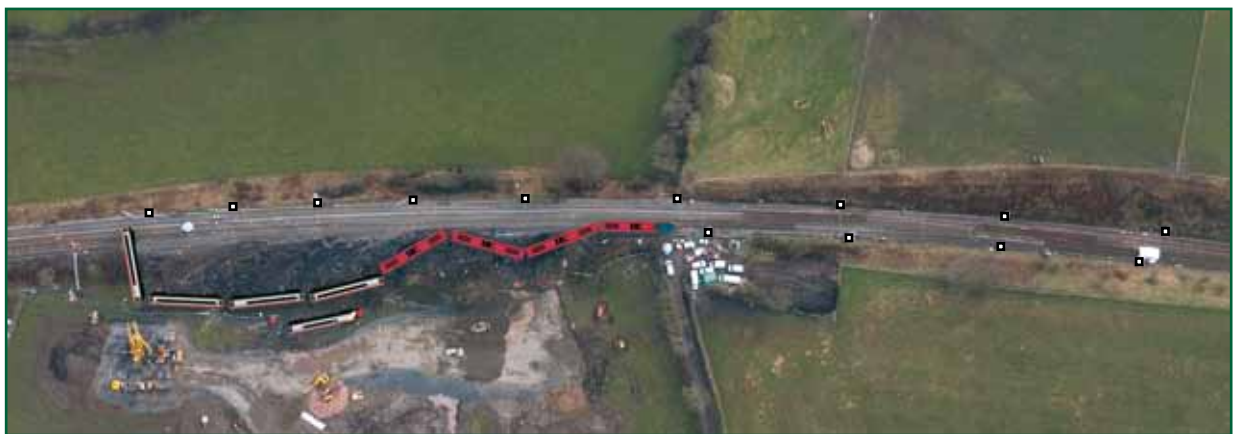
Figure 36: Final location of the vehicles from train 1S83 after the derailment

547 Vehicles six to nine remained coupled and followed the preceding vehicles, coming to rest variously orientated on the embankment slope and in the down cess, with the cab of vehicle nine just past the toes of 3A points. The leading bogie of vehicle six was found on top of the concrete block first struck by vehicle five and, which formed the foundation for mast M2. Figure 36 shows the final location of the vehicles. The time from the moment of the derailment until all the vehicles came to rest was approximately 13 seconds.

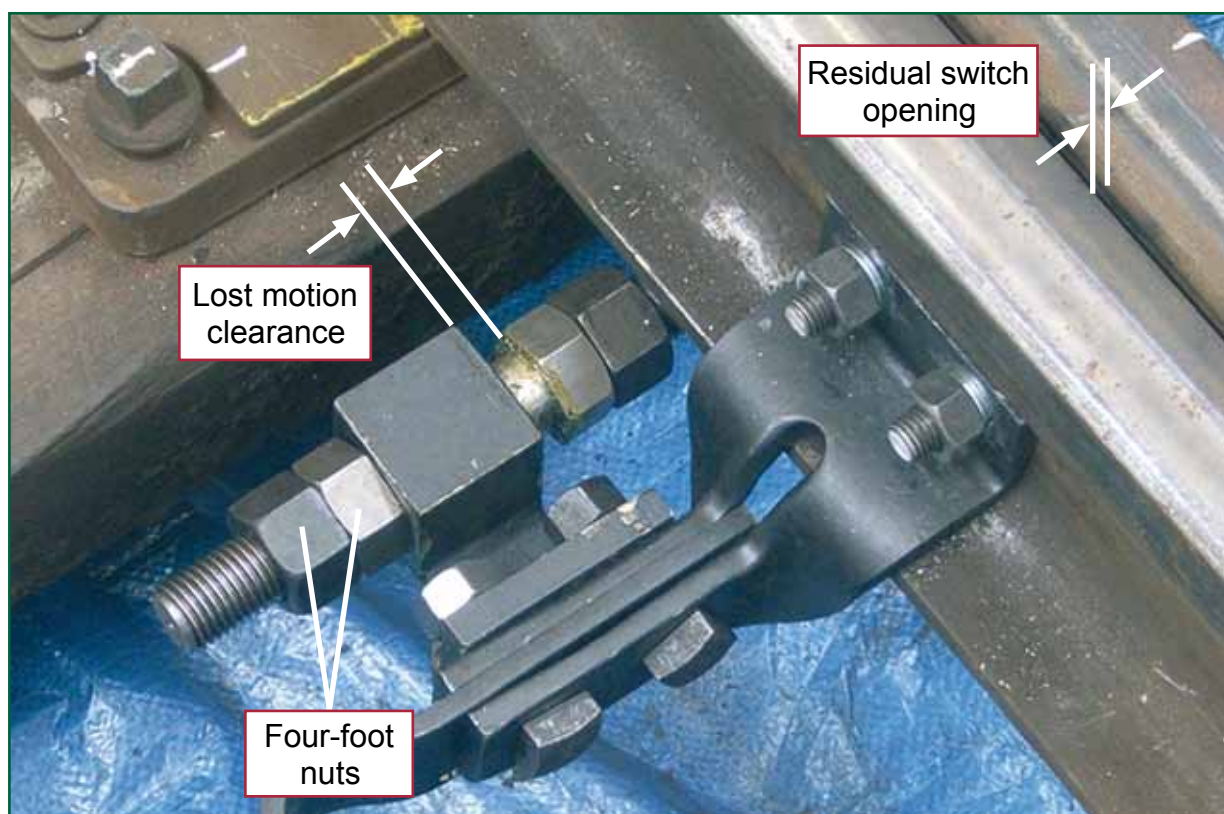
Figure 44: Escapement joint on a reconstructed stretcher bar

- 14 There is an escapement joint at the point of connection between the supplementary drive and the third permanent way stretcher bar (Figure 44). Clearances within this joint, known as lost motion, isolate the supplementary drive and the toes of the switches from any switch rail movements and associated forces induced by trains that could cause damage.

- 15 The adjustment of the clearance at the escapement joint allows installers and maintainers to alter the position of the closed switch rail relative to its adjacent stock rail. Any gap present between the two rails at this location is known as the residual switch opening (Figures 43 and 44). Network Rail found from experience that it was beneficial to have a small gap present between the rails at this location to prevent the points from seizing due to changes in temperature affecting the supplementary drive. Standard NR/GN/SIG/11772, applicable at the time of the accident, stated that the residual switch opening should be 1.5 mm; however, no tolerance or maximum figure was specified.

- 17 If the joint between the stretcher-bar bracket and the right-hand switch rail fails (marked as X on Figure 43), the left-hand switch rail will tend, due to its natural flexure, to relax towards its stock rail and hence reduce the free wheel clearance. The position the rail now adopts is controlled solely by its connection to the supplementary drive, and by the remaining stretcher bars. When trains pass with the stretcher bar in this condition, the closing of the residual switch opening will no longer increase the free wheel clearance, increasing the likelihood of flange-back contact. The degree of flange-back contact will be related to the position of the four-foot nuts of the escapement joint (Figure 44) since this determines the amount of residual switch opening prior to any joint failure.

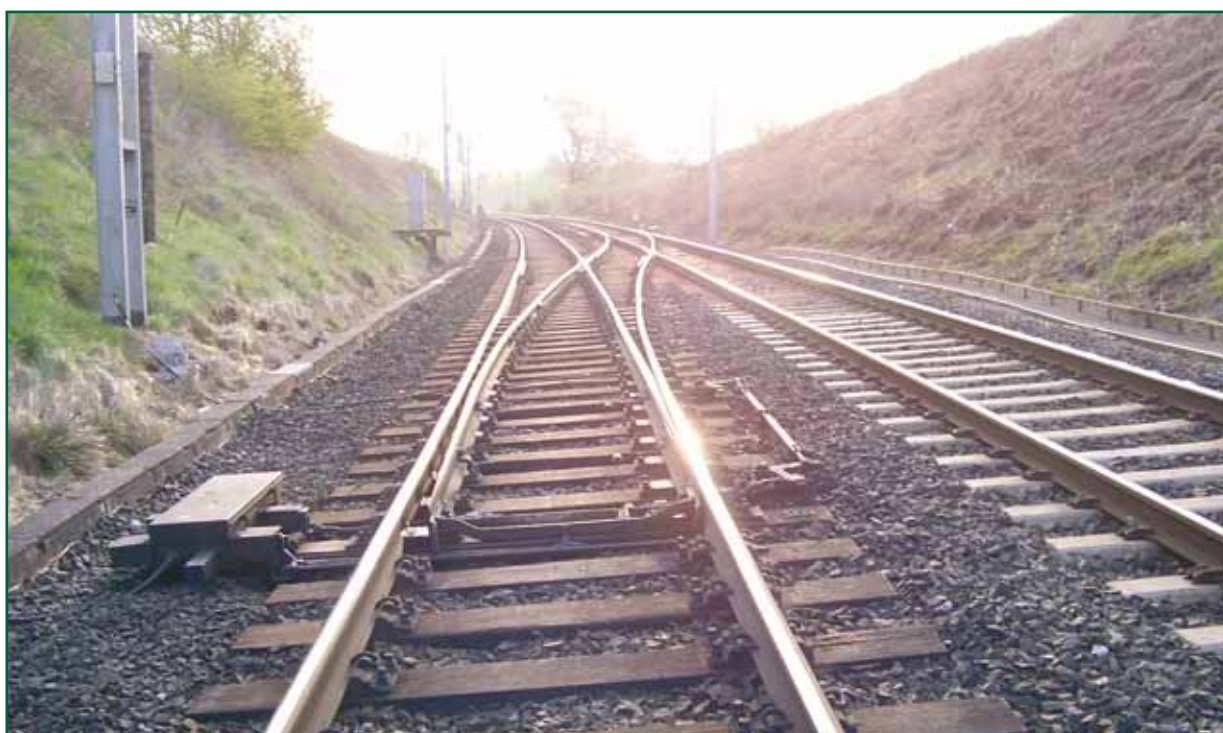
Figure 46: Lambrigg 2B points, May 2006 (courtesy of Network Rail)

- 5 A still photograph taken by a Network Rail engineer in May 2006, during a routine inspection of the track, gives evidence that an excessive gap was still in existence at that time (Figure 46).

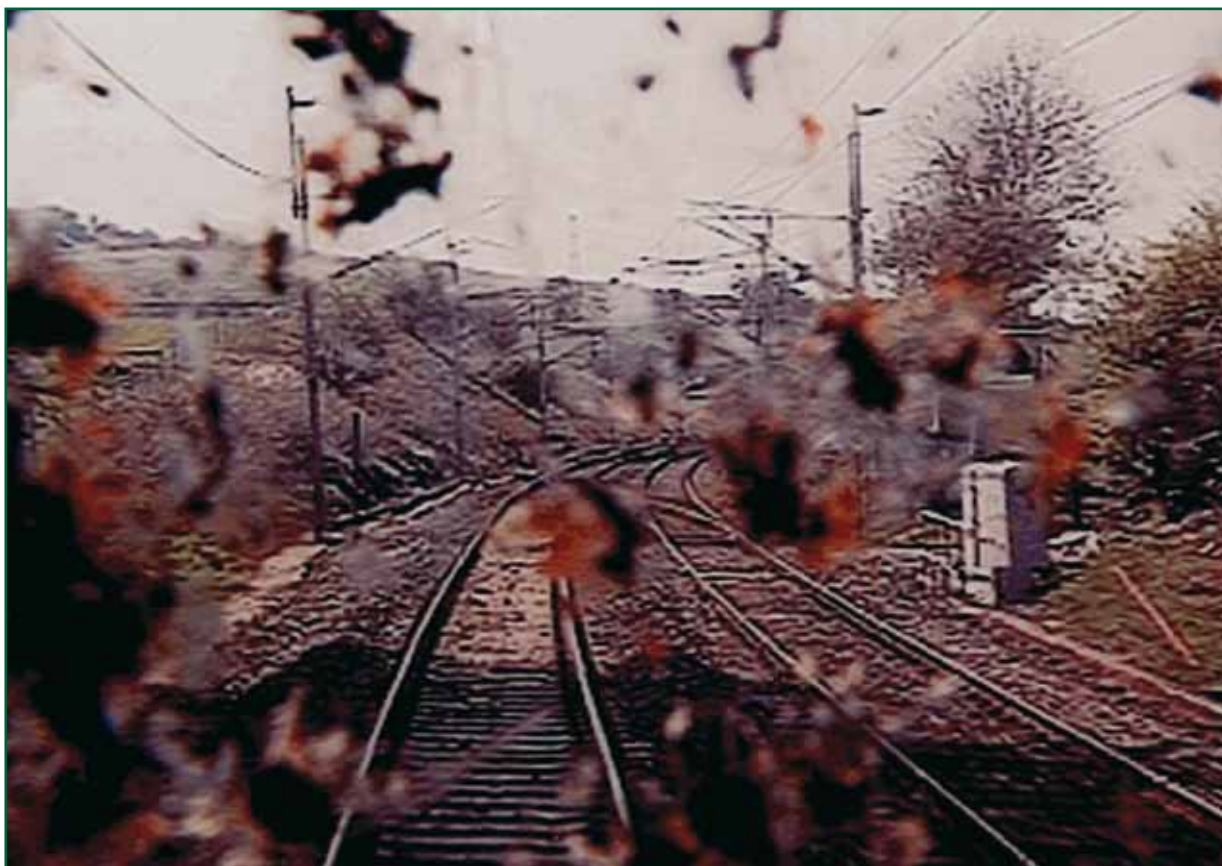
Figure 47: Approach to Lambrigg viewed from the up line in May 2006. Scrap rail behind location cabinet is visible

- 12 The NMT is fitted with forward and rearward facing video systems. These are provided for Network Rail engineers to relate geometrical records to physical locations, and are neither used nor intended for condition analysis. In May 2006 the NMT front-facing video was taken in good lighting conditions on a run on the up line. It shows points 2B to have all three permanent way stretcher bars present. The approach to the former crossing at Lambrigg, where the site access was located, can be seen clearly and a length of rail can be seen behind the location cabinets on the down side (Figure 47).

- 13 On 3 January 2007, the NMT ran in early-morning poor visibility with the rear-facing camera operational. Points 2B appear to have all three permanent way stretcher bars intact. The length of scrap rail behind the location cabinets is still present in the same position as in May 2006.

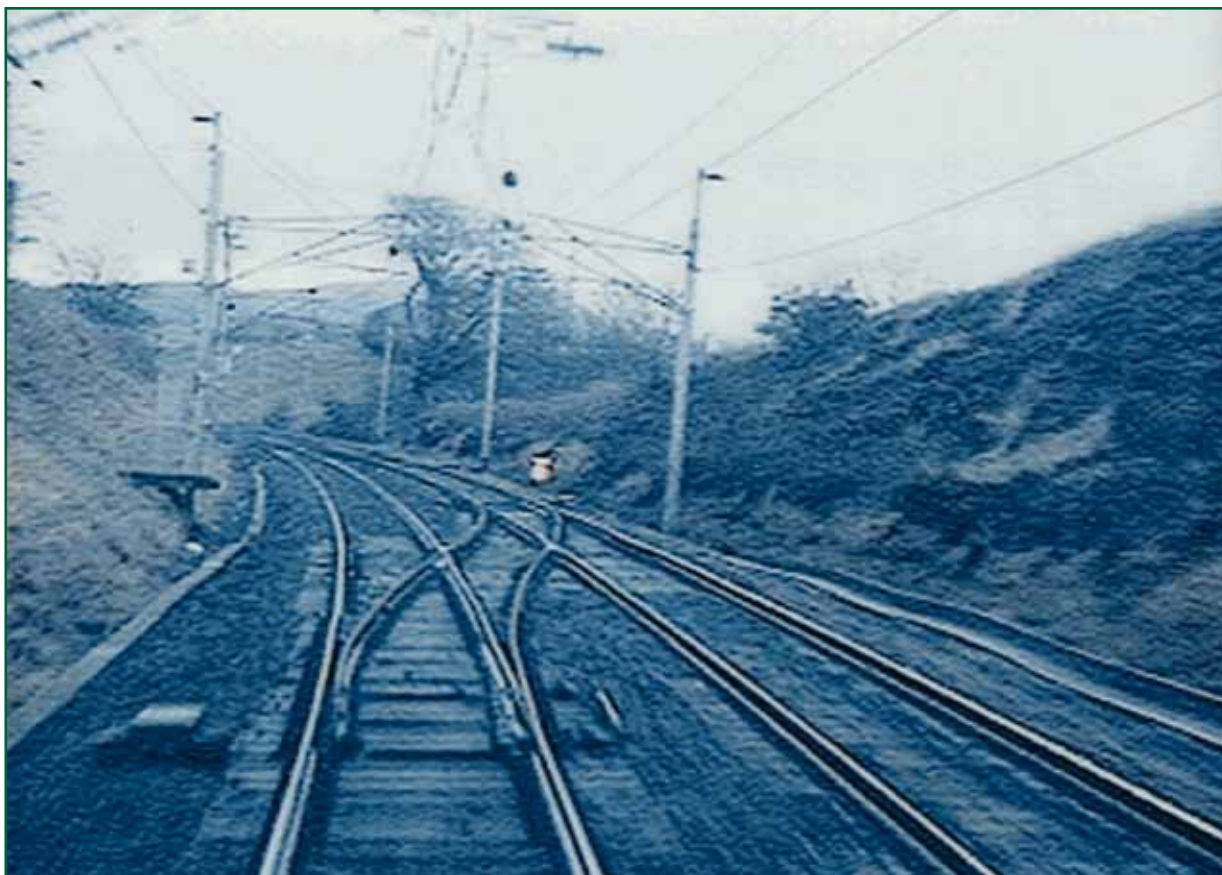
Figure 48: Points 2B viewed from the front of the NMT on 10 January 2007

- 14 On 10 January 2007, the NMT ran in slightly better lighting conditions than the previous week and the front-facing camera was working. Points 2B appear to have all three permanent way stretchers present (Figure 48). The NMT is fitted with a laser-based six-foot scanning system. This measures the distance from the scanner to any object in its path beneath the train. The data from this system was analysed by the RAIB to derive the relative positions of the switch and stock rail at 2B points. The six-foot scanner data shows the minimum free wheel clearance (Appendix D, paragraph 12) to be of the order of 60 mm.
