Rail Accident Investigation Branch

Rail Accident Report

**Derailment of a freight train near Moor Street
station, Birmingham
25 March 2008**

Report 07/2009
March 2009

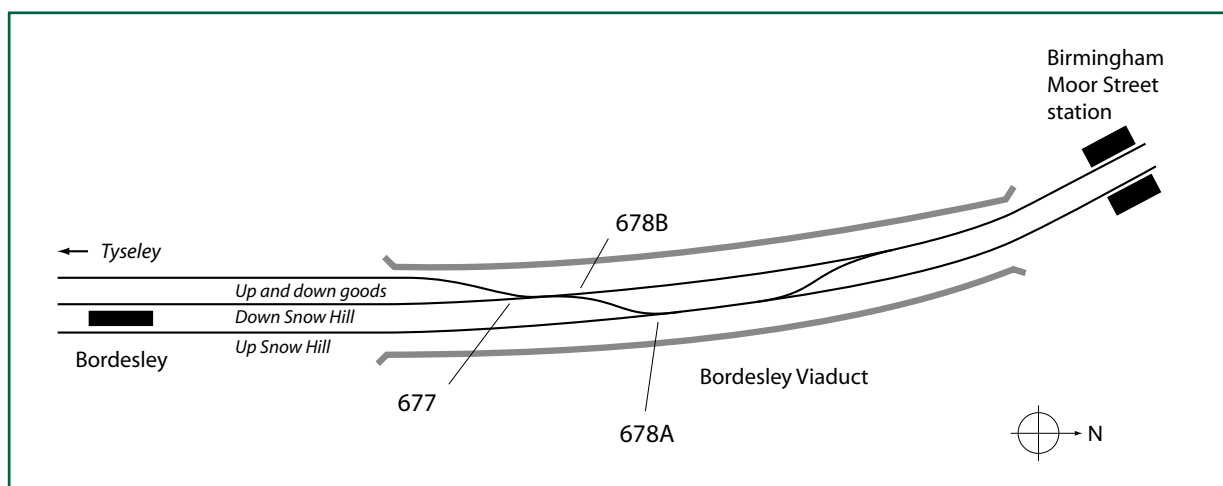
Figure 2: The track layout at Moor Street South junction

- 9 There was significant damage to 677 points and some damage to 678B points, the operating equipment and *sleepers*, *baseplates* and *timbers* along the route of derailed running. A section of the adjacent viaduct *parapet* was demolished.
- 10 The 16th wagon suffered significant damage to its leading left-hand suspension assembly; the three other derailed wagons suffered less severe damage.
- 11 Rail traffic was initially stopped on all lines. The up Snow Hill line was released for *single line working* at 07:57 hrs. Repairs to the points equipment and track components were completed and normal operations recommenced on the down Snow Hill line and up Snow Hill line at 01:55 hrs on 26 March 2008.

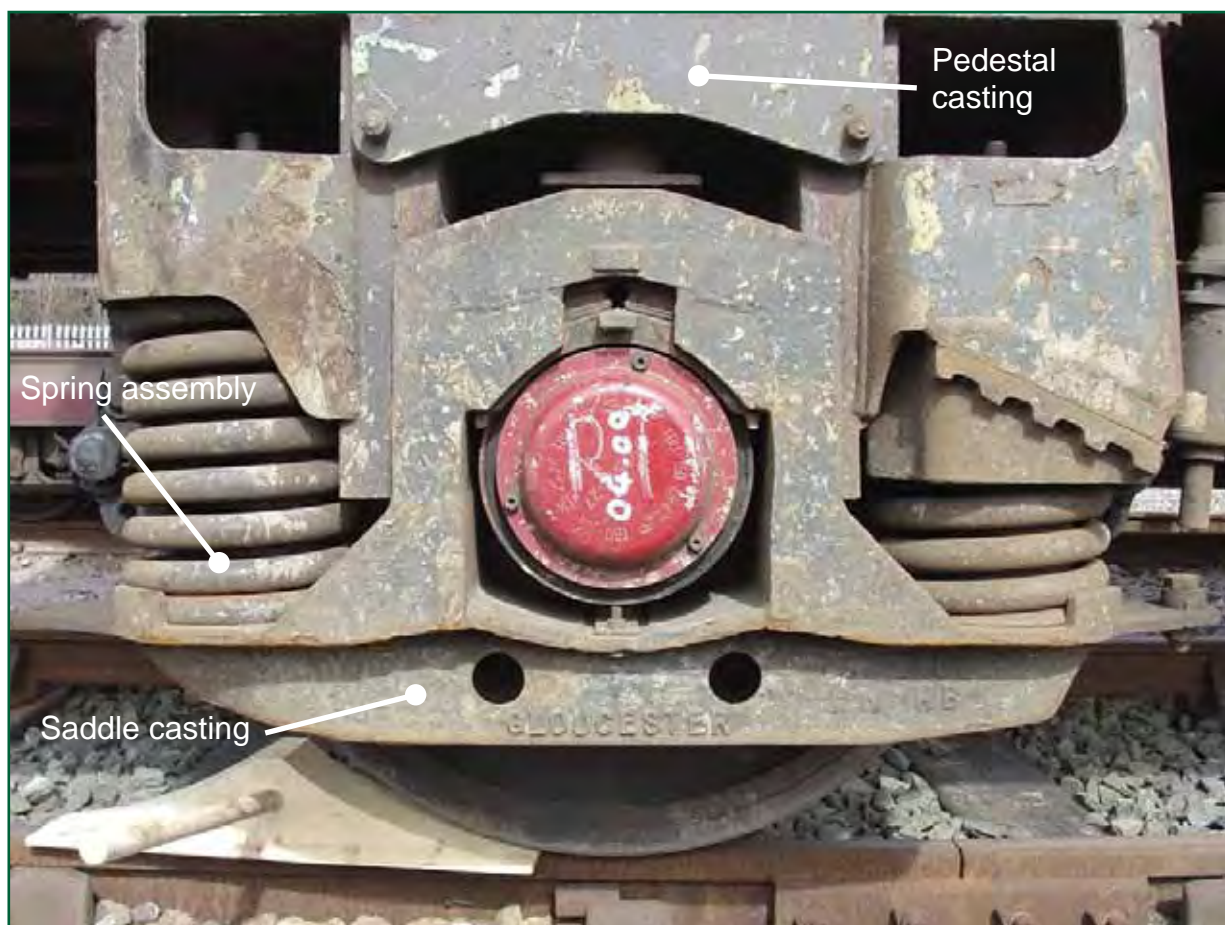
Figure 5: SSA pedestal suspension as fitted to wagon 470152

- 34 Damage was sustained to the left leading suspension and wheel bearing of 470152 while running derailed (Figure 8). The suspension eventually failed with the springs coming adrift. The lower suspension and bearing of the left leading corner were ploughed into the ballast causing the wagon to yaw and diverge further to the left. The 15th and 16th wagons both overturned to their left-hand sides dragging the trailing end of the 14th and leading end of the 17th into derailment. During this time the *brake pipe* separated and the train brake was applied automatically.

- the 16th wagon, 470152, had significant damage to the left leading suspension, wheel and bearing and damage to other elements of its *running gear*.
