Rail Accident Investigation Branch

Rail Accident Report

**Detachment of containers from freight wagons
near Cheddington and Hardendale
1 March 2008**

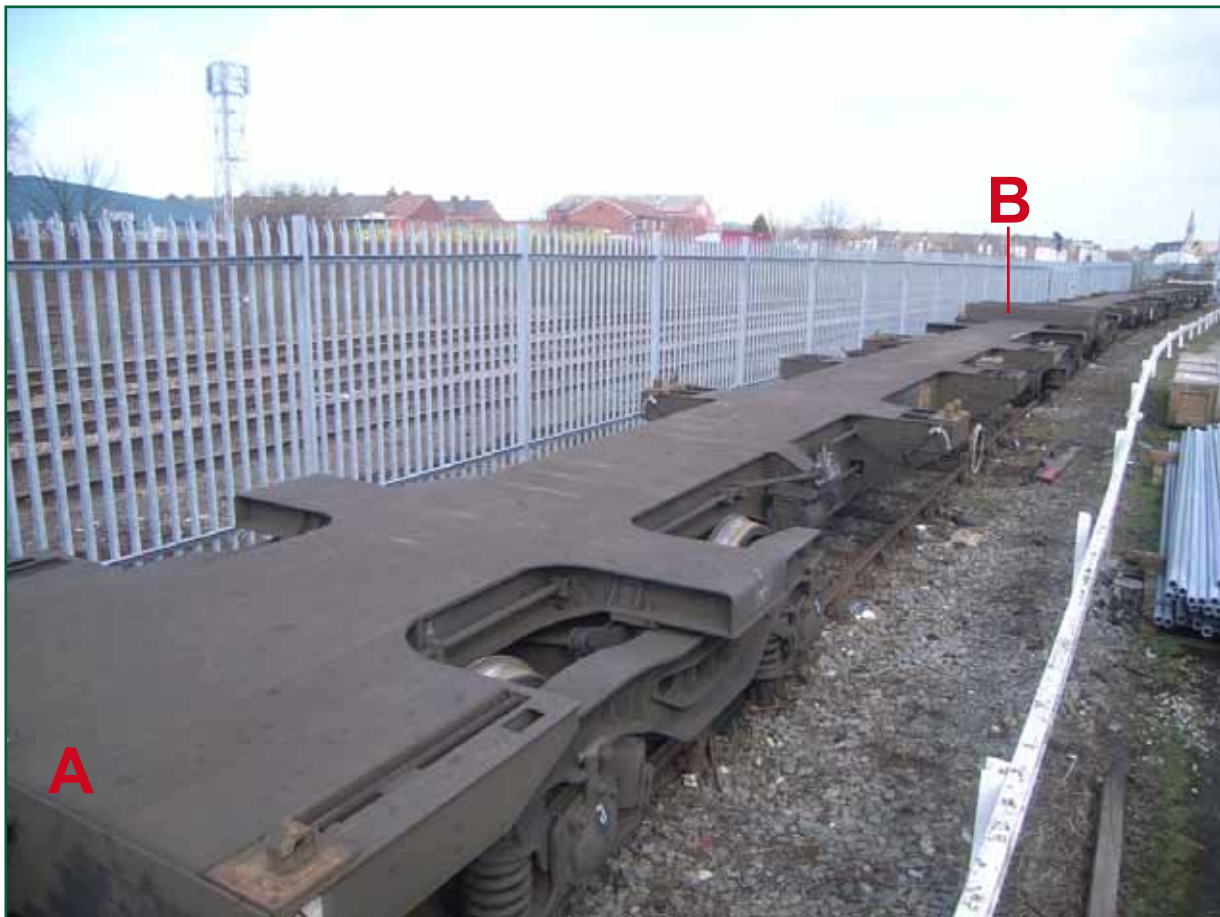
Figure 5: Fastline FEA-B wagon (ends labelled A & B)

- 71 The FEA-B wagons utilise fold-down spigots with inboard hinges to locate and secure containers. This type of fold-down design is unique to the FEA-B in the UK and issues identified with its operation are reported at paragraphs 116 and 130. Another feature of the FEA-B wagon is the spine frame design (Figure 5), which exposes approximately half the bottom surface area of containers; this is discussed further at paragraph 172.

172 The FEA-B wagon has a central spine with outriggers at the spigot locations (Figure 5). Between the outriggers, the width of the spine is less than half the width of a container and therefore the container overhangs the flat frame of the wagon except at the outrigger positions. On a conventional wagon with a full width underframe, less of the container's bottom surface is exposed.

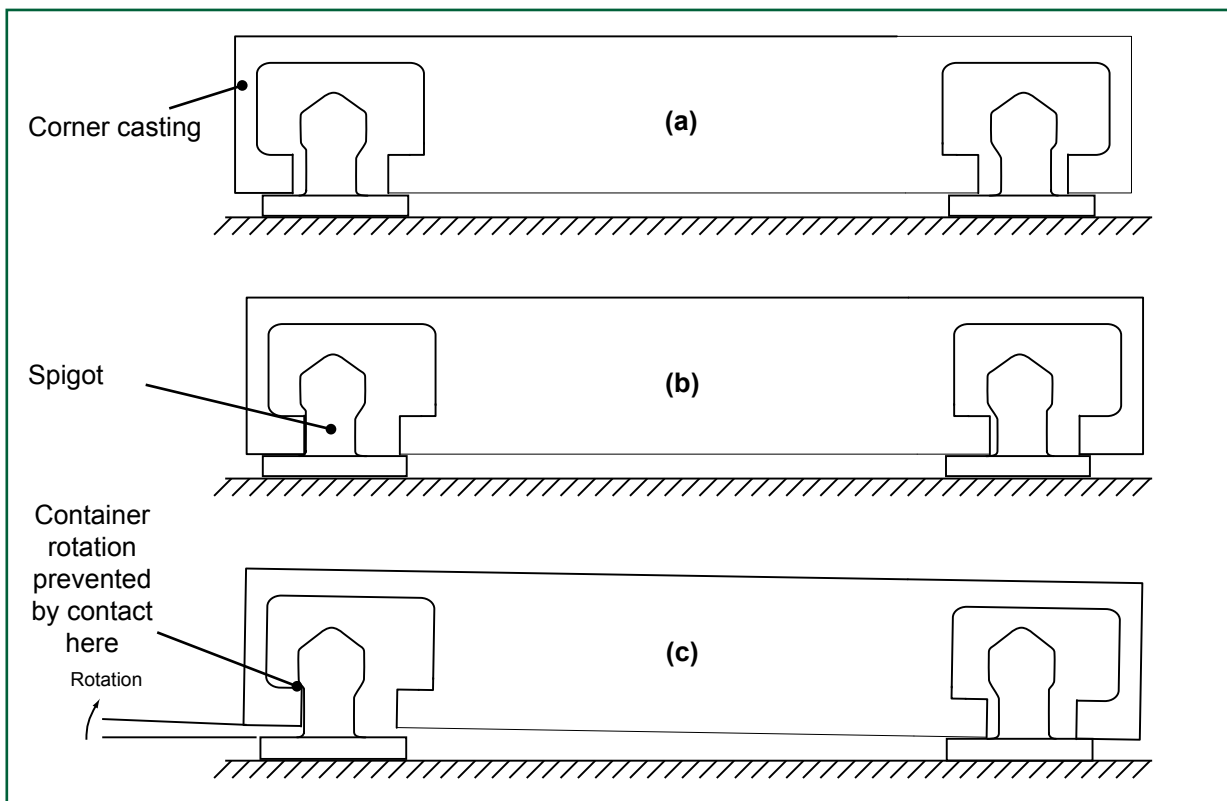
Figure 7: Principle of operation of spigots in windy conditions

109 The principle of operation of the UIC spigot for providing overturning restraint is shown in Figure 7. From a central position relative to the spigots (Figure 7a) the container must first slip laterally to the right on the wagon frame until the windward corner castings make contact with the neck of the windward spigot as shown in Figure 7b. Studies by BRR⁴ have shown that such sliding under lateral forces will always precede overturning. Then, and if the wind forces are strong enough to cause the windward side of the container to lift, the corner casting on the windward side will rise until it obtains a purchase on the underside of the spigot head (Figure 7c). This purchase provides the necessary vertical restraint to prevent overturning. Empty containers are at greater risk of overturning in windy conditions than loaded containers, unless restrained by the spigots.

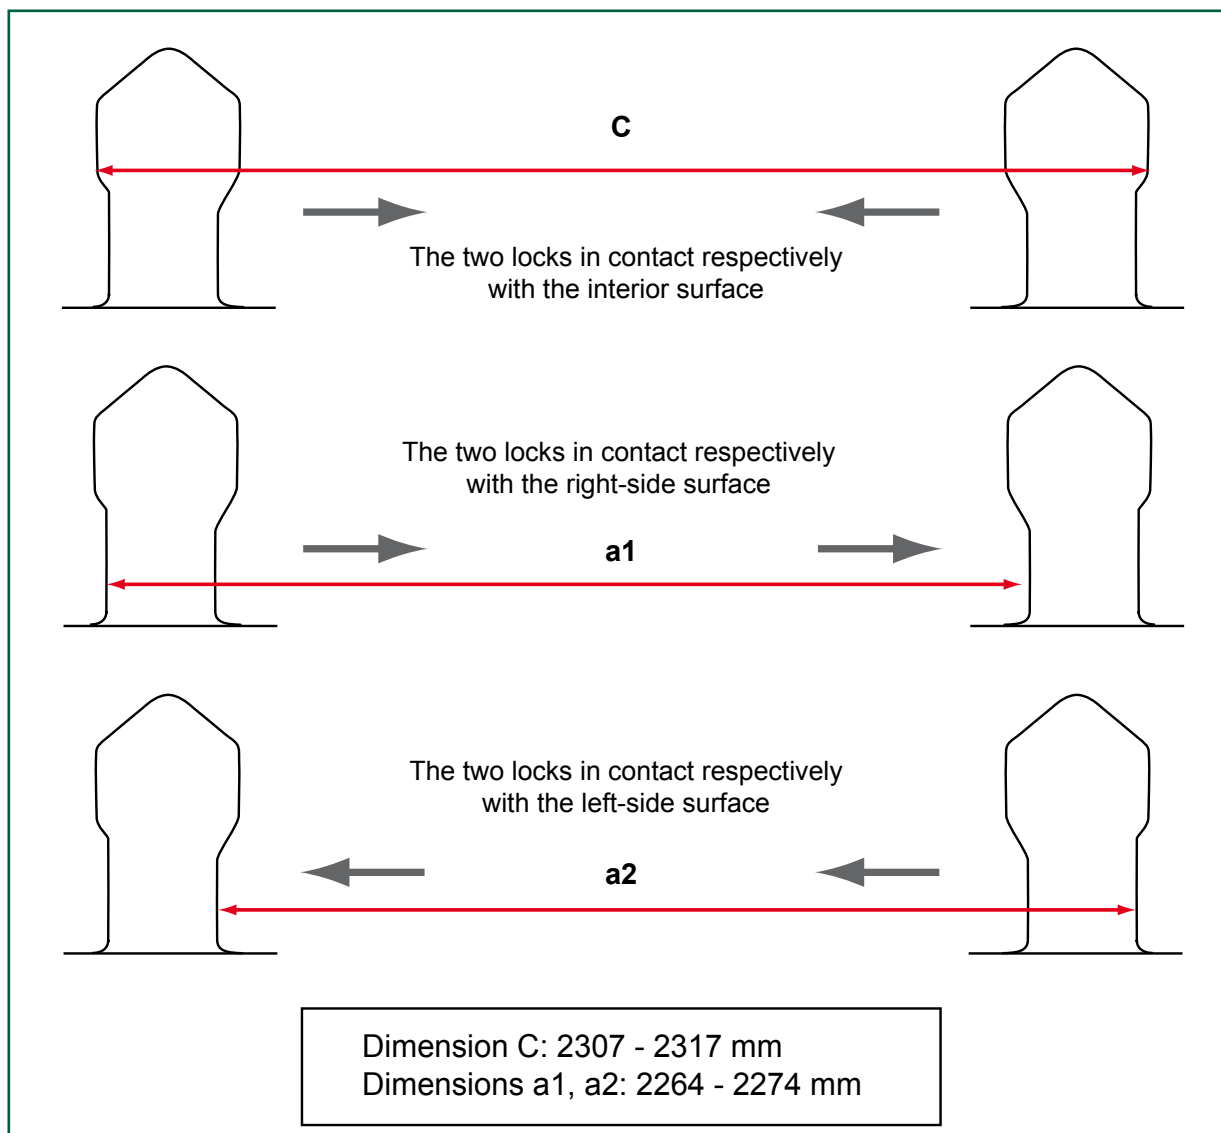
Figure 8: Lateral spacing requirements for fold-down spigots specified in UIC 571-4 appendix C

110 In order to ensure contact between the corner casting and spigot on the windward side of the wagon under all permissible tolerances of the spigots and corner castings, certain dimensional tolerances on the lateral spacing of pairs of spigots must be met. These are specified in appendix C of UIC 571-4, 'Standard Wagons – Wagons for combined transport – characteristics', 4th Edition, October 2004, for both fixed and fold-down spigots. Note that at the time of the FEA-B wagon design, the 2nd edition (January 1991, amended October 1994) was current, but is no longer readily available. It prescribed the same spigot lateral spacing as the current 4th edition which is referred to here for ease of reference. The key lateral dimensions, c , a_1 , a_2 , are shown in Figure 8. The ranges in the dimensions are necessary to allow for variations in the spacing and geometry of the container corner castings and spigots due to manufacturing and wear. Additionally for fold-down spigots, allowances are made for the clearances between the spigot locating blocks and the pockets in the wagon frame (Figure 9) which are necessary for the spigot to be deployed and retracted easily.

- 115 Measurements of the pocket cut-outs on wagon 643003 showed that some were slightly smaller than the tolerance in UIC 571-4, by a maximum of 1.5 mm. This could affect the ease with which the spigot blocks fits into the pocket cut-outs. The clearances however affect the critical dimensions shown in Figure 8.

- 116 All the wagons involved in the incidents were measured to check whether their dimensions c , a_1 , a_2 (Figure 8) were compliant with appendix C of UIC 571-4. For wagon 643003 (Cheddington), eight of the ten spigot pairs were not compliant to UIC 571-4, mainly falling below the a_1 and a_2 criteria by between 1 and 5 mm. The two other spigot pairs, which were carrying the middle container, were compliant, but only marginally so. Similar measurements of the spigots which were carrying containers on the four wagons involved at Hardendale showed that 19 of the 20 spigots did not comply, again mainly falling below the a_1 and a_2 criteria by between 1 and 7 mm.

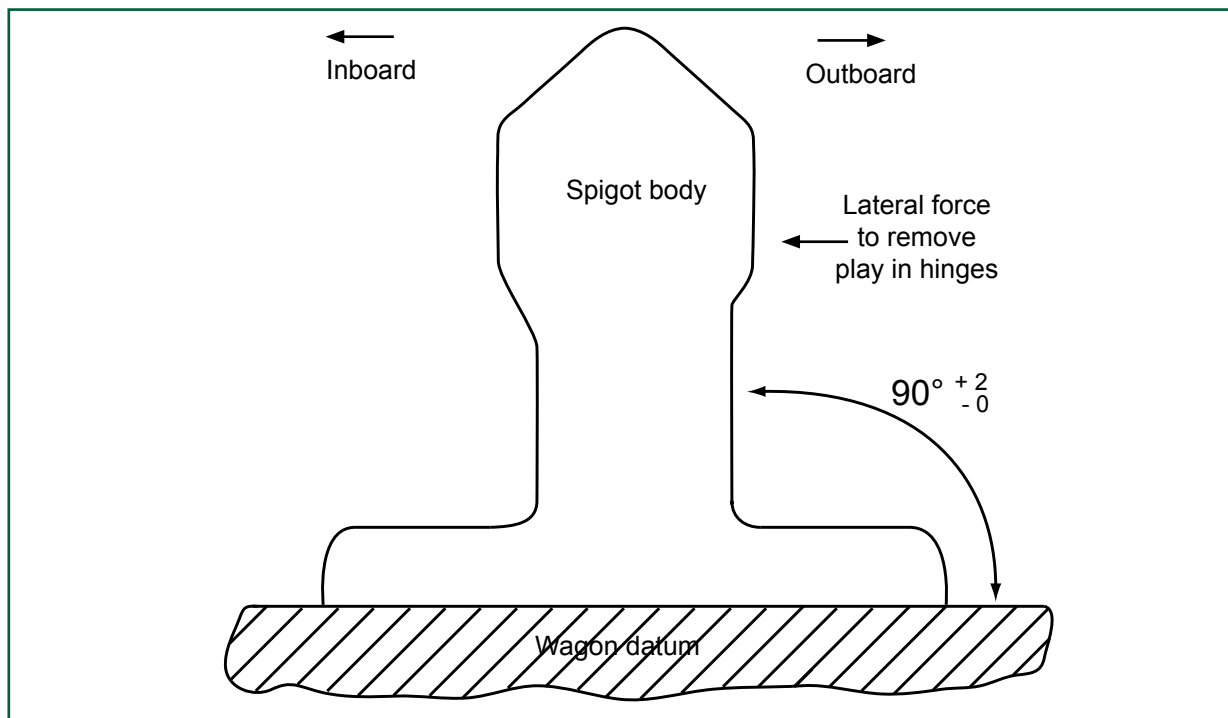
Figure 10: Angular tolerance on spigot tilting specified in UIC 571-4 appendix C (this diagram is not shown in UIC 571-4)

- 111 To ensure that once correct contact is made between the corner casting and spigot on the windward side, the spigot is able to resist the vertical force applied to it by the container which is trying to lift off, UIC 571-4 appendix C also specifies an angular tolerance on the tilting of the spigot (Figure 10). The spigot must not be able to tilt inwards (i.e toward the centre of the vehicle) by more than 2 degrees from the vertical, measured relative to the wagon platform which is assumed to be horizontal. This is to prevent the fold-down spigot rotating excessively in the same sense as the lifting container and losing its ability to hold down the lifting container on the wagon platform.

- Fixed spigots (Figure 12) which are compliant with UIC 571-4 provide overturning restraint, those that are not compliant do not provide reliable restraint.
- Fold-down spigots with inboard hinges, as fitted to the FEA-B wagons do not offer any overturning restraint, even if the spacings are complaint, because the spigot rotation follows the rotation of the overturning container on the windward side.
- Fold-down spigots with outboard hinges (Figure 13), as fitted to most wagons with UIC spigots, may not reliably restrain overturning containers if there is sufficient play in the hinges to allow them to initially rotate inwards, pivoting about the inboard edge as shown in Figure 14. During testing, inward rotations of up to 4.5 degrees were measured; the maximum specified in the UIC 571-4 is 2 degrees.
