Rail Accident Investigation Branch

Rail Accident Report

Road-rail vehicle runaway incidents at Brentwood, Essex and at Birmingham Snow Hill 4 November & 31 October 2007

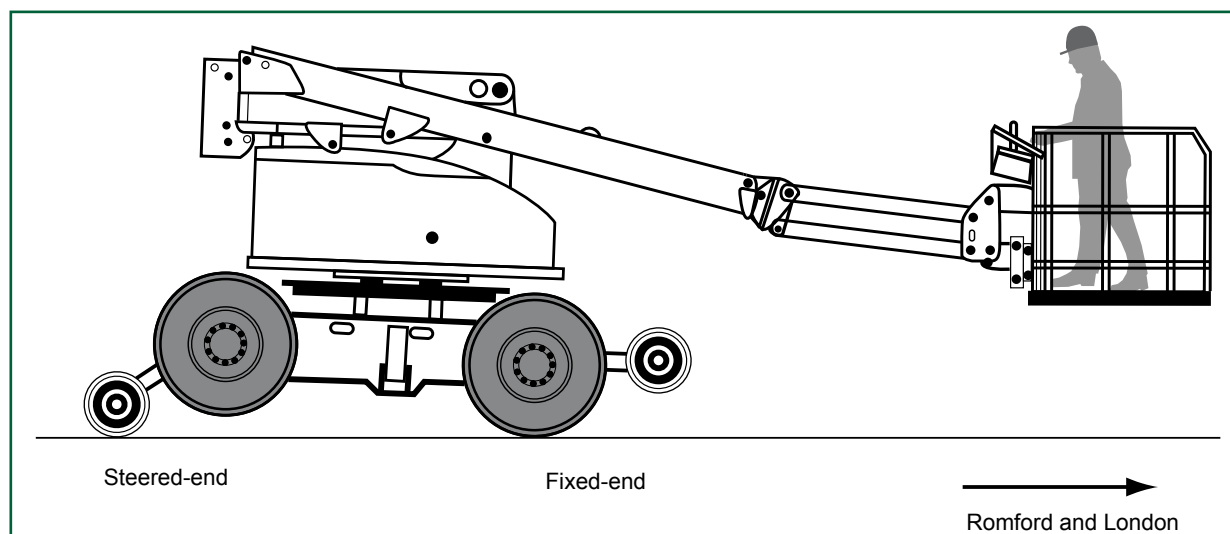
Figure 5: Orientation of Basket 14 RRV during on-tracking

- 50 The operator got into the work basket and drove the Basket 14 RRV to the road-rail access point, approaching the track at around 45 degrees. The machine controller helped guide him. The work basket was over the end of the machine with the fixed axle (the *fixed-end*); it was facing downhill toward Romford. The opposite end of the machine (the *steered-end*) was uphill. Figure 5 shows the orientation of the Basket 14 RRV, and the position of the operator. The machine controller was on the track nearby, most probably at the steered-end. On-tracking commenced at around 10:12 hrs.

- 51 The machine controller indicated that the rail wheels were in position, and the operator operated the *rail gear switch* on the basket control panel that lowered the rail gear. The position of the *changeover lever* - located on the superstructure - meant that the wheels at the steered-end lowered.

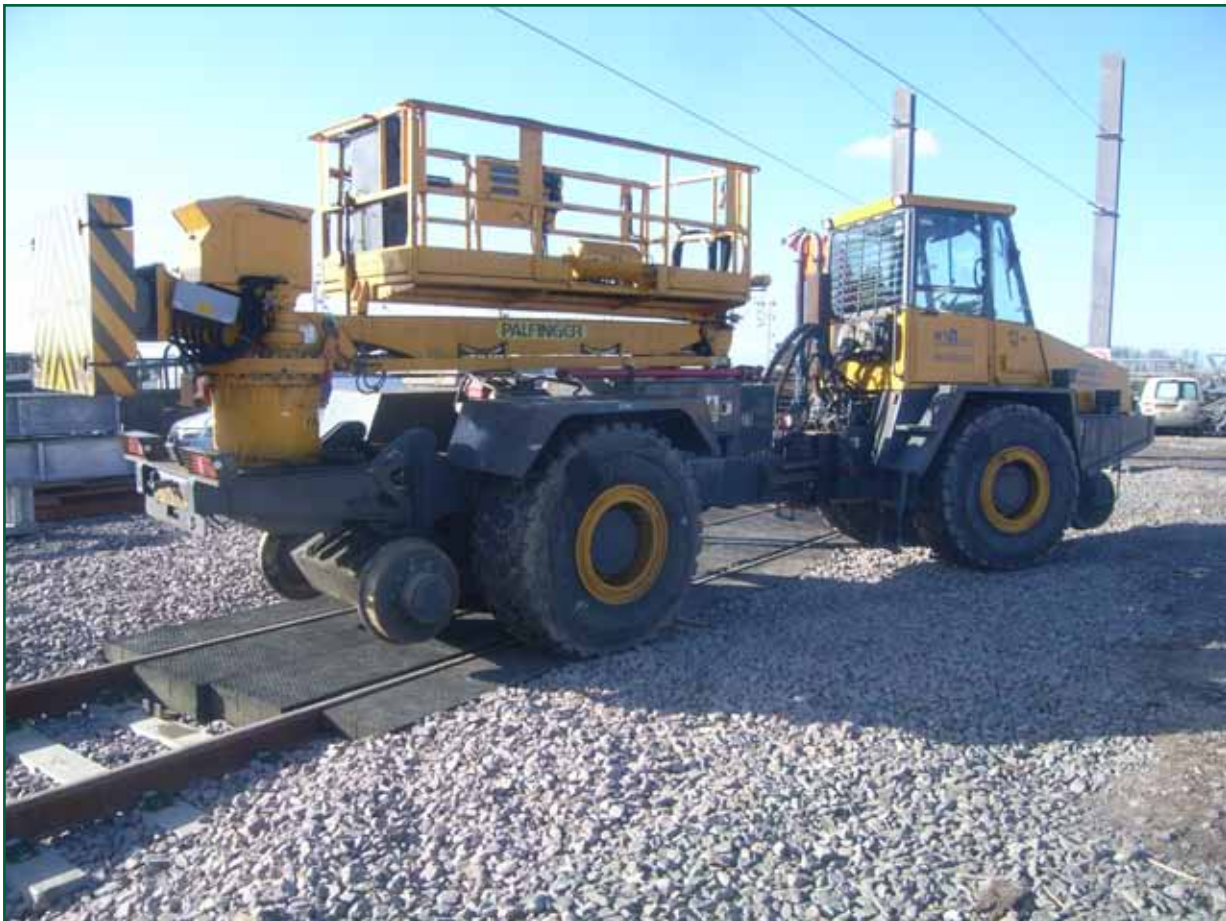
Figure 9: TD-18 RRV

- 87 The TD-18 RRV, the machine that ran away, was a converted articulated road dumper truck. It is a high ride RRV and has a *knuckle-boom* elevating work basket, Figure 9. Except when the work basket is being used, the TD-18 RRV is operated from a chassis-mounted driving cab.

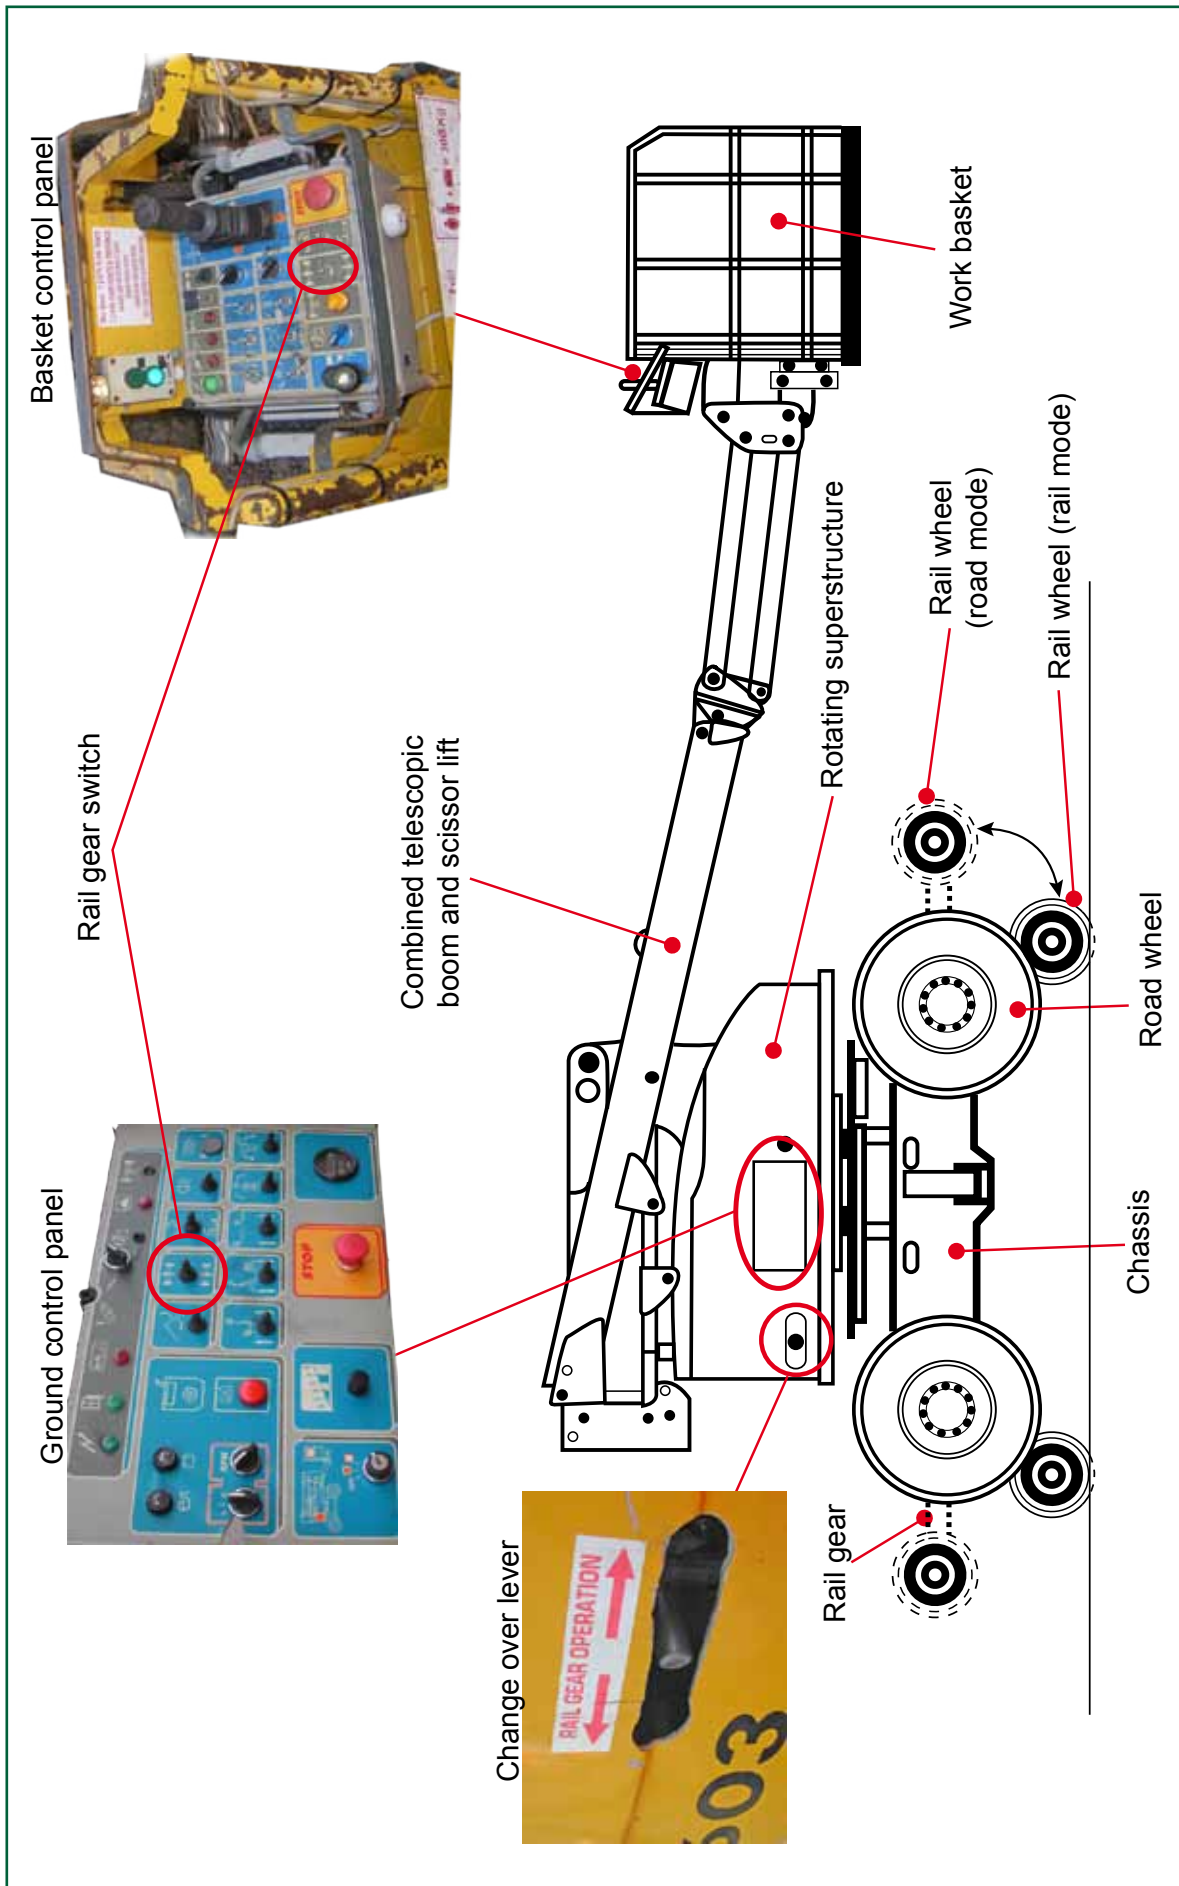
Figure 10: Basket 14 RRV – principal features

- 109 Figure 10 shows the principal features of the Basket 14 RRV. It shows the machine with the rail wheels in both road mode (dashed lines) and rail mode (solid lines) positions. In road mode, the road wheels are on the ground and the rail wheels are up. When going to rail mode, the rail wheels lower onto the rail and then rotate around until they press into contact with the road wheels – the latter operation raises the machine and lifts the road wheels off the ground.

- 112 The rail gear is lowered (and raised) using a toggle switch (the rail gear switch); there is one on each control panel. The switch only operates one set of rail gear at a time. When the rail gear switch is operated, the position of a changeover lever (Figure 10) determines whether the front or rear rail gear is lowered or raised. This lever, mounted separately on the superstructure, moves a valve that diverts oil to the hydraulic rams at the end selected.
