**Report on the runaway manually propelled  
trolley between Larkhall and Barncluith Tunnel  
2 November 2005**

# Report on the runaway manually propelled trolley between Larkhall and Barncluith Tunnel 2 November 2005

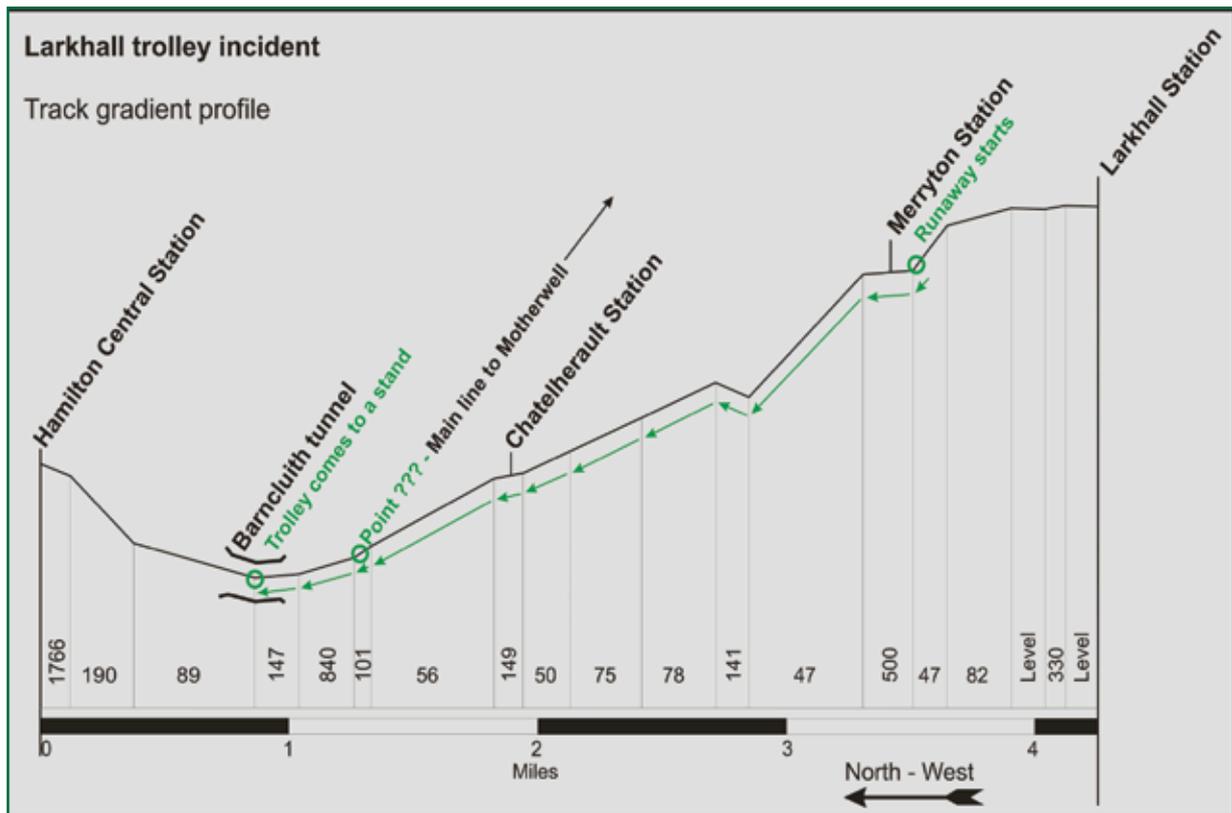
Figure 4: Gradient profile diagram from Larkhall to Hamilton Central

- 17 The gradient on the Larkhall branch is shown in Figure 4. The trolley ran away from a location on the 1 in 47 gradient on approach to signal MH710 on the Larkhall side of Merryton station (the lineside gradient marker at Merryton shows 1 in 48 although the gradient on the track diagram is 1 in 47). The station is on a 1 in 500 down gradient. Beyond the station the incline changes to a 1 in 47 down gradient for approximately 750 m followed by a 1 in 141 rising gradient for approximately 200 m. After this the gradient is downward to Barncluith Tunnel and varies between 1 in 56 and 1 in 840. It is only within Barncluith Tunnel that a 1 in 89 up gradient is reached. In railway terms, 1 in 47 is a steep gradient, with the steepest gradient on Network Rail controlled infrastructure being approximately 1 in 28 on the Lickey Incline.

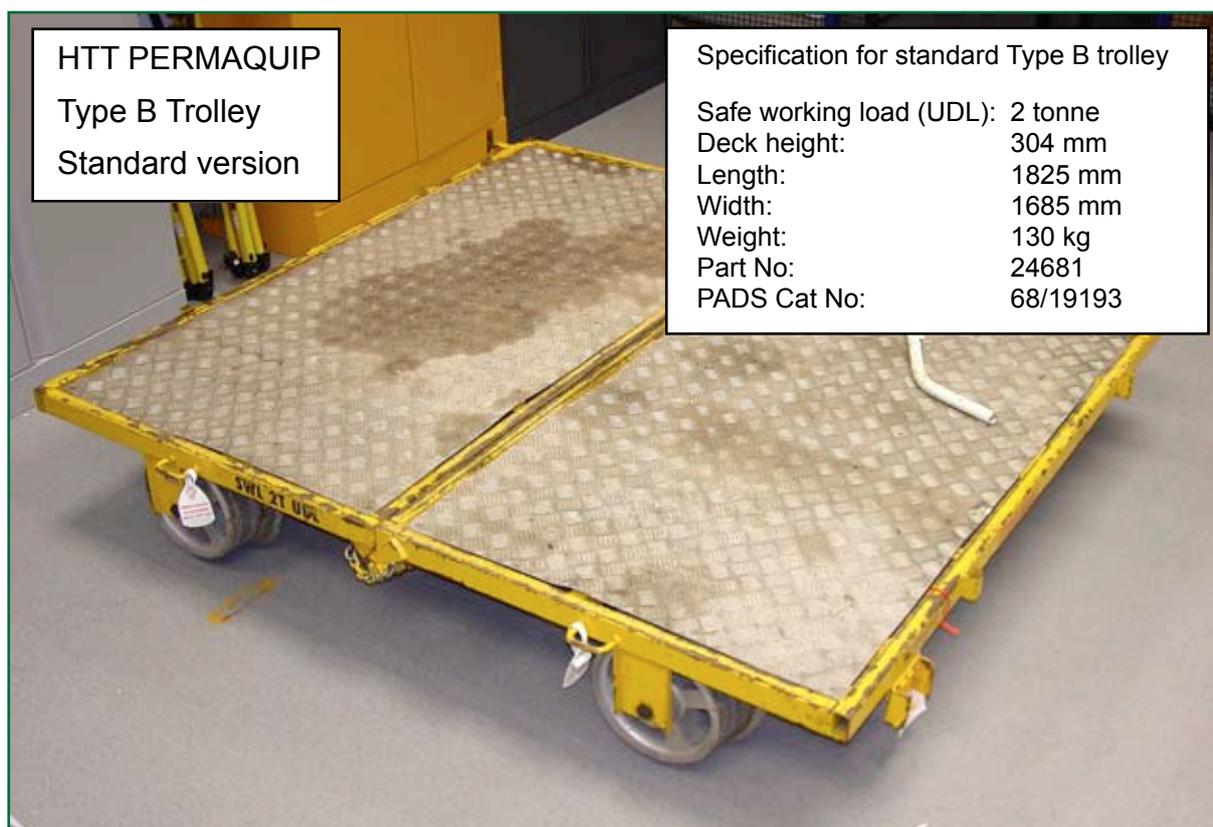
Figure 5: HTT Type B trolley

- 30 The incident trolley (see Figure 5) was a Type B portable trolley serial number RT10574, manufactured by Harsco. It is also known as a *standard* design trolley. It was commonly referred to as a '*bogie*' by the local work force.

65 The trolley that was used had contaminated brake linings (see paragraph 124) and had an inspection bull tag giving the date of next annual service as June 2005, ie before the date of the incident.

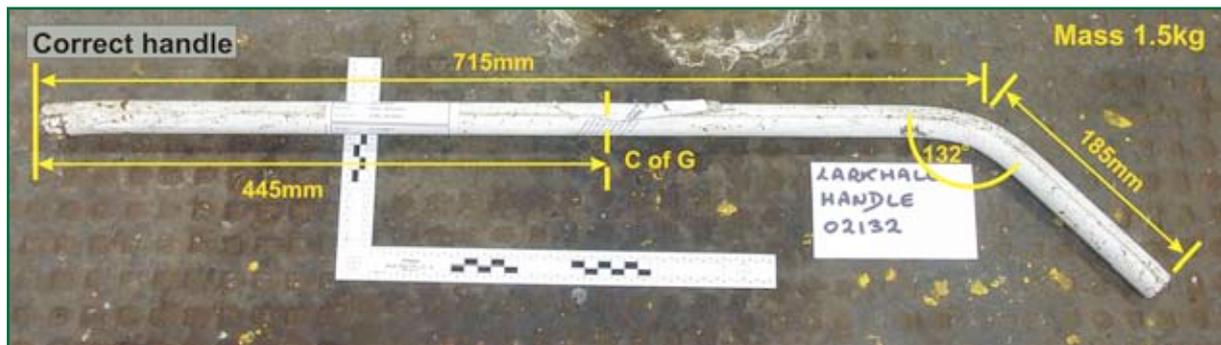
Figure 16: Type B trolley - correct brake handle

175 The handle found at Haughhead Junction (see paragraph 111) was identified as that used on the incident trolley. However it was not supplied for use with a Type B Permaquip trolley (Figure 10), but for use with a *Link* trolley also known as a Type A (Figure 12).

176 Torrent's records of their AP38 tests show that they had supplied the correct handle when the trolley was initially hired to Carillion. The investigation could not establish why an incorrect handle had been used with the incident trolley.

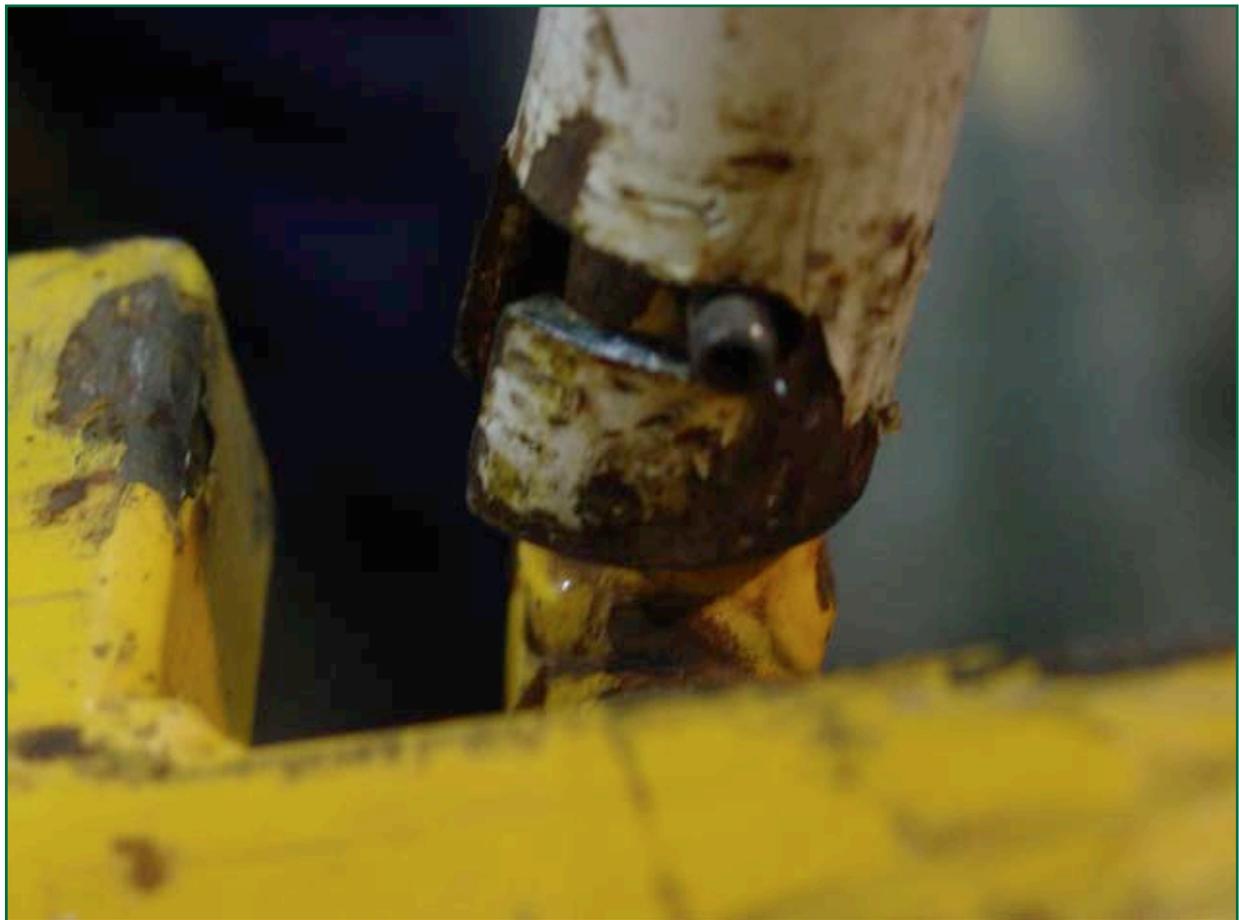
Figure 17: Handle and locating lug connected for Type B trolley

- 190 The weight and mass of the handle combined with the movement of the trolley along the track would have caused the handle to 'bounce' on the spring mechanism. This movement likely caused the trailing brakes to repeatedly apply and release during the unescorted runaway travel, further reducing their effectiveness.

- 191 When the brake handle was ejected from the trolley in the proximity of the number 58 points the braking effort changed to a larger value. This increased force and the change to an Up gradient within Barncluith Tunnel caused the trolley to eventually stop at its final location within the tunnel
- 192 No other issues in respect of the trolley other than the brake pad material, the pads contamination, the difference in performance between the two ends of the braking system and the inappropriate handle contributed to the incident.
