Rail Accident Investigation Branch

Rail Accident Report

Derailment at Starr Gate, Blackpool 30 May 2006

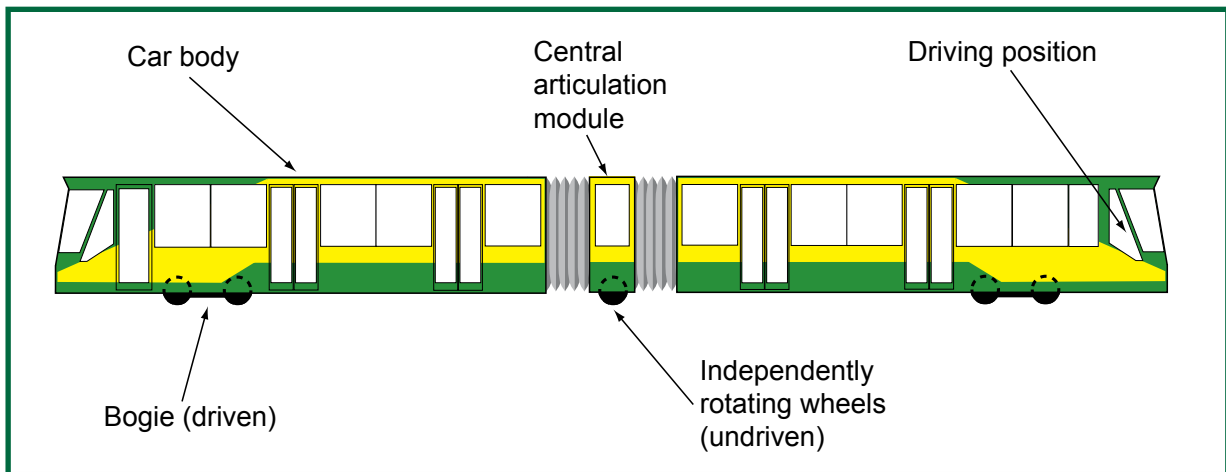
Figure 2: Principal arrangement of the tram

- 16 Tram 611 was owned and being developed by Tram Power. Other organisations were involved in the earlier stages of design and construction.
- 17 The tram comprises two car bodies which are connected together by a central articulation module. The outer end of the each car body is carried by a single four wheel *driven bogie* which incorporates automotive axle components. The articulation module is carried on a pair of wheels which are free to rotate independently of each other. Neither of these wheels is driven. All the wheels on the tram include rubber elements between the outer rim and wheel centre. The principal arrangement of the tram is shown in Figure 2. It is designed to be capable of traversing curves of radius 15 m and greater.
