Rail Accident Investigation Branch

# Rail Accident Report

## **Tram collision at Soho Benson Road, Midland Metro 19 December 2006**

Report 17/2007  
June 2007

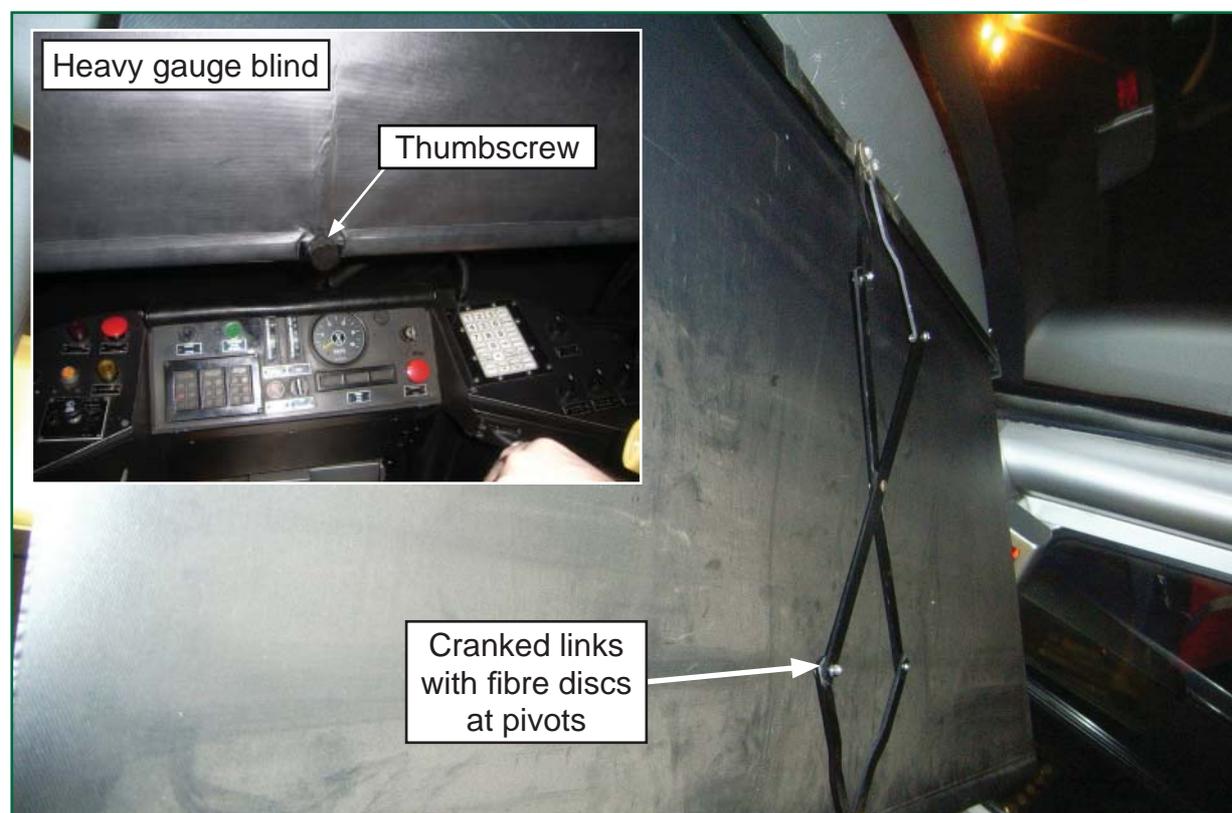
Figure 11: Sunblind mechanism - type I

60 Sunblind type I, the original equipment, has a scissor mechanism with cranked links, fibre discs at its pivots, a heavy gauge blind and a thumbscrew to adjust clamping force and, in turn, the force that is required to deploy or retract the blind. See Figure 11.

62 RAIB testing found 18 sunblinds of 25 that were not fit for purpose, despite the fleet being subjected to a TMM post-accident check of sunblind mechanism performance with no faults reported.
