Rail Accident Investigation Branch

# Rail Accident Report

## Fire on HGV shuttle in the Channel Tunnel 21 August 2006

## 21 August 2006

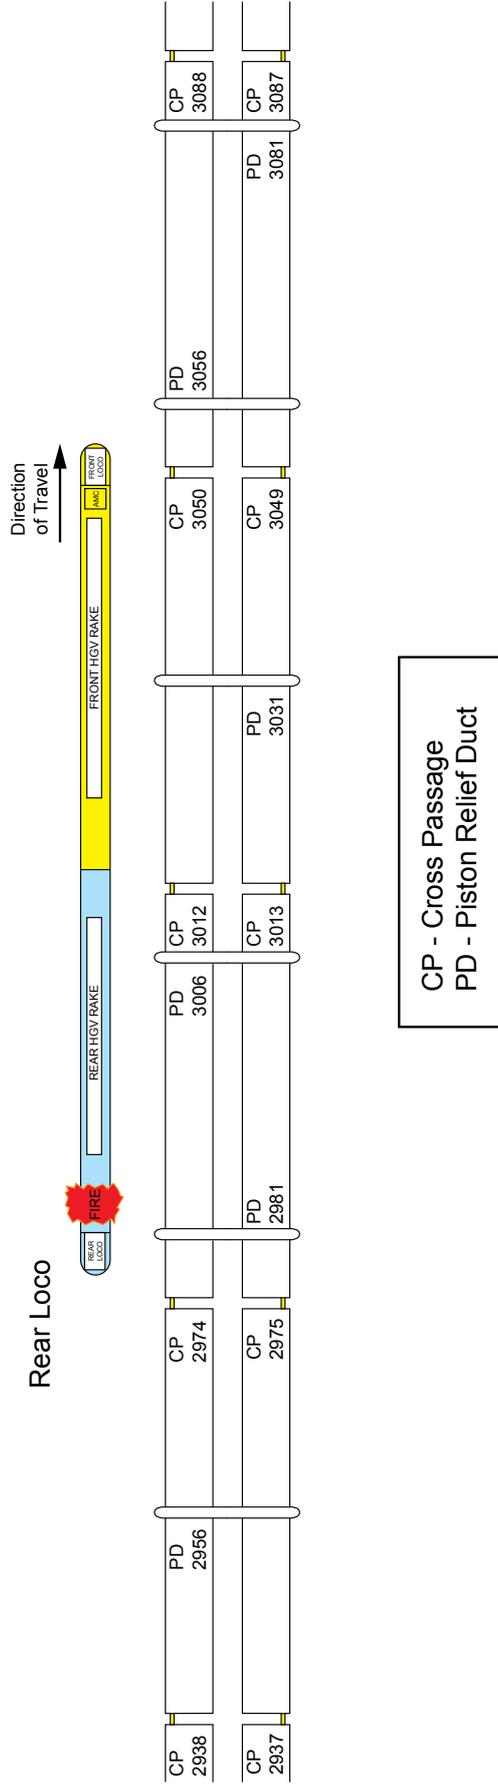
Figure 3: Diagram of the area in which Mission 7370 came to a stand

- 42 As soon as the driver was certain he had passed fully through the 'go zone', he brought the shuttle to a stand at CP3050 at 13:40 hrs (Figure 3). After receiving a call from the RCC authorising an evacuation, he assisted the Chef de Train with the process.

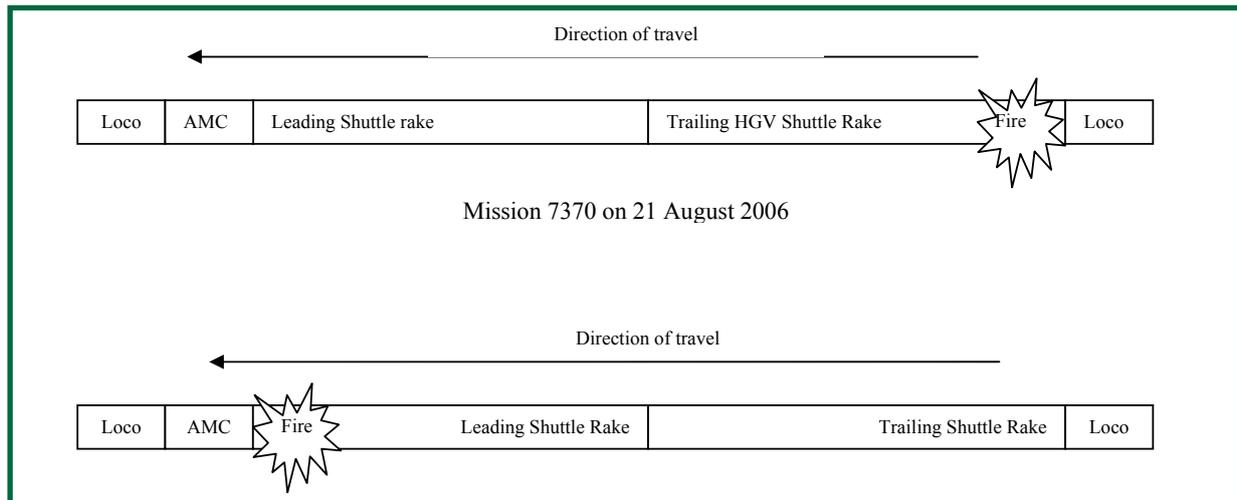
Figure 11: Alternative scenario involving fire at front of the shuttle

313 With a fire at the front of the shuttle and smoke present, the train crew would have been faced with three possibilities according to the relevant Eurotunnel procedure:

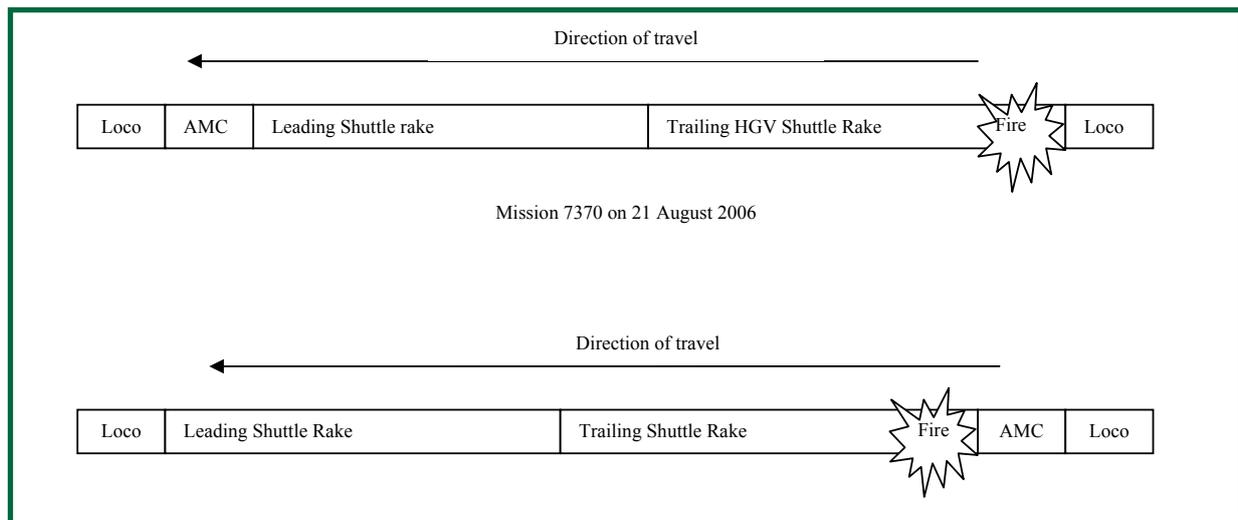
Figure 12: Alternative scenario involving fire and AMC at rear of shuttle

316 If the AMC had been located at the rear of the shuttle any smoke from the HGV on fire would have been initially blown over the AMC. The Chef de Train would have closed the HVAC inlets to ensure that the AMC was sealed from smoke ingress.

- 317 The relevant Eurotunnel procedure calls for the initial response to the incident by the EMS Controller to switch on the SVS fans and configure them to blow smoke away from the AMC. If the AMC had been at the rear of the shuttle, this would have meant blowing smoke in the opposite direction from that which was actually required on 21 August 2006, i.e. the SVS would have been configured to blow smoke from the UK to France, away from the back of the shuttle.

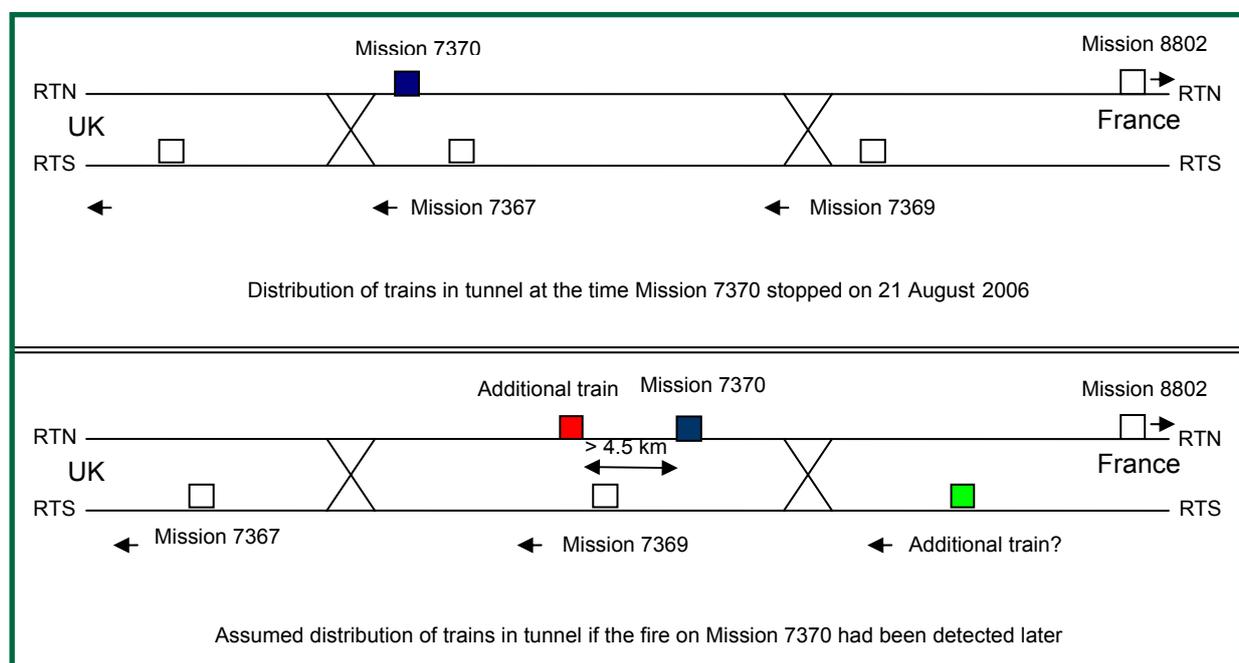
Figure 13: Alternative scenario involving an additional train in the running tunnel

323 The complication that potentially arises from having a train located in the running tunnel behind a HGV shuttle with a fire on board is that the need to blow smoke away from the AMC means that the smoke is being blown towards any train(s) following the incident shuttle.
