Rail Accident Investigation Branch

Rail Accident Report

**Derailment of a road rail vehicle at Terryhoogan,
near Scarva, Northern Ireland
9 March 2008**

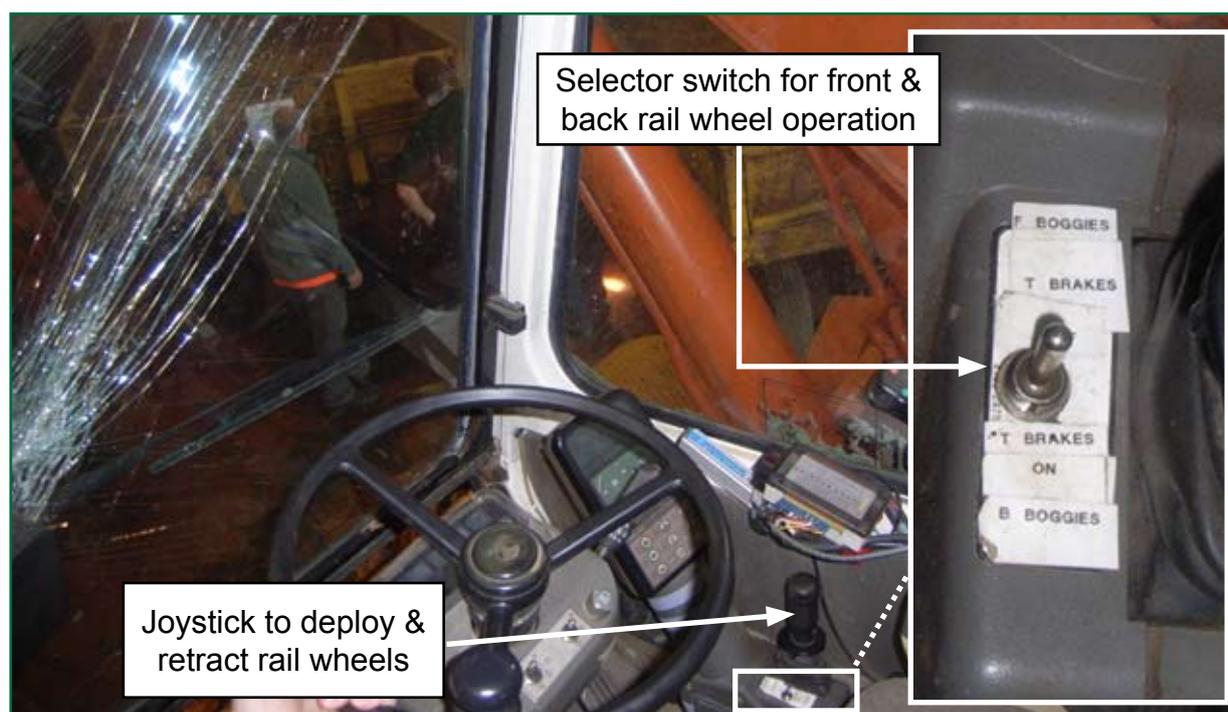
Figure 5: The excavator's cab controls for raising and lowering the rail wheels

- 18 On this excavator, the operator changes from road to low ride mode by:
- throwing a switch forwards or backwards to enable the operation of the front or rear rail wheels (Figure 5);
 - using a joystick to operate hydraulic rams that raise or lower the rail wheels (Figure 5);
 - observing left and right-hand indicator lights that illuminate when the front and rear rail wheels are in their pre-set, fully deployed position, as determined by a position sensor (Figures 6 and 7);
 - releasing the joystick; and
 - returning the switch to neutral to lock the rail wheels in place.
