Rail Accident Investigation Branch

Rail Accident Report

**Incident at Greenhill Upper Junction, near
Falkirk
22 March 2009**

Report 04/2010
March 2010

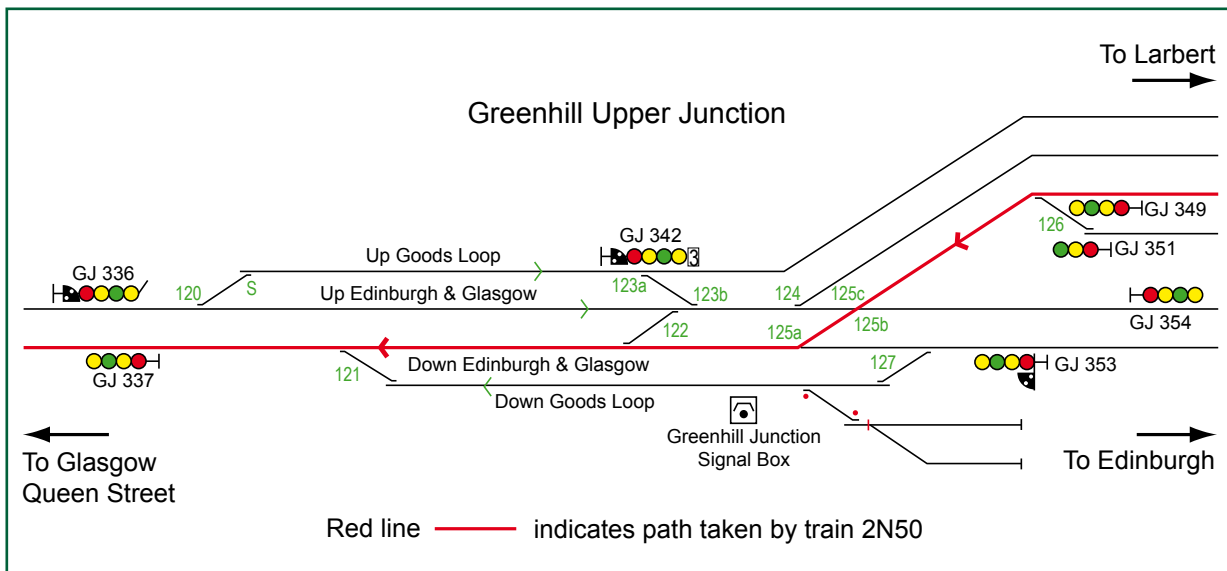
Figure 2: Track and signalling layout at Greenhill Upper Junction

- 17 At about 09:45 hrs on 22 March 2009, train 2N50, the 09:17 hrs from Alloa to Glasgow Queen Street, formed by a three-car class 170 *diesel multiple unit*, traversed Greenhill Upper Junction (figure 2) at 64 mph (103 km/h). One of the point ends, designated 125C, forming part of a set of switch diamonds, was in the incorrect position and the train trailed through them forcing them across to the correct position and damaging the mechanism as a result.

- 22 Greenhill Upper Junction is 17 miles 29 chains (28 km) from Glasgow Queen Street station on the main line between there and Edinburgh Waverley station. It is about 3 miles (5 km) west of Falkirk and is where the line from Larbert and Stirling joins the Edinburgh and Glasgow line (figure 2).
- 23 The permissible speed for trains crossing the junction to or from the Larbert direction is 70 mph (113 km/h); the permissible speed for trains on the Edinburgh and Glasgow line is 100 mph (161 km/h).
- 24 Trains crossing the junction from the Larbert direction must first pass over the switch diamonds consisting of 125C and 125B point ends on the up Edinburgh and Glasgow line, followed by the trailing point ends of 125A turnout, located where the line from Larbert joins the down Edinburgh and Glasgow line.

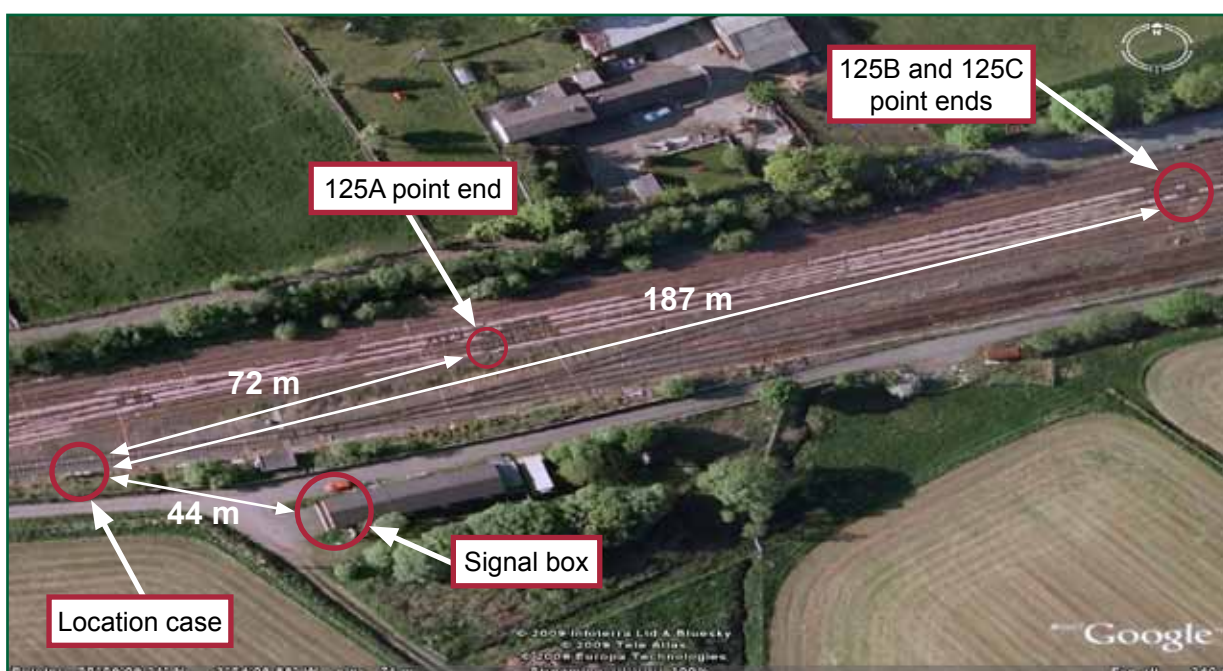
Figure 7: Site layout at Greenhill Upper Junction

108 The physical layout of the site is shown in figure 7. This shows that it is 187 m from location case 17/2C to the switch diamonds, 72 m to the point machine at 125A points and 44 m to the signal box.

- 178 The consequence of this was that, because of the long distances on the site (figure 7), the tester was not able to communicate verbally from his position at the location case with the person who was stationed to manually operate 125B/C point ends. The tester sometimes had to leave the location case where the detection relays are housed in order to speak to the person at the switch diamonds.

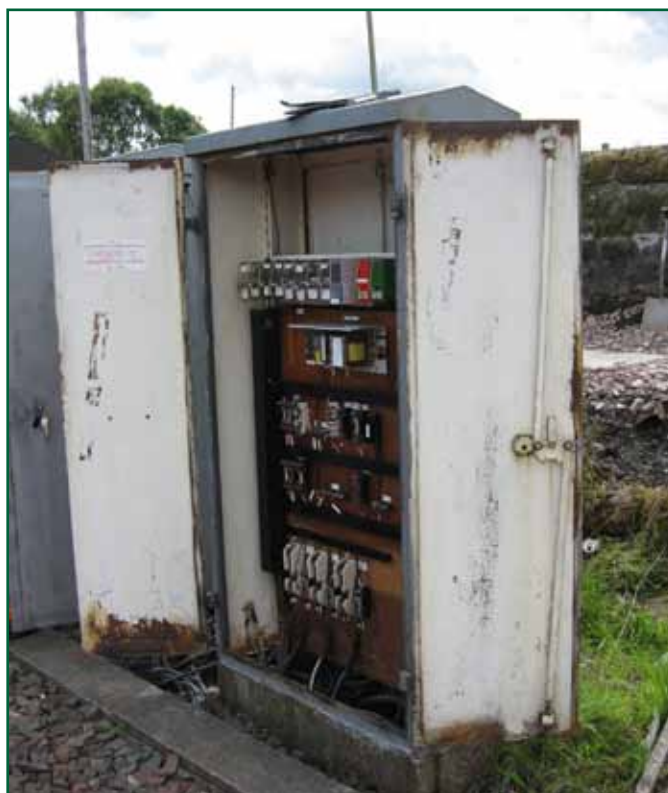
Figure 10: Location case 17/2C

1. When a signaller sets a route over 125 points by pushing the entrance and exit buttons on the panel, the required position of the points is commanded by the interlocking in Greenhill relay room and by equipment in location case 17/2C (figure 10). The command to change the position of a set of points is known as points calling.

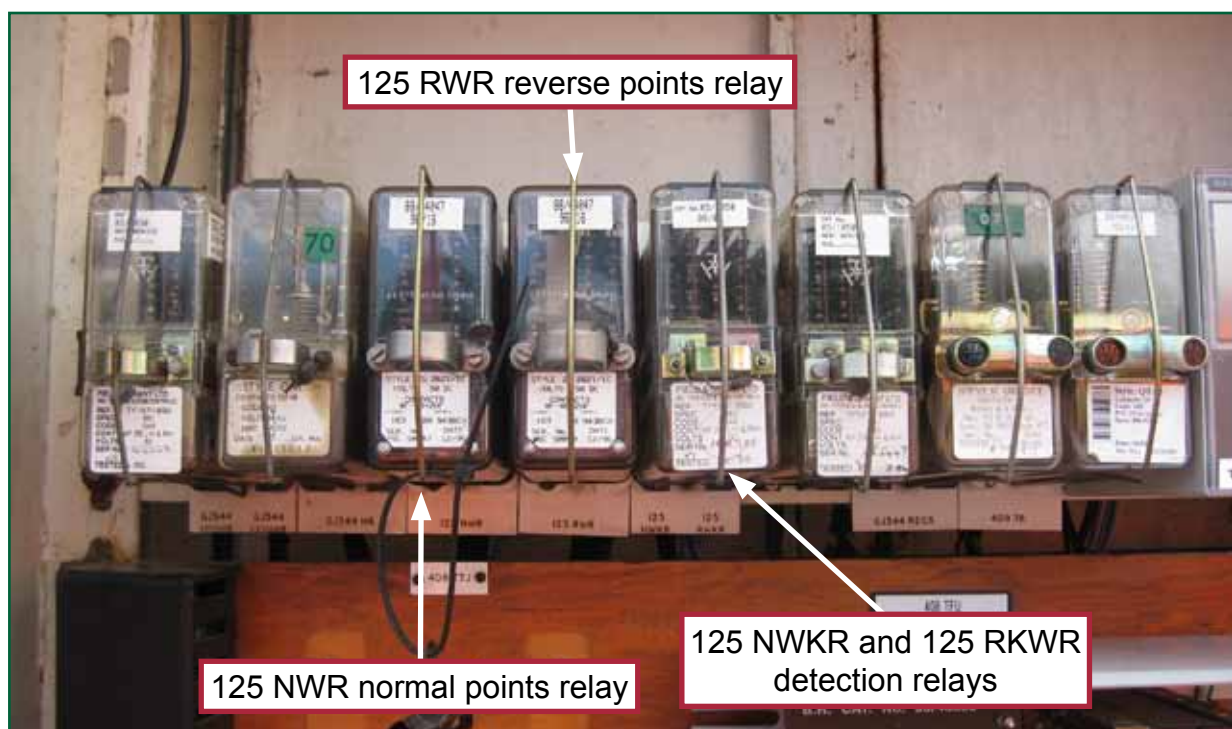
Figure 11: The relays associated with the control of 125 points

4. The relays in table 3 belong to the BR specification 930 series of 'miniature' relays and operate on 50 volts direct current. They are each enclosed in a clear plastic case to provide protection from the elements. The complete assembly plugs into a plugboard to which the various connections are wired. The relay is held in place by a retaining clip. Figure 11 shows the relays in table 2 in position in location case 17/2C.

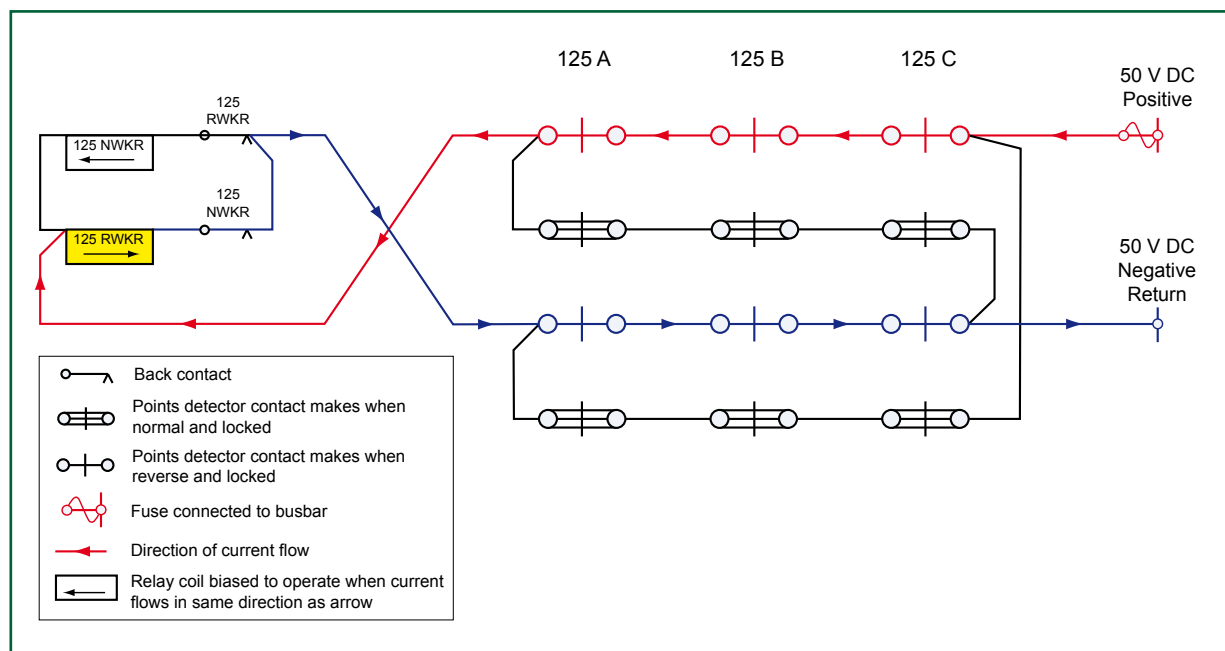
Figure 12: Simplified diagram of the detection circuit associated with 125 points (showing points detected and locked reverse)

5. The two detection relays, 125 NWKR and 125 RWKR, are both contained in a single plastic case and each has six front contacts and two back contacts. They are biased relays which only energise when direct current is flowing in one direction through their coil.
6. Figure 12 shows a simplified diagram of the detection circuit associated with 125 points. There are two detection contacts for each point end position to allow the circuits to be *double cut*. They are contained within each point machine (figure 13) and are wired in series between each of the 125 point ends. Each contact has to be closed, either normal or reverse, in order to energise the appropriate detection relay. This should only occur when all the associated switch rails are in the correct position.

9. The circuit containing the 125 detection relays uses only two wires to connect them to the detection contacts in the point machines and is therefore known as a two wire detection circuit. Such a circuit is a pole changing circuit as the polarity (the direction of the electric current) is changed depending on which detection contacts are made which reduces the number of wires that would otherwise be required. The circuit requires wire straps to be fitted to the terminals inside 125C and 125A point machines (figure 12) to enable it to work.
