Rail Accident Report

Fatal accident at Whitehall West junction, Leeds 2 December 2009

Report 15/2010
September 2010

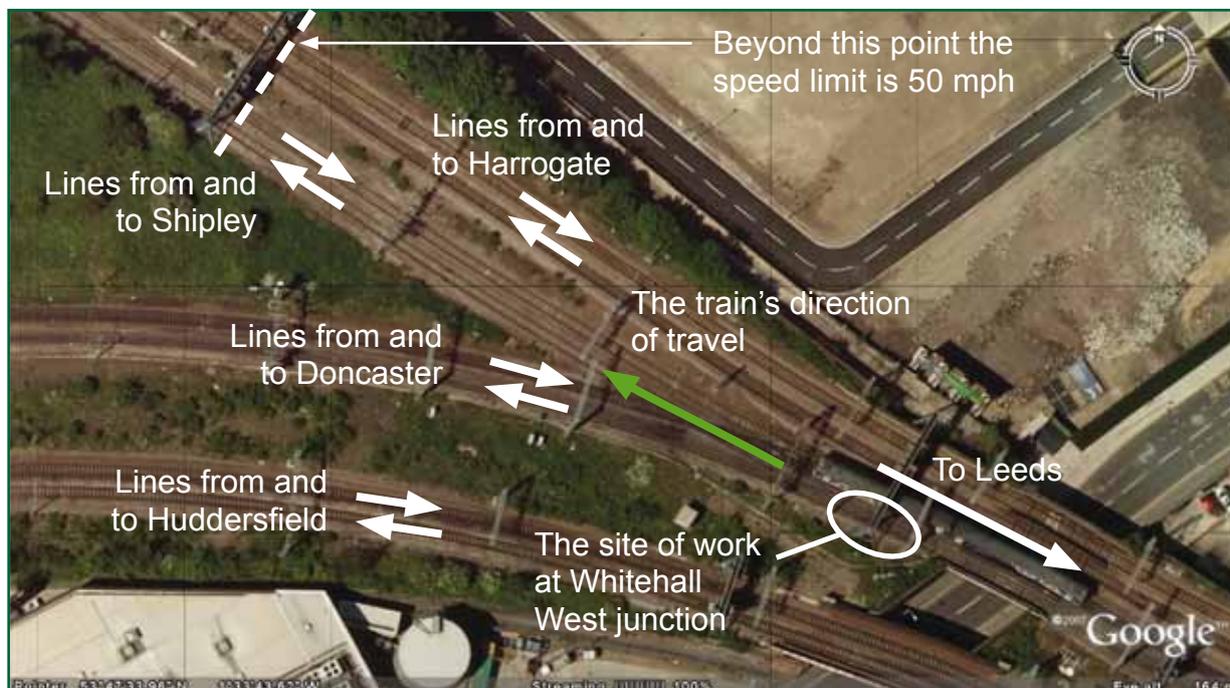
- 9 Whitehall West junction is approximately 800 metres west of Leeds station and comprises lines that take trains from and to Shipley or Doncaster. North and south of the junction are lines that take trains from and to Harrogate and from and to Huddersfield respectively (figure 2).

Figure 2: Whitehall West junction, the tracks to and from Leeds station and the normal direction of trains. (Courtesy of Google Earth)

- 18 In the hour and 22 minutes leading up to the accident, 27 trains passed the site of work; the east-facing lookout warned the site lookout of the approach of several trains and work stopped while these trains passed over the junction. In this time the west-facing lookout did not give warning for any train travelling over the site of work, as this is not the normal direction of travel for trains from Doncaster or Shipley (see figure 2).

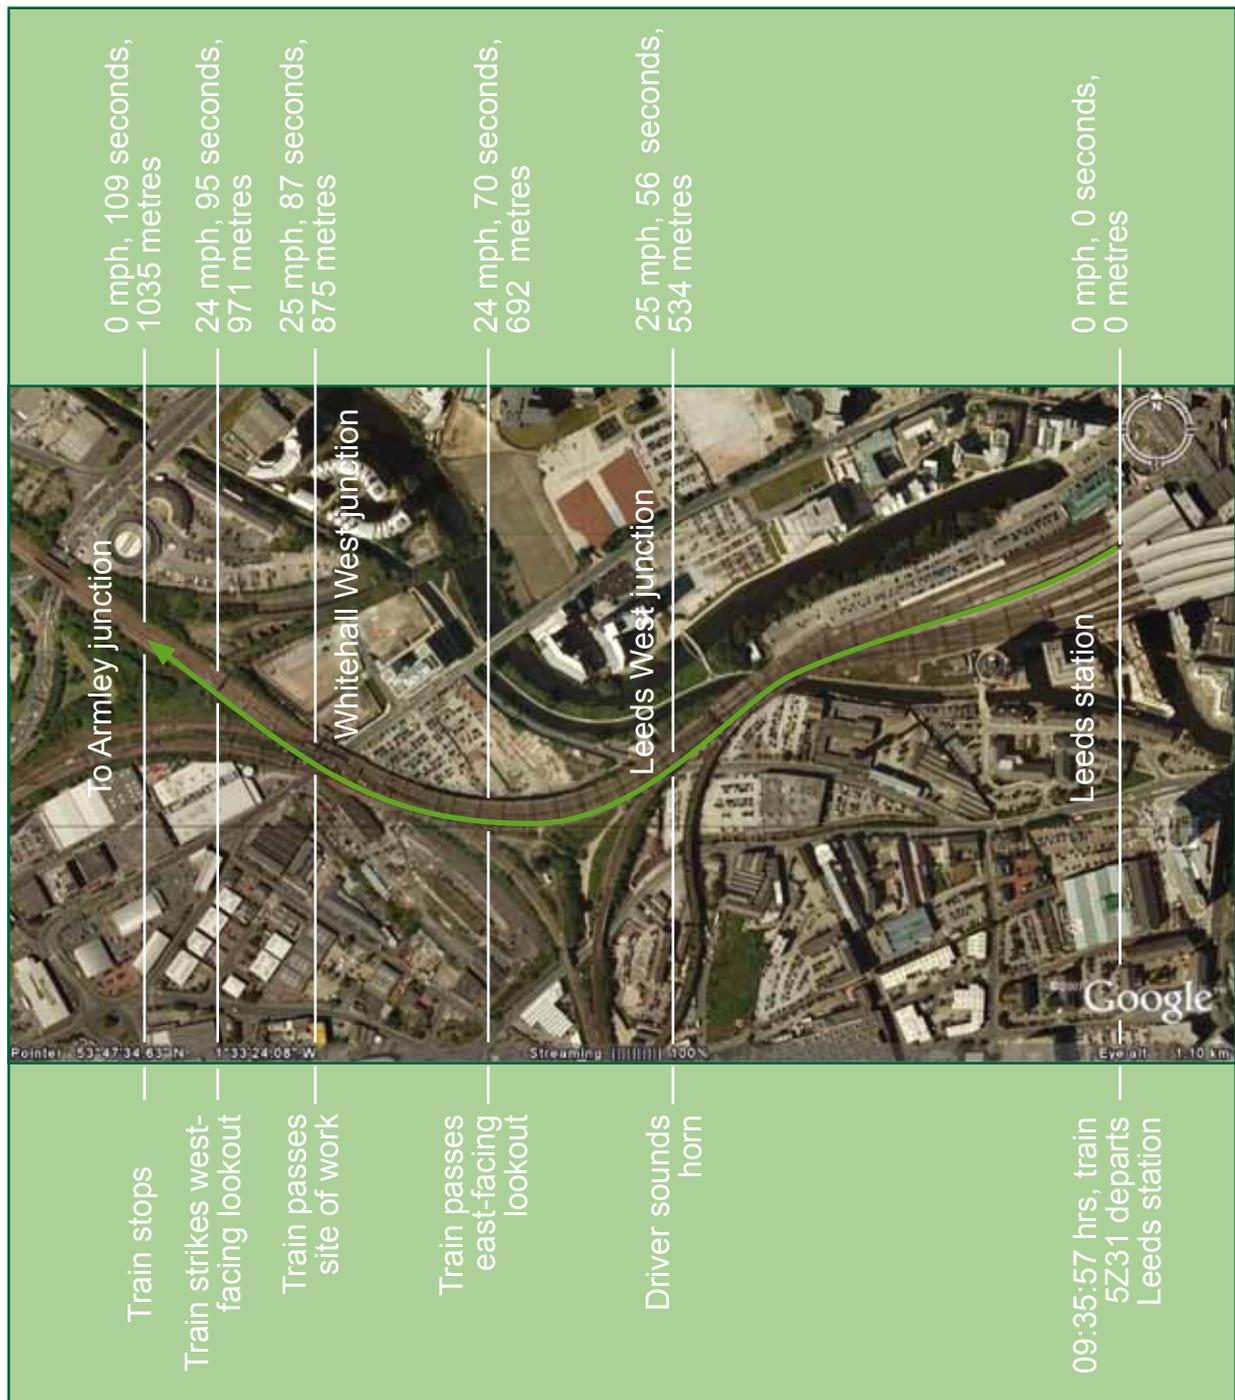
Figure 5: The train's route from Leeds station (image from Google Earth)

- 24 The trainee and supervisor saw that their train had a green signal for them to proceed onto the line to Shipley; information from the train's data recorder shows that at 09:35:57 hrs the train drove out of Leeds station, accelerated to the 25 mph (40 km/h) speed limit and then coasted. See figure 5 for the train's route and figure 6 for a reconstruction of the trainee driver's view from the cab when leaving Leeds station.

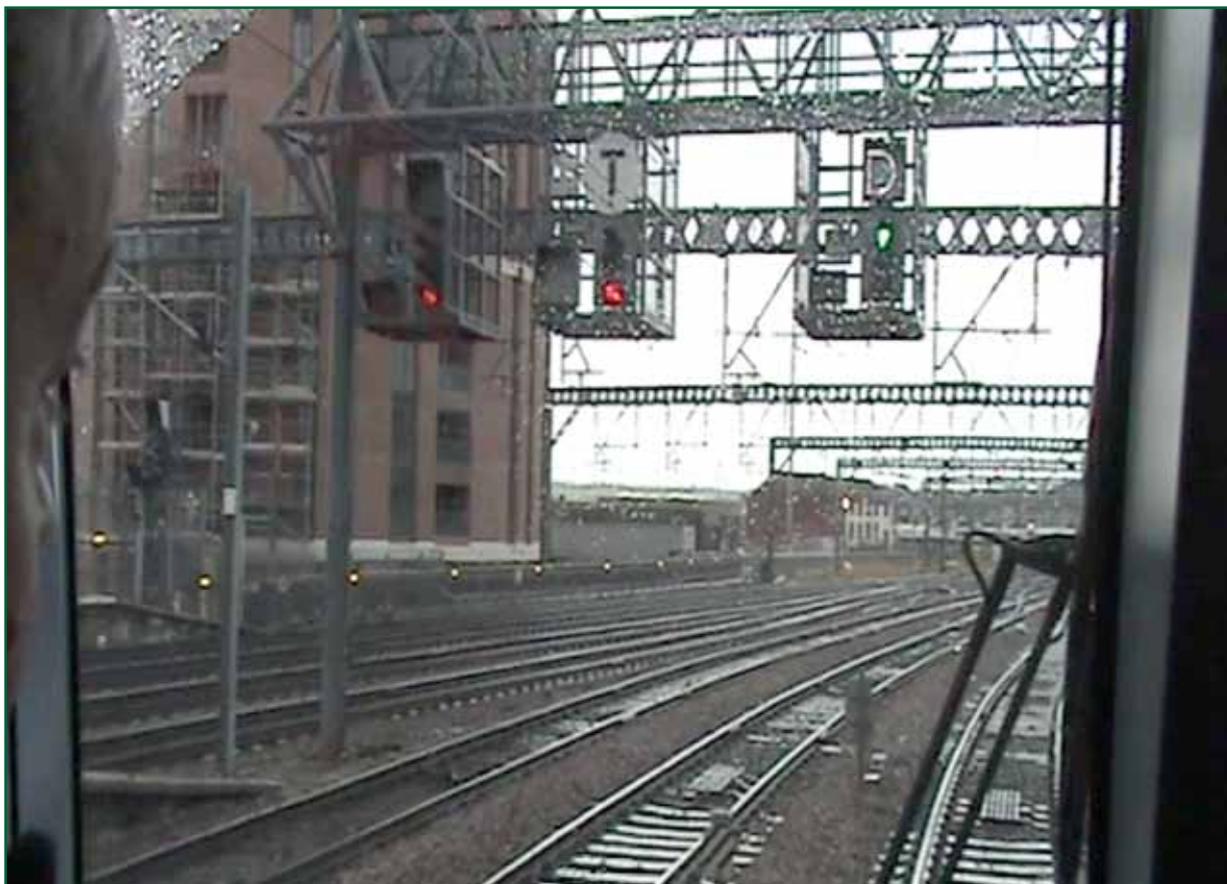
Figure 6: The driver's view leaving Leeds station

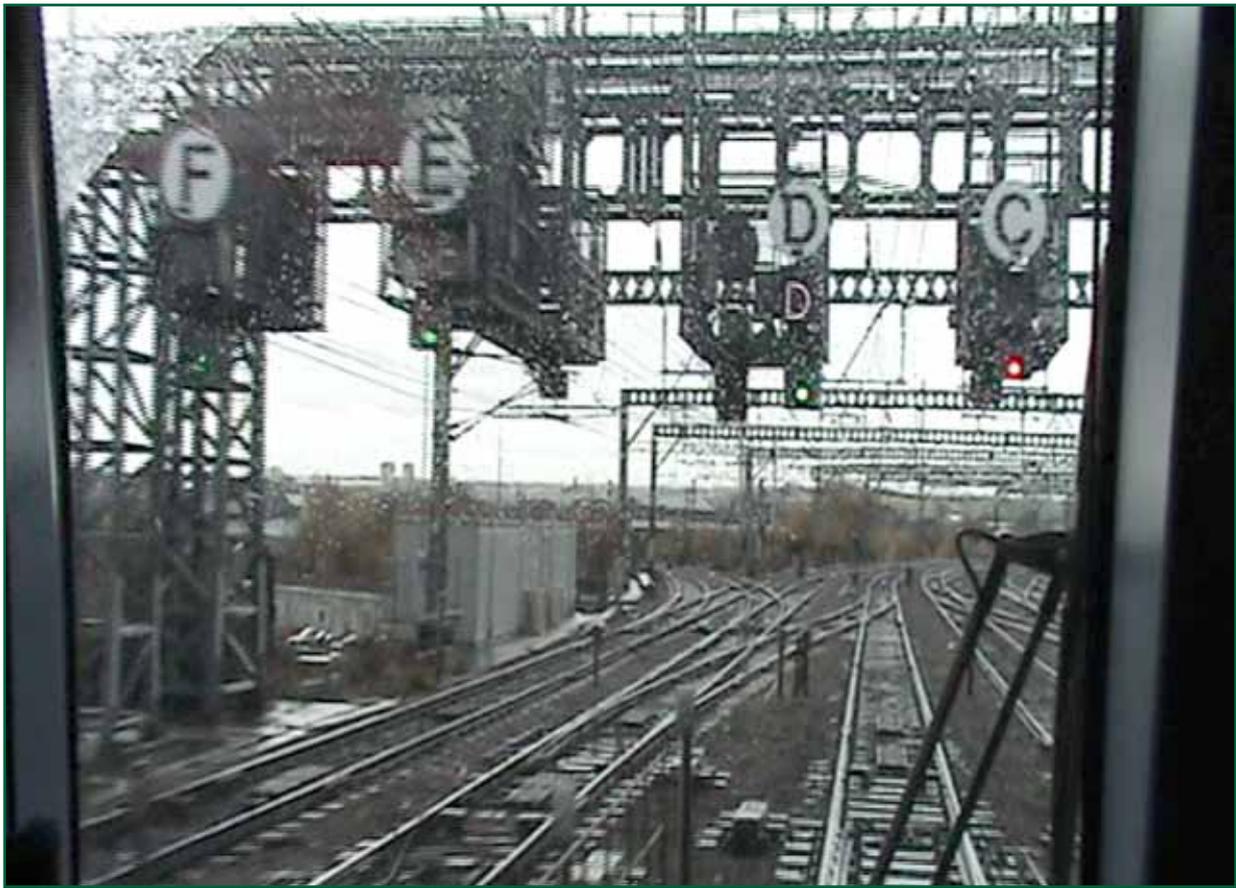
- 25 The supervisor told the trainee that the route to Shipley required close attention as the train curves left then right, signals at Leeds West, Whitehall West and Armley junctions must be seen, understood and obeyed and there are other trains and track workers in the area. Figure 7 shows the track and signals at Leeds West junction.

Figure 7: The driver's view of the track and signals at Leeds West junction
