# Rail Accident Report

**Near-miss on Victory level crossing, near  
Taunton, Somerset  
19 December 2009**

# Near-miss on Victory level crossing, near Taunton, Somerset, 19 December 2009

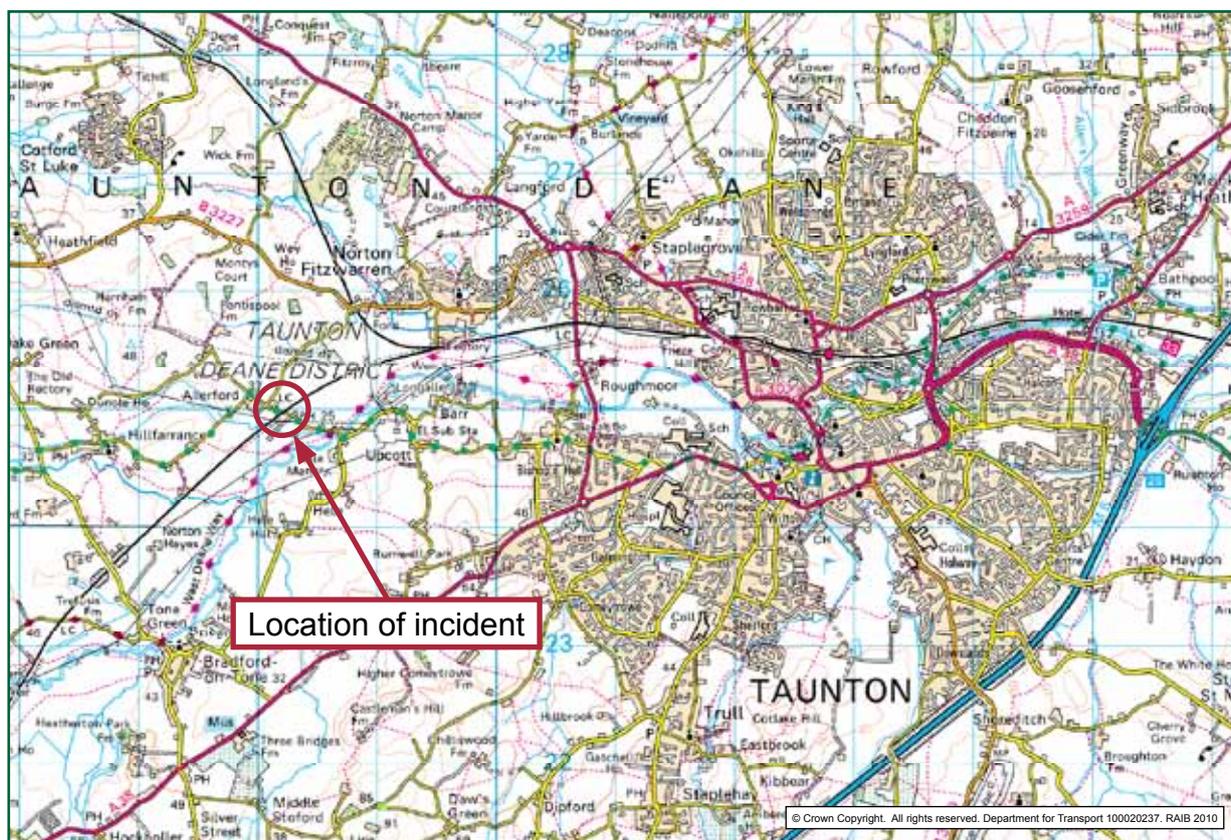
- 5 At around 18:40 hrs on 19 December 2009 an unaccompanied wheelchair user was traversing Victory level crossing, located approximately 3 miles west of Taunton, in Somerset, travelling from the north side of the crossing to the south side (figure 1). As he approached the south side of the crossing, the front right-hand wheel of his wheelchair became trapped in an area of *ballast* located in the south-west corner of the crossing (figure 2). While he was attempting to free the wheel, the level crossing audible warning tone sounded to warn of an approaching train. Unable to free the wheel, the wheelchair user took hold of a nearby fence and pulled himself free from the wheelchair. Moments later the train passed over the level crossing and struck the back wheel of the wheelchair.

Figure 1: Extract from Ordnance Survey map showing location of incident
