Rail Accident Investigation Branch

# RAIB Bulletin 03/2013

## Signal NW36 passed at danger at Norton-on-Tees West, 16 January 2013

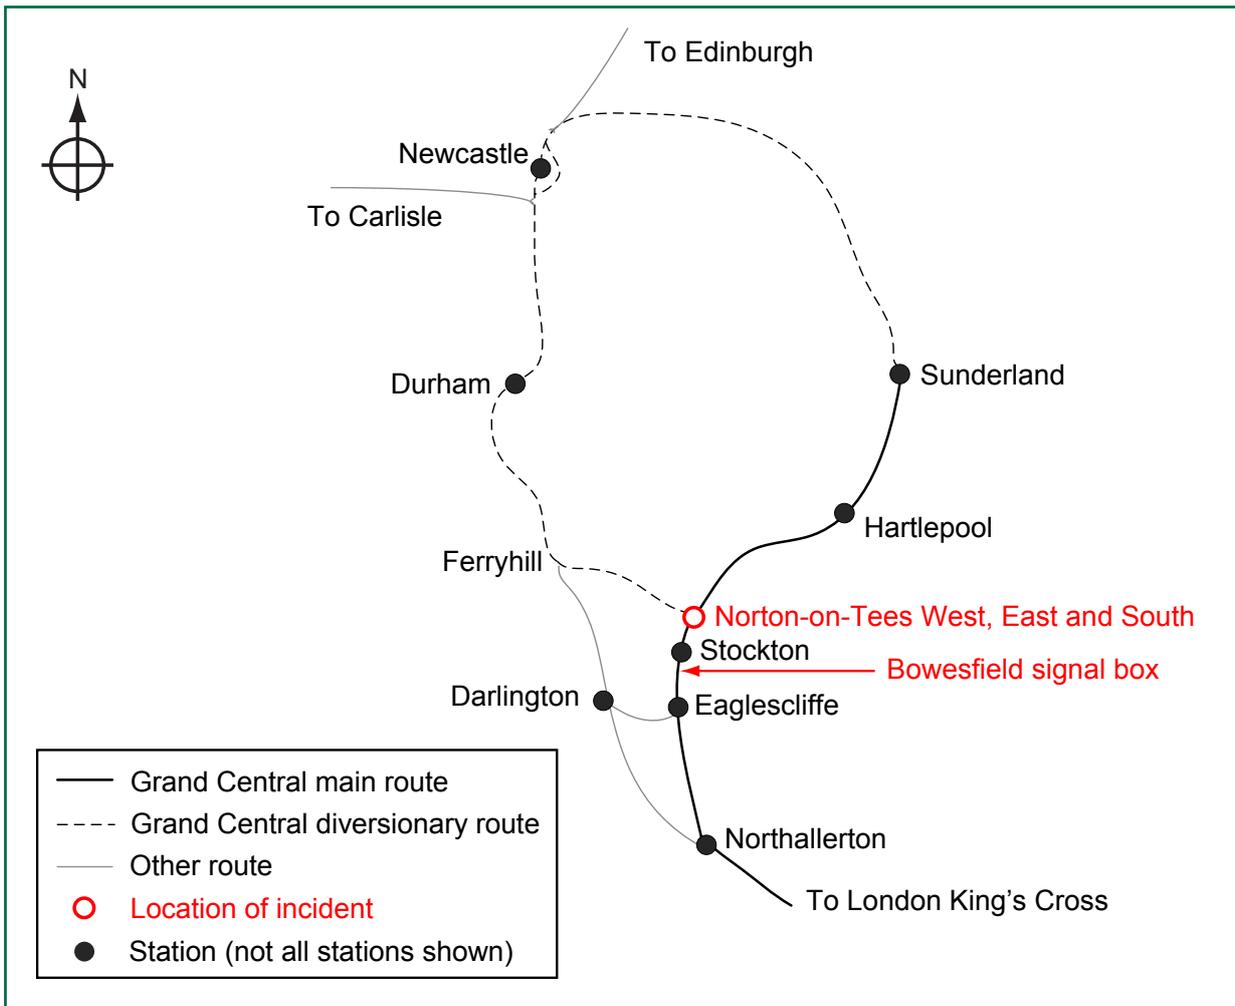
Figure 1: The main and diversionary routes used by Grand Central services between Sunderland and Norton-on-Tees (not to scale).

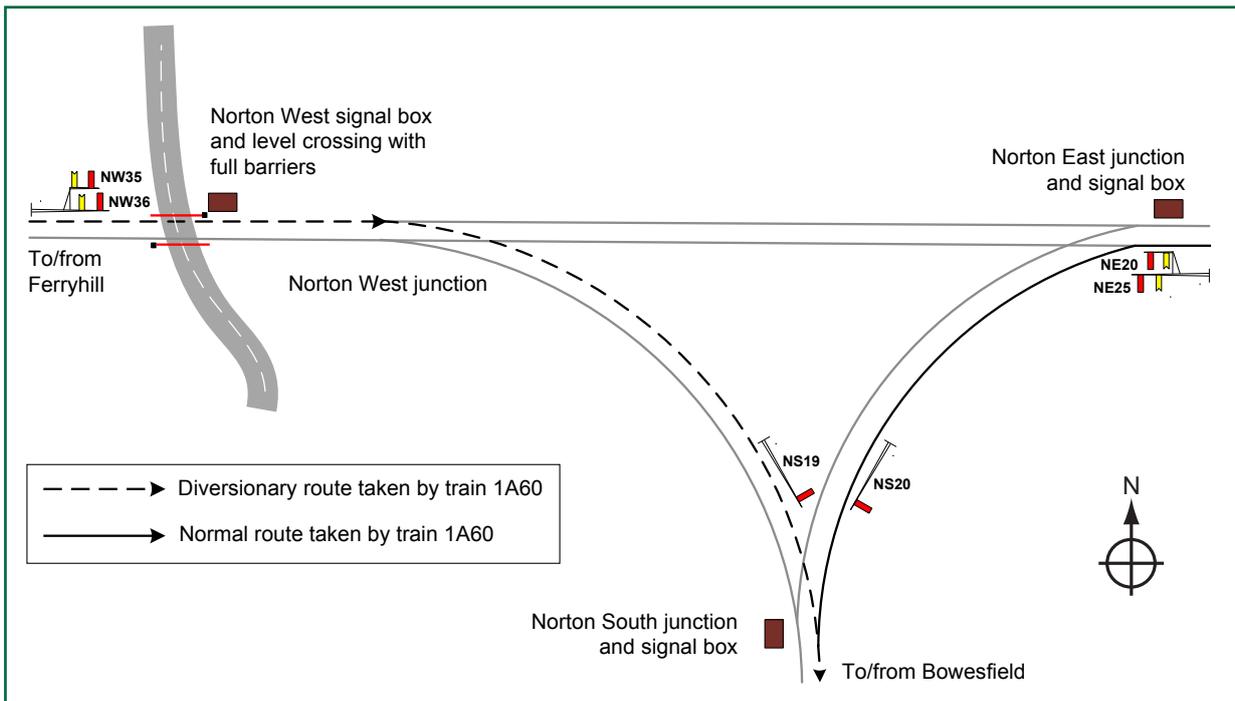
Figure 2: Key features of the route between Norton-on-Tees West, Norton-on-Tees South and Norton-on-Tees East (not to scale and not all signals shown).
